E. Arborist Report

Siena College Masterplan development Riversdale Road, Camberwell VIC Arboricultural Impact Assessment

Arboricultural Impact Assessment Report regarding ninety-six (96) trees located within the vicinity of the proposed Masterplan (Stages 1–4) at Siena College, 815 Riversdale Road, Camberwell

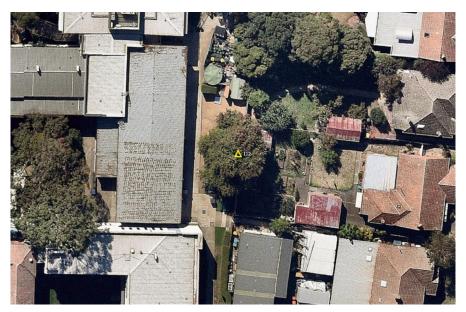
- 7.2.4 Tree 112 will be situated within close proximity to the proposed construction footprint and associated landscaping works of the Veritas Centre. To ensure the future viability of the tree the following action, over and above the generic protection, is proposed:
 - Detail design ensures minimal encroachment within the TPZ by either service installation, building foundations or hard landscaping.
 - If major encroachment is deemed necessary to facilitate development, root mapping along the
 proposed line of encroachment is recommended to ascertain the level of impact. The root mapping
 should be undertaken at set intervals, designated by the project Arborist, to allow detailed
 management plans to be formulated prior to construction work commencing.

Figure 18. Site map showing Tree 112, which requires specific protection measures for Stage 1 works. (ArborSite, March 2021).

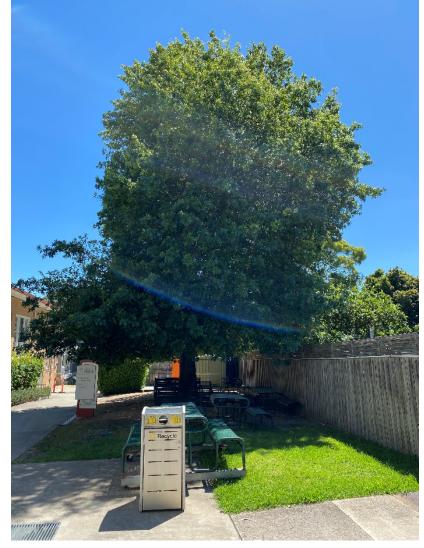
Figure 19. An image showing Tree 112 in its current growing environment. (ArborSafe, March 2021).

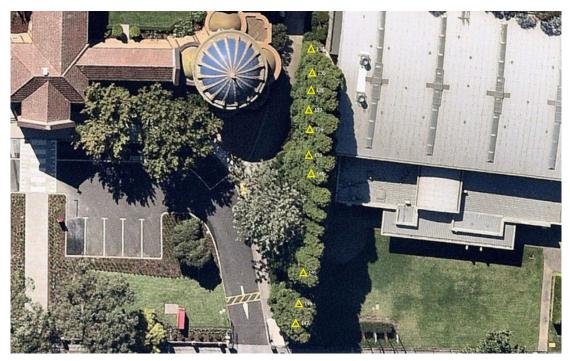
- 7.2.8 Trees 134, 135, 136, 137, 138, 139, 140, 145, 146 and 147 will be situated within close proximity to the proposed construction footprint and excavation of the Gymnasium/underground car park and underground car park entrance ramp. To ensure the future viability of the trees the following action, over and above the generic protection, is proposed:
 - Where the proposed excavation for the underground carpark or the carpark entrance ramp encroaches more than 10% into the trees TPZ, root mapping is recommended to ascertain the extent of impact. The root mapping should be at set intervals, designated by the project Arborist, to ascertain the extent of root encroachment into the area of proposed excavation. This work should be undertaken prior to construction work commencing to allow for detailed management plans to be formulated.

Figure 20. Site map showing trees requiring specific protection measures for Stage 2 works. (ArborSite, March 2021).

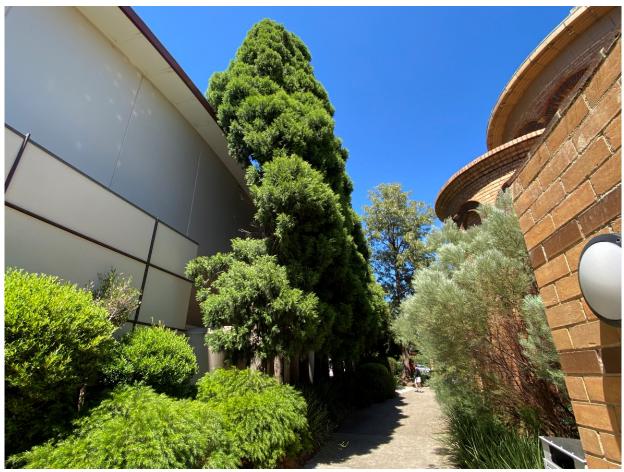
Figure 21. An image showing the avenue of *Cupressus torulosa* (Bhutan Cypress) in their current growing environment. (ArborSafe, March 2021).

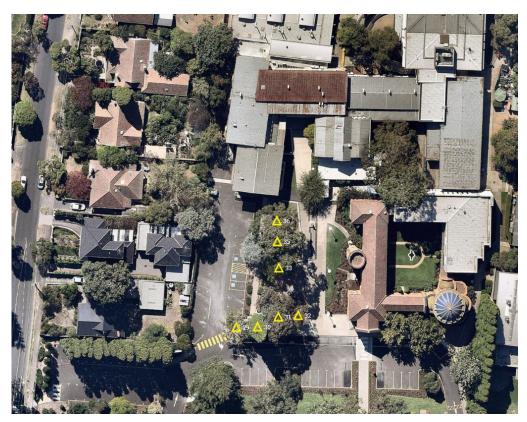
- 7.2.12 Trees 29, 30, 31, 32, 33, 35 and 36 will be situated within the proposed landscaping upgrade area for the Stage 3 Salamanca Precinct works, and prior to that the temporary car park and access and site shed zone. It is likely works will be undertaken within the TPZ of these trees. To ensure the future viability of the trees the following actions, over and above the generic protection, is proposed:
 - All trees have trunk protection installed and all affected TPZ have ground protection installed. If site
 sheds are located within TPZs these can act as protection measures as long as the shed feet have
 ground protection installed under them.

Figure 22. Site map showing trees requiring specific protection measures for Stage 3 works. (ArborSite, March 2021).

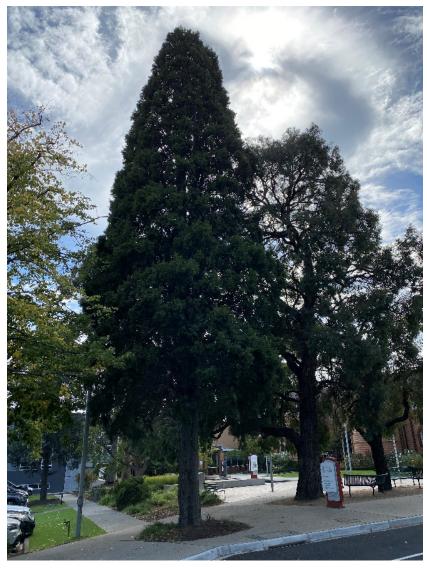
Figure 23. An image, looking north, of Trees 30, 31 and 32 in their current growing environment. (ArborSafe, March 2021).

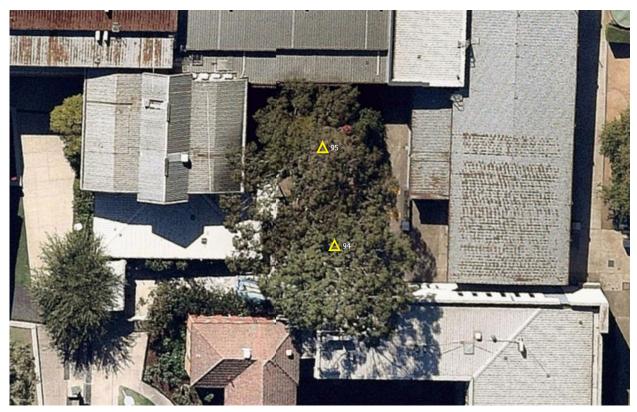
- 7.2.16 Trees 94 and 95 will be situated within the middle of the proposed landscaping upgrade works for the central courtyard. To ensure the future viability of the trees the following action, over and above the generic protection, is proposed:
 - Detail design ensures minimal encroachment within the TPZ by either service installation, hard landscaping excavation works or level changes.

Figure 24. Site map showing tree requiring specific protection measures for Stage 4 works. (ArborSite, March 2021).

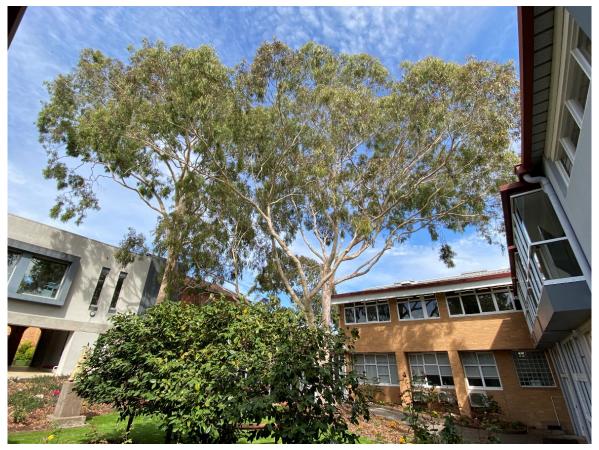
Figure 25. An image showing Trees 94 and 95 in their current growing environment. (ArborSafe, March 2021).

- 7.2.27 Irrespective of the proposed development it was recommended that Trees 94 and 216 are pruned as per the specifications provided within Appendix E Tree Assessment Data.
