Case Meallin Xavier College Masterplan development Barkers Road, Kew VIC Arboricultural Impact Assessment

22 July 2021

C92266v4

Arboricultural Impact Assessment Report regarding ninety-seven (97) trees located within the vicinity of the proposed Masterplan development at Xavier College, Barkers Road, Kew

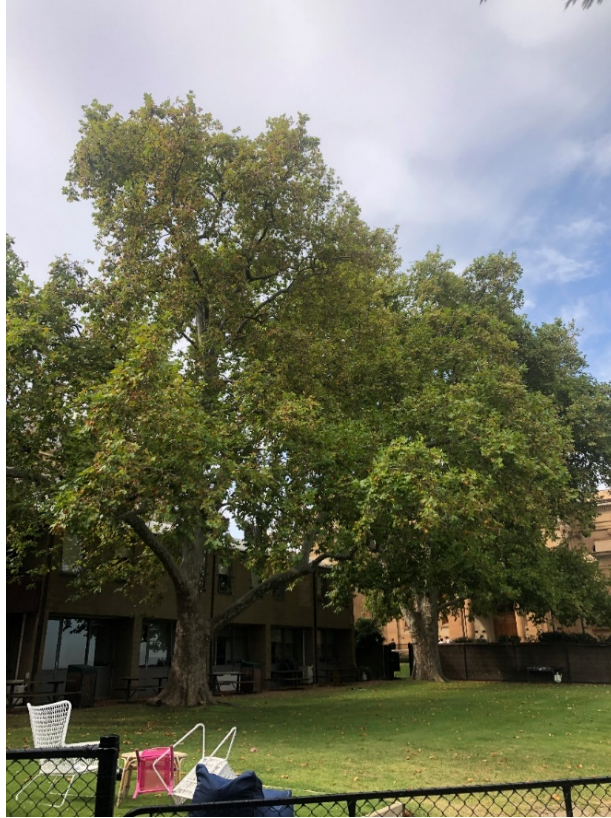
- 5.2.5 Three (3) trees are considered of site significance due to age, size and location within the site These are trees 300 and 301, both *Platanus x acerifolia* (London Plane) and 302 *Cupressus torulosa* (Bhutan Cypress).

- 5.2.6 Trees 300 and 301 are significant examples of their species and offer considerable amenity to the local landscape while tree 302 is a significant example of *Cupressus torulosa* (Bhutan Cypress) and is one of a pair that flank the Xavier Chapel. The trees have become iconic with regard to local landscape when considered in context of the historic Chapel.

Figure 5. View to south of Trees 300 and 301 *Platanus x acerifolia* in their growing environment. (Justin Herbert, March 2021).

- 7.6.1 Trees 300, 301 and 302 require added care and TPZ protection during demolition works of the grandstand and senior boarding structures. The trees TPZ are to be fenced off where possible. Any heavy machinery will operate from outside the TPZ, unless ground protection is installed, or it operates from a pre-existing concrete foundation hardstand within the TPZ area. The demolition is to commence at the outer extent of the TPZ and move inwards to minimise root damage to the trees.

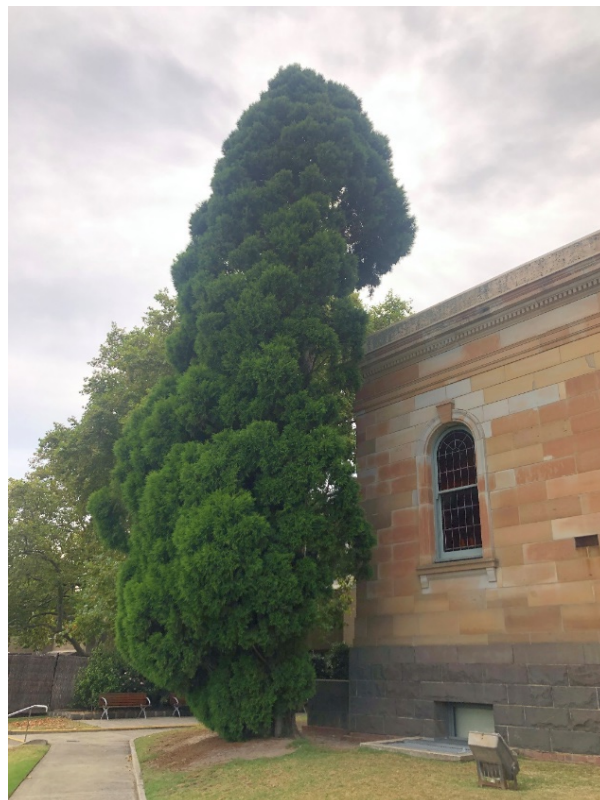
Figure 6. View to north of Tree 302 *Cupressus torulosa* in its growing environment. (Justin Herbert, March 2021).

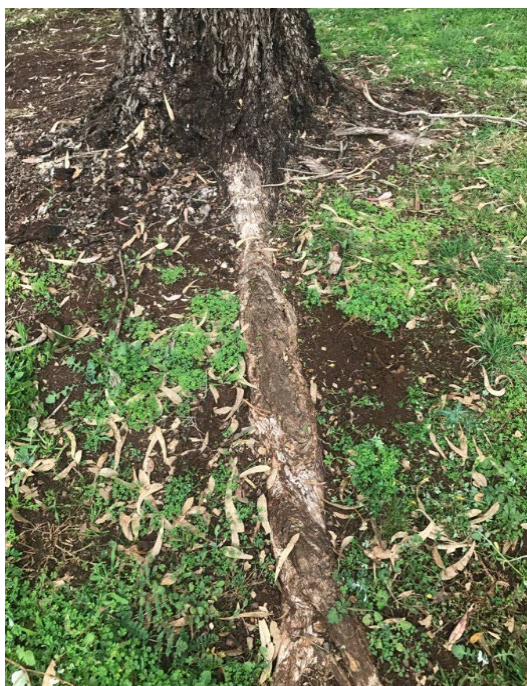
Figure 14. An example of damage to tree roots caused via mowing. (Luke Dawson, June 2017).

Another advantage to mulching around the trunk and root crown is that it limits damage to both parts from mowing equipment. This in turn reduces mechanical damage and compaction.

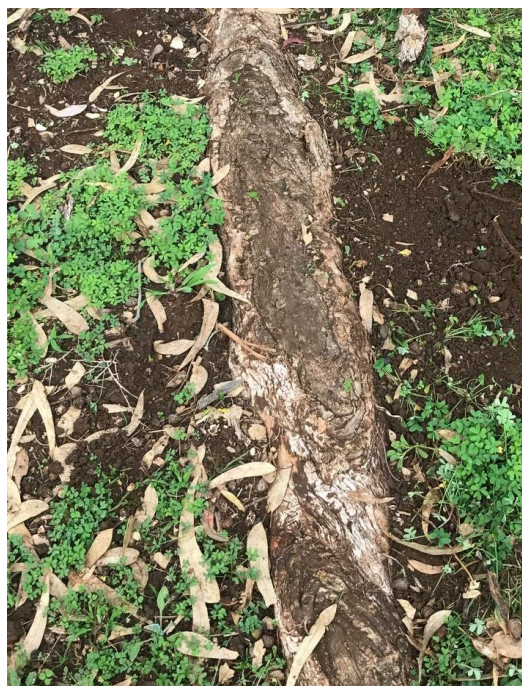
Figure 15. Image showing wound caused to upper portion of surface root by mower. (Luke Dawson, June 2017).
