Structural Report

32 Corby Street Balwyn North VIC

Prepared for Sanjiv Vij

Project Ref No.	21294	Version	2	Date	07/10/2021
Version	Issue Description				Date
1	Draft– Issued to Client				07/10/2021
2	Final – Issued to Client				07/10/2021
<p><i>This report has been prepared in accordance with the terms and conditions of appointment. N2K Consulting cannot accept any responsibility for any use of or reliance on the contents of this report by any third party.</i></p>

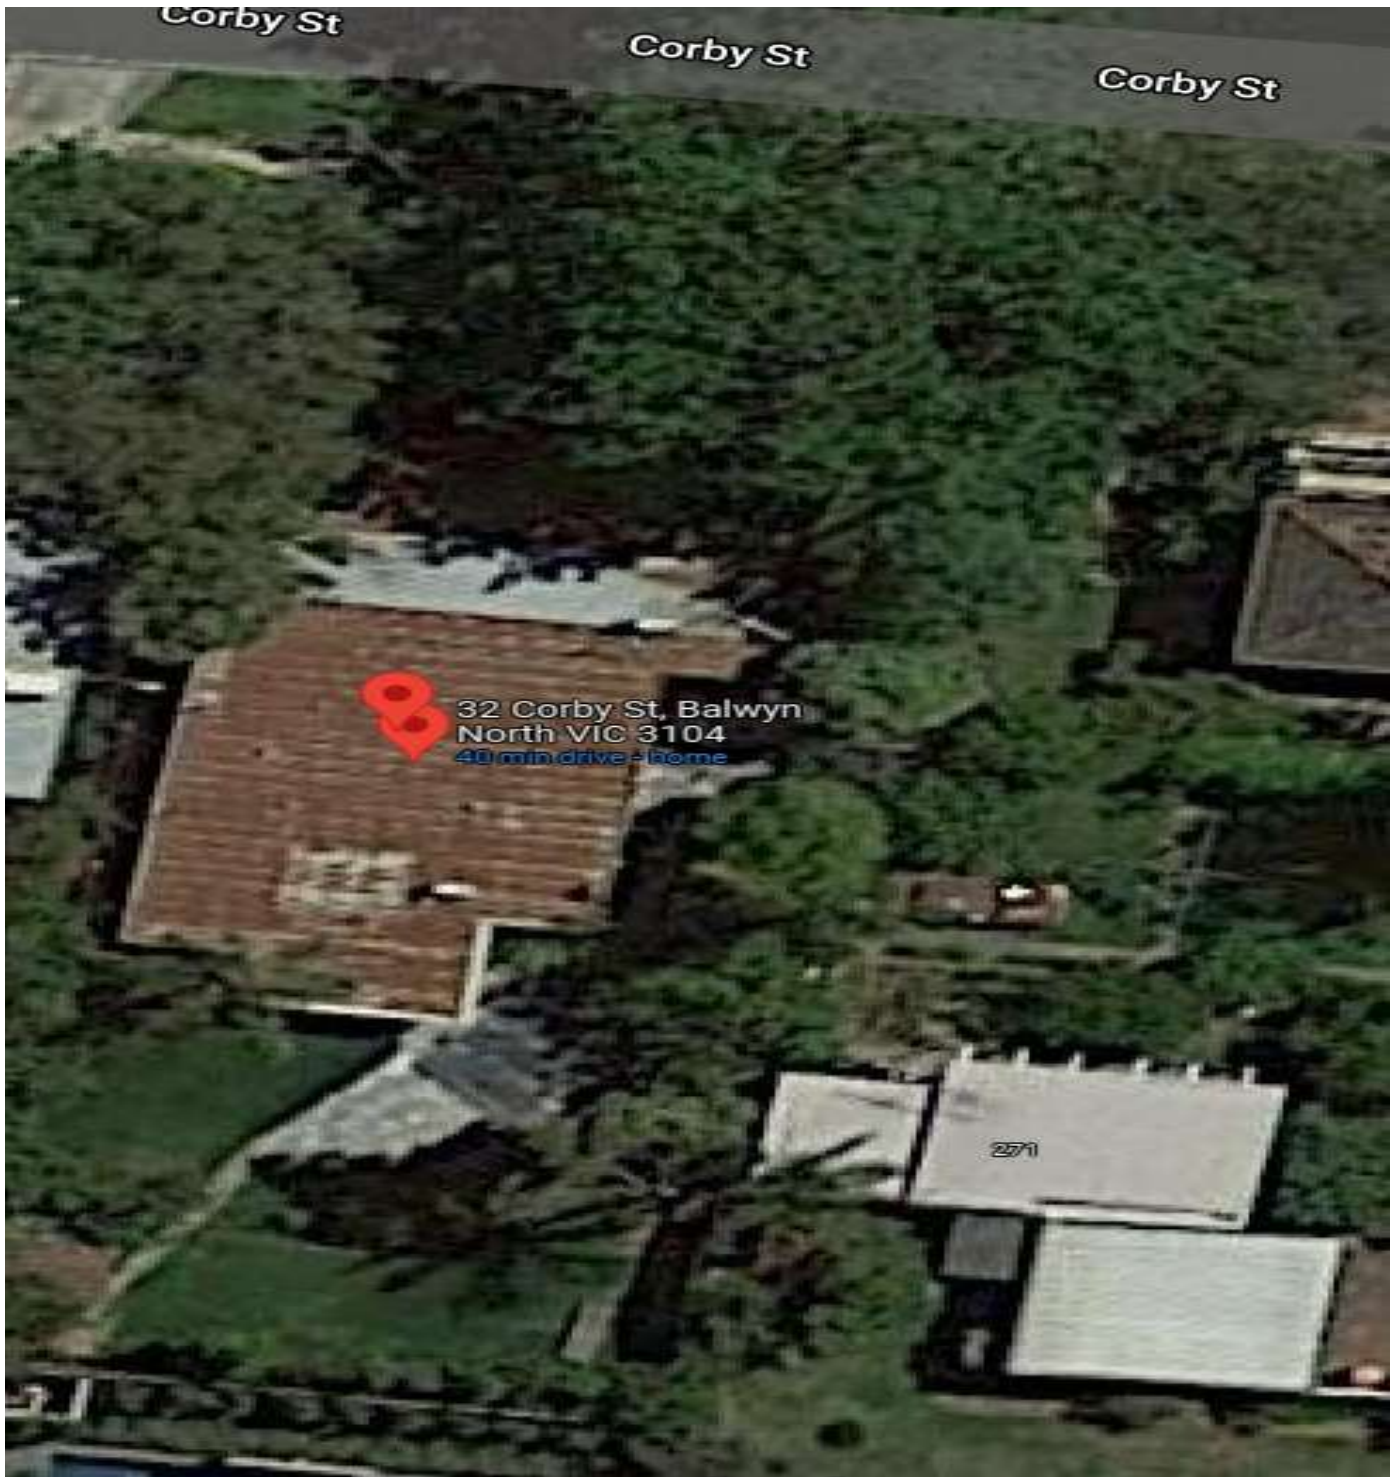
Photograph 1 – General plan view of boundary

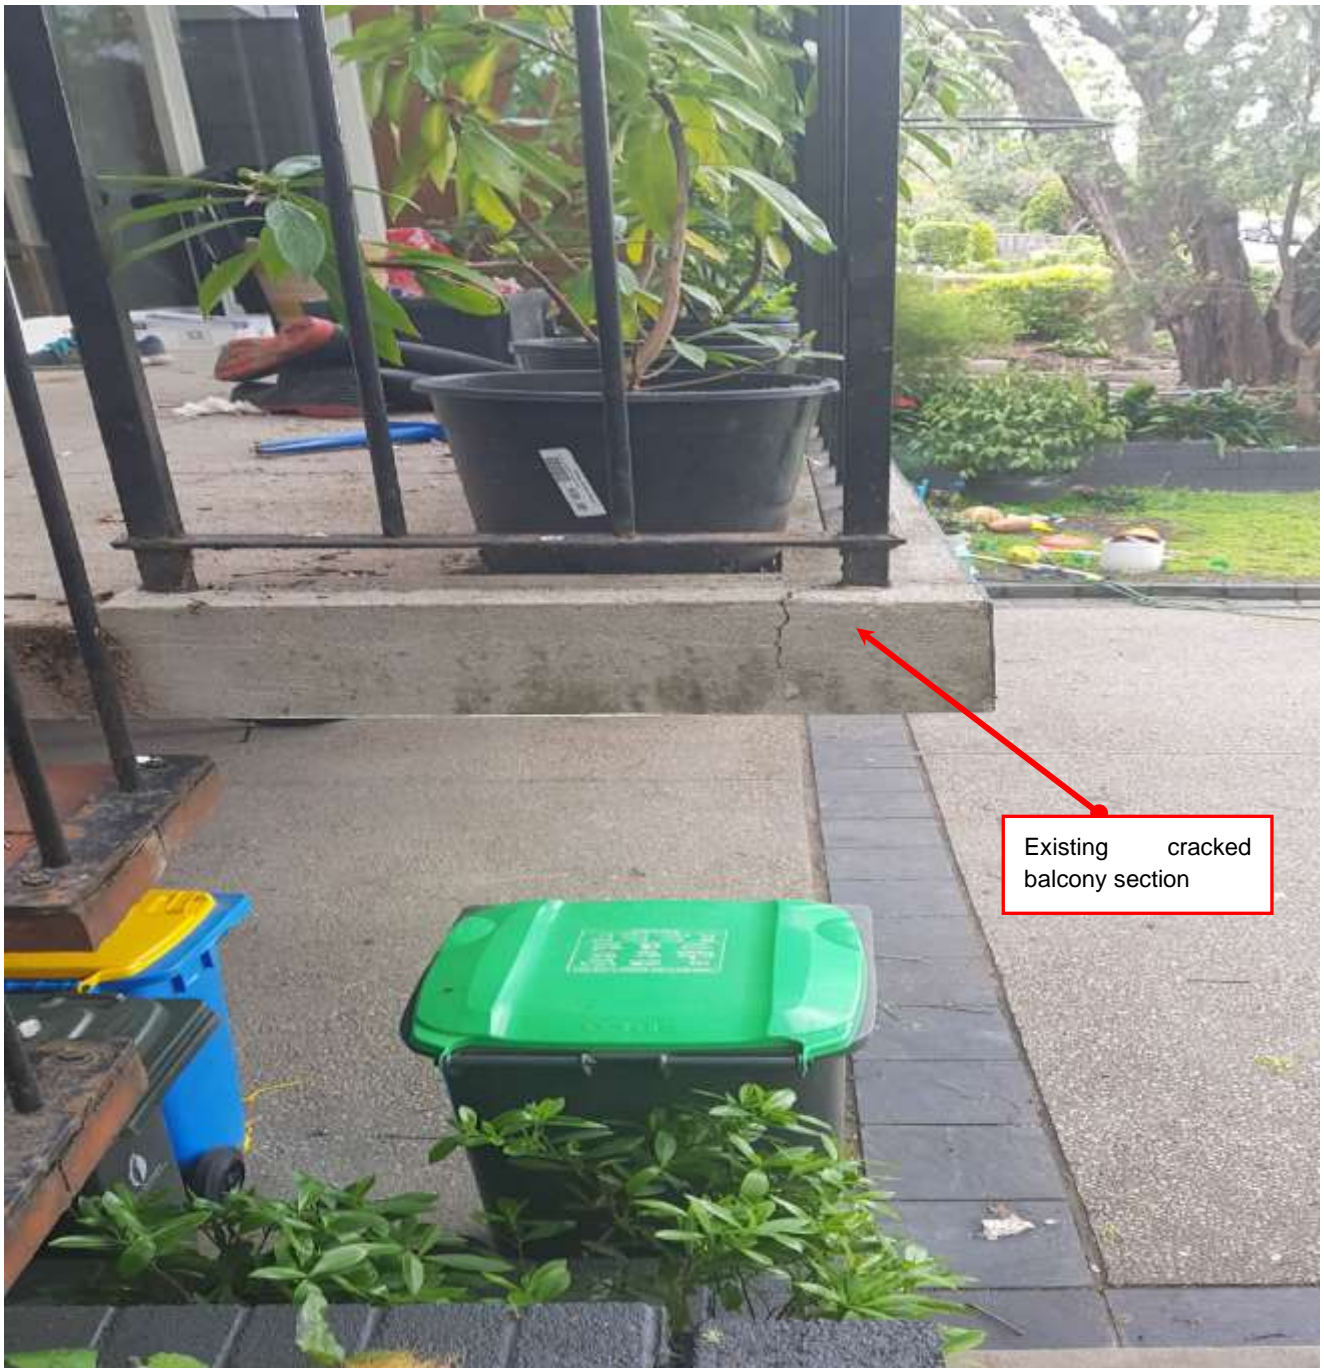
Photograph 2 – Cracked balcony slab

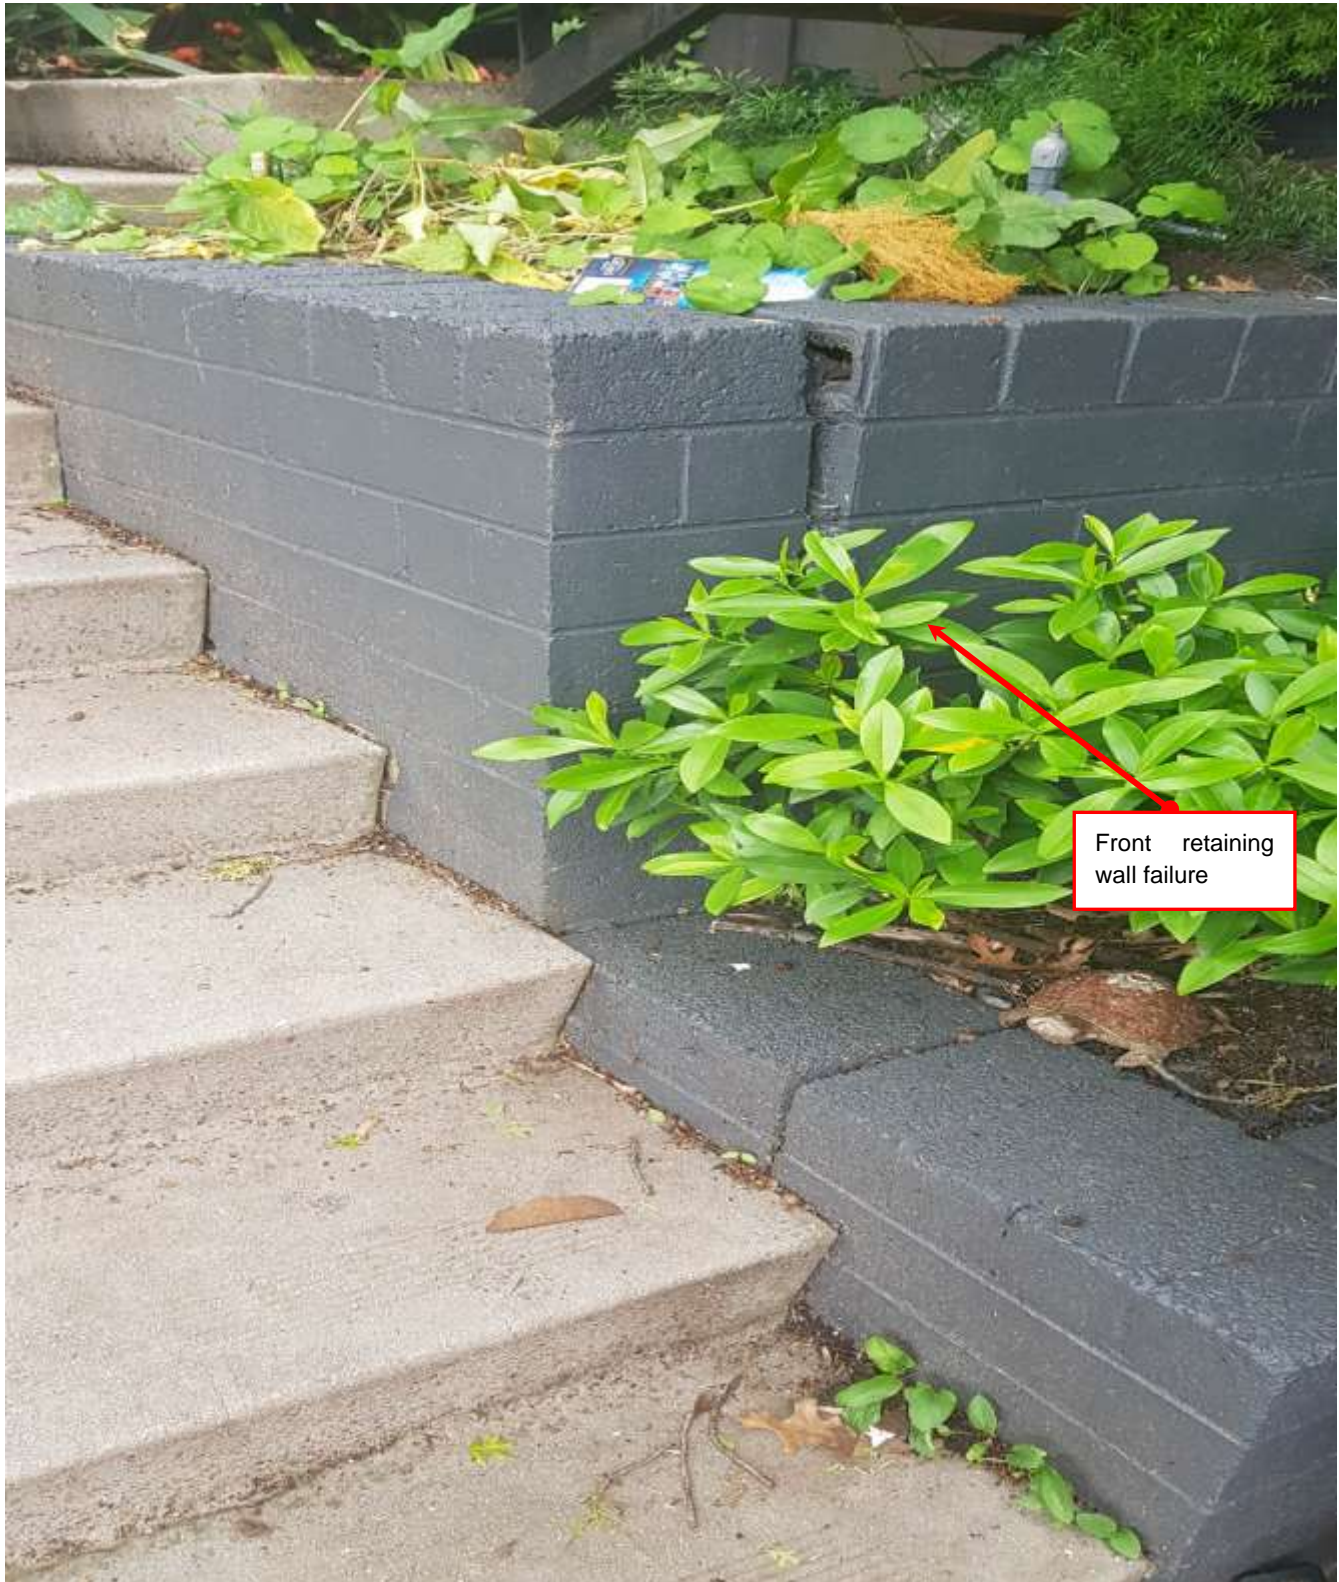
Photograph 3 – Cracked retaining wall

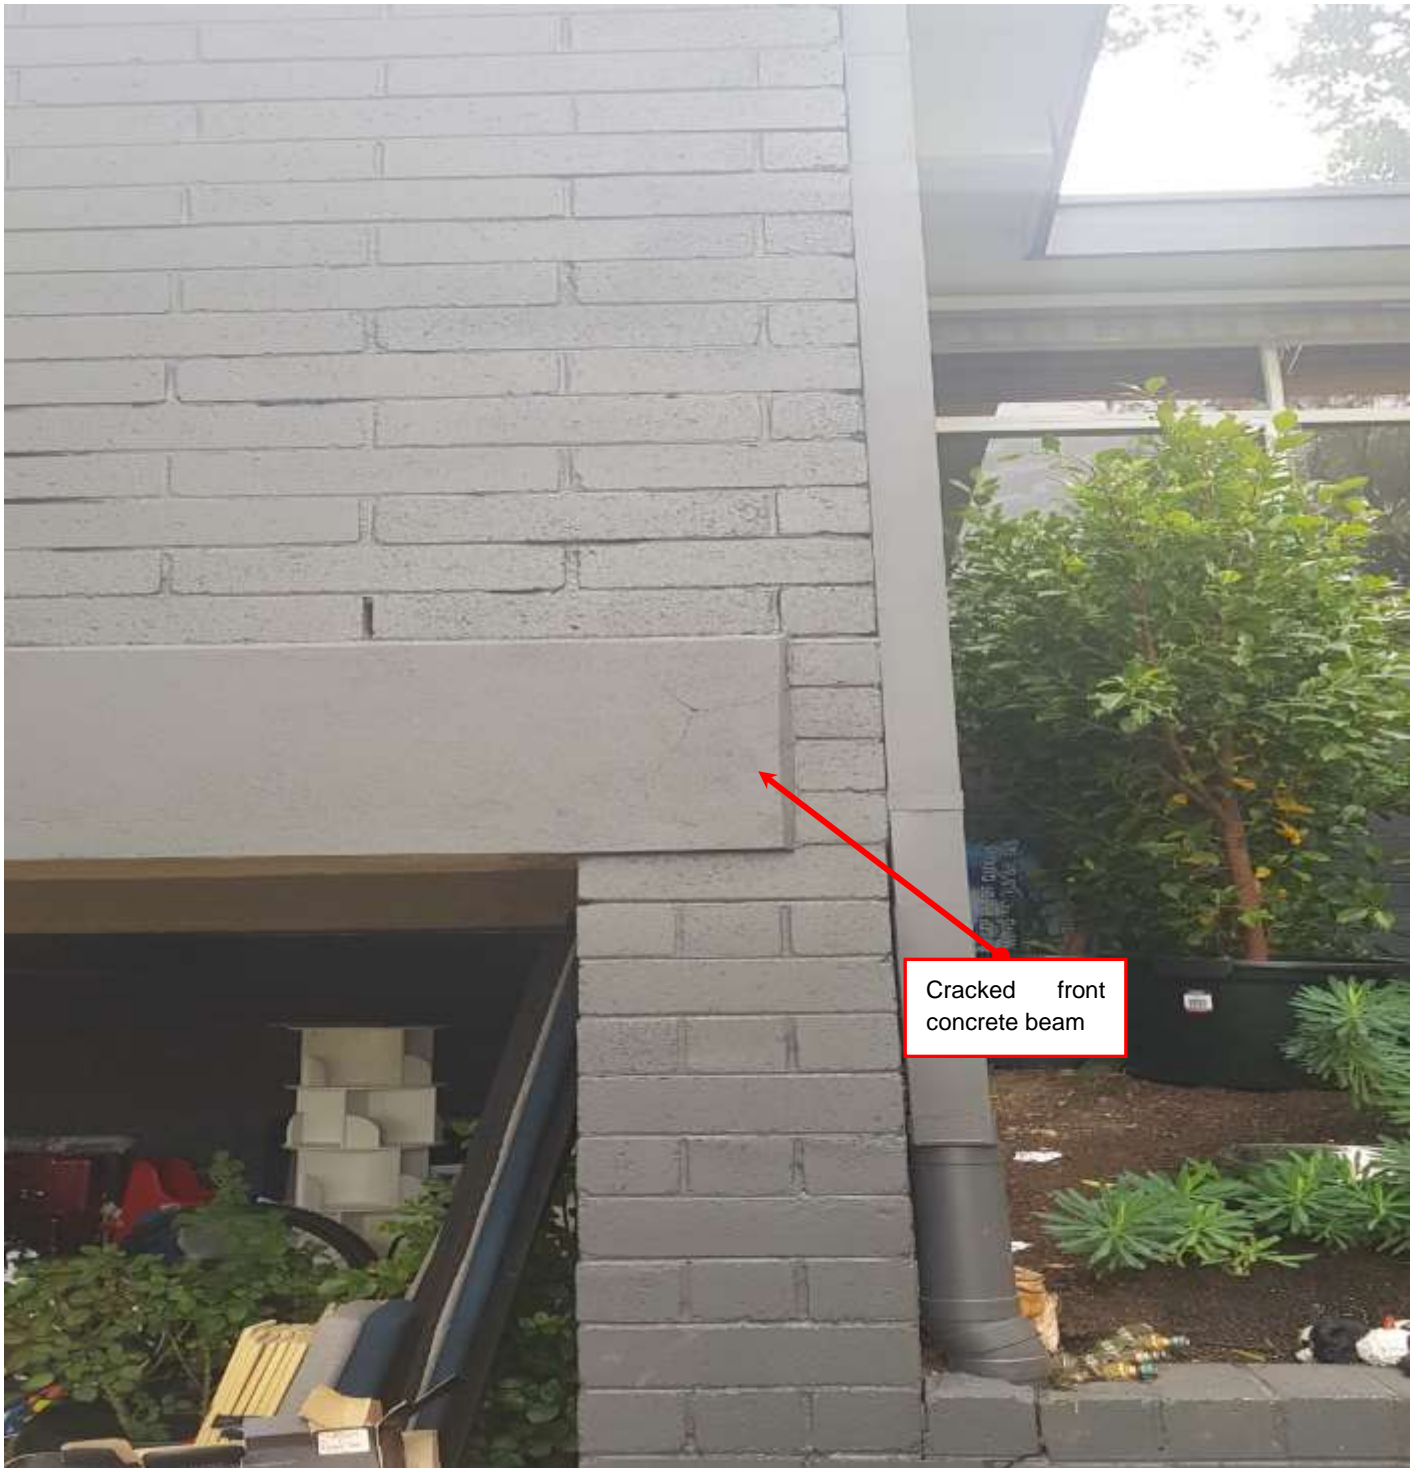
Photograph 4 – Front basement beam cracked section

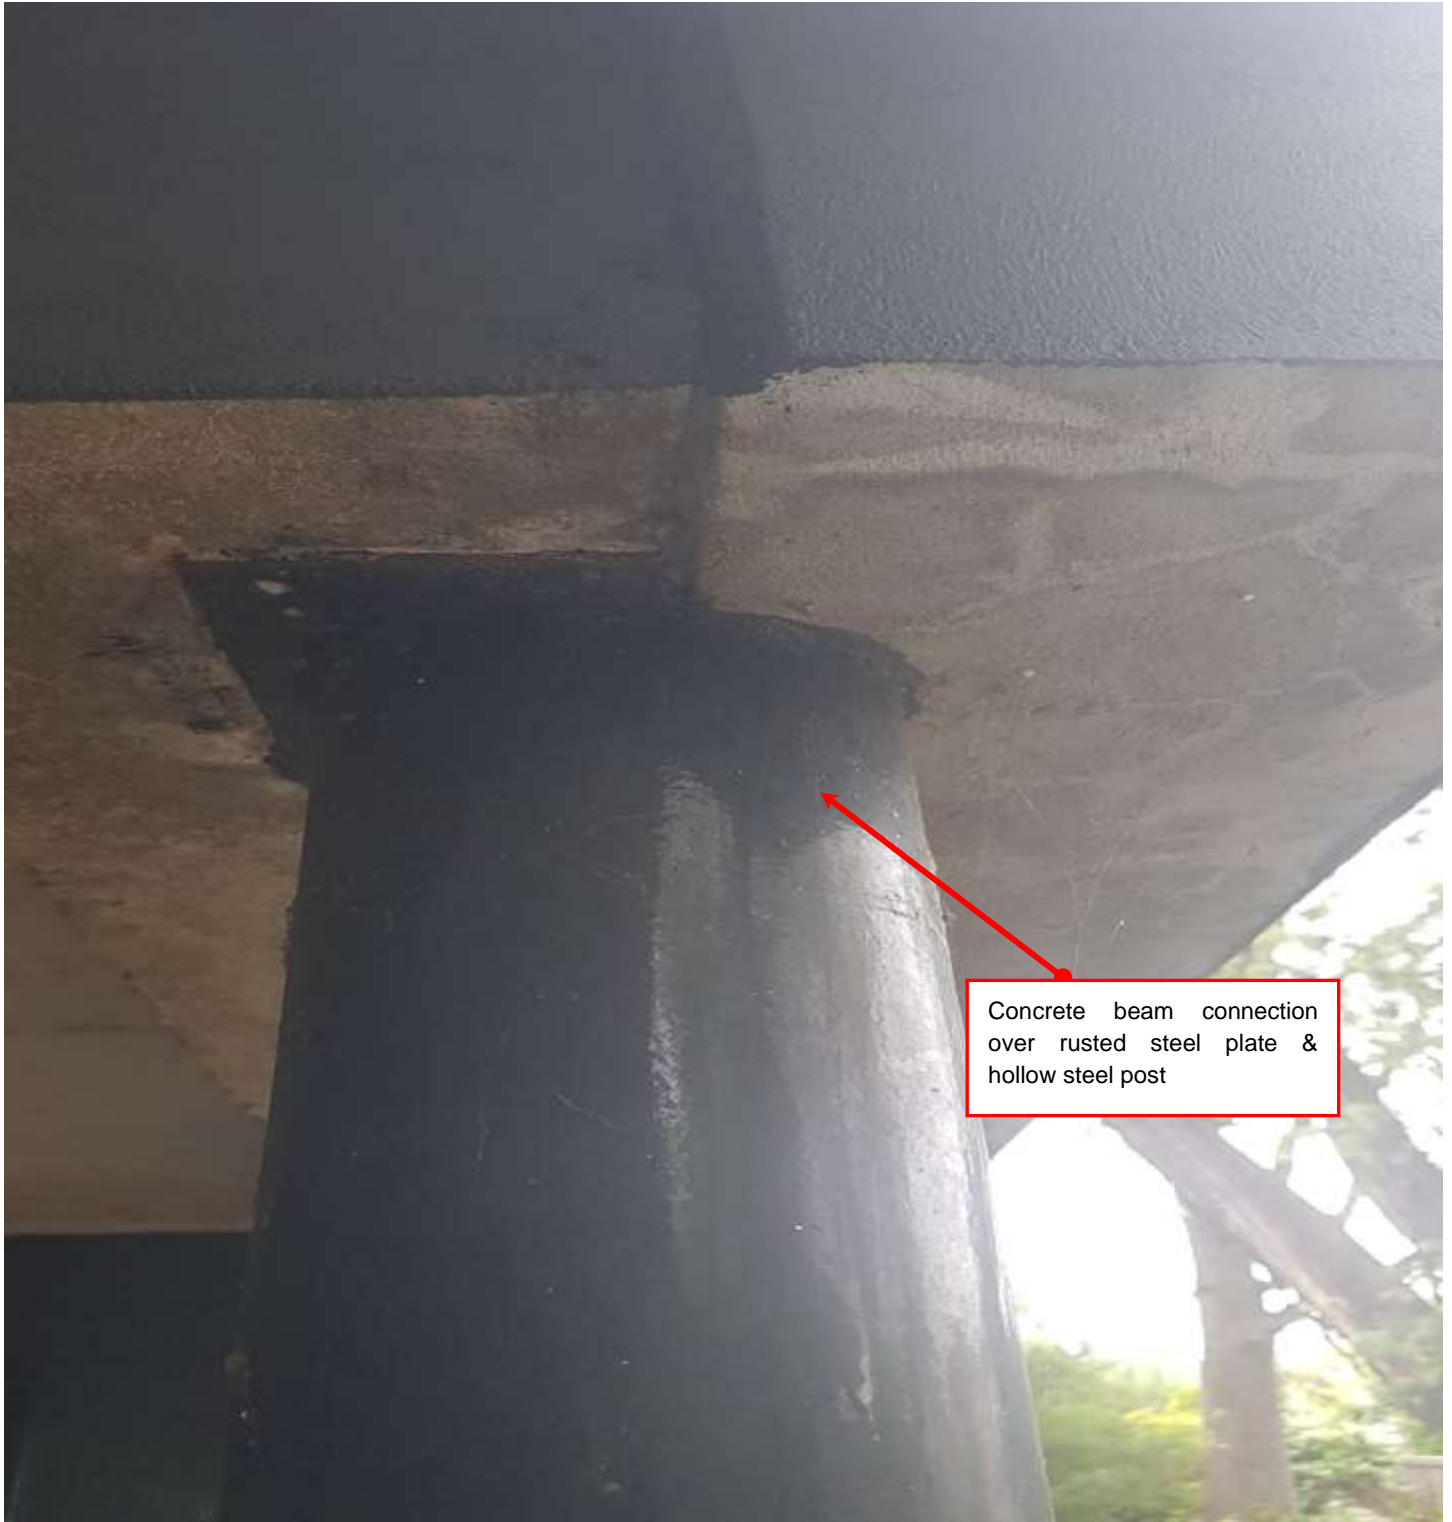
Photograph 5 – Concrete slab rusted support

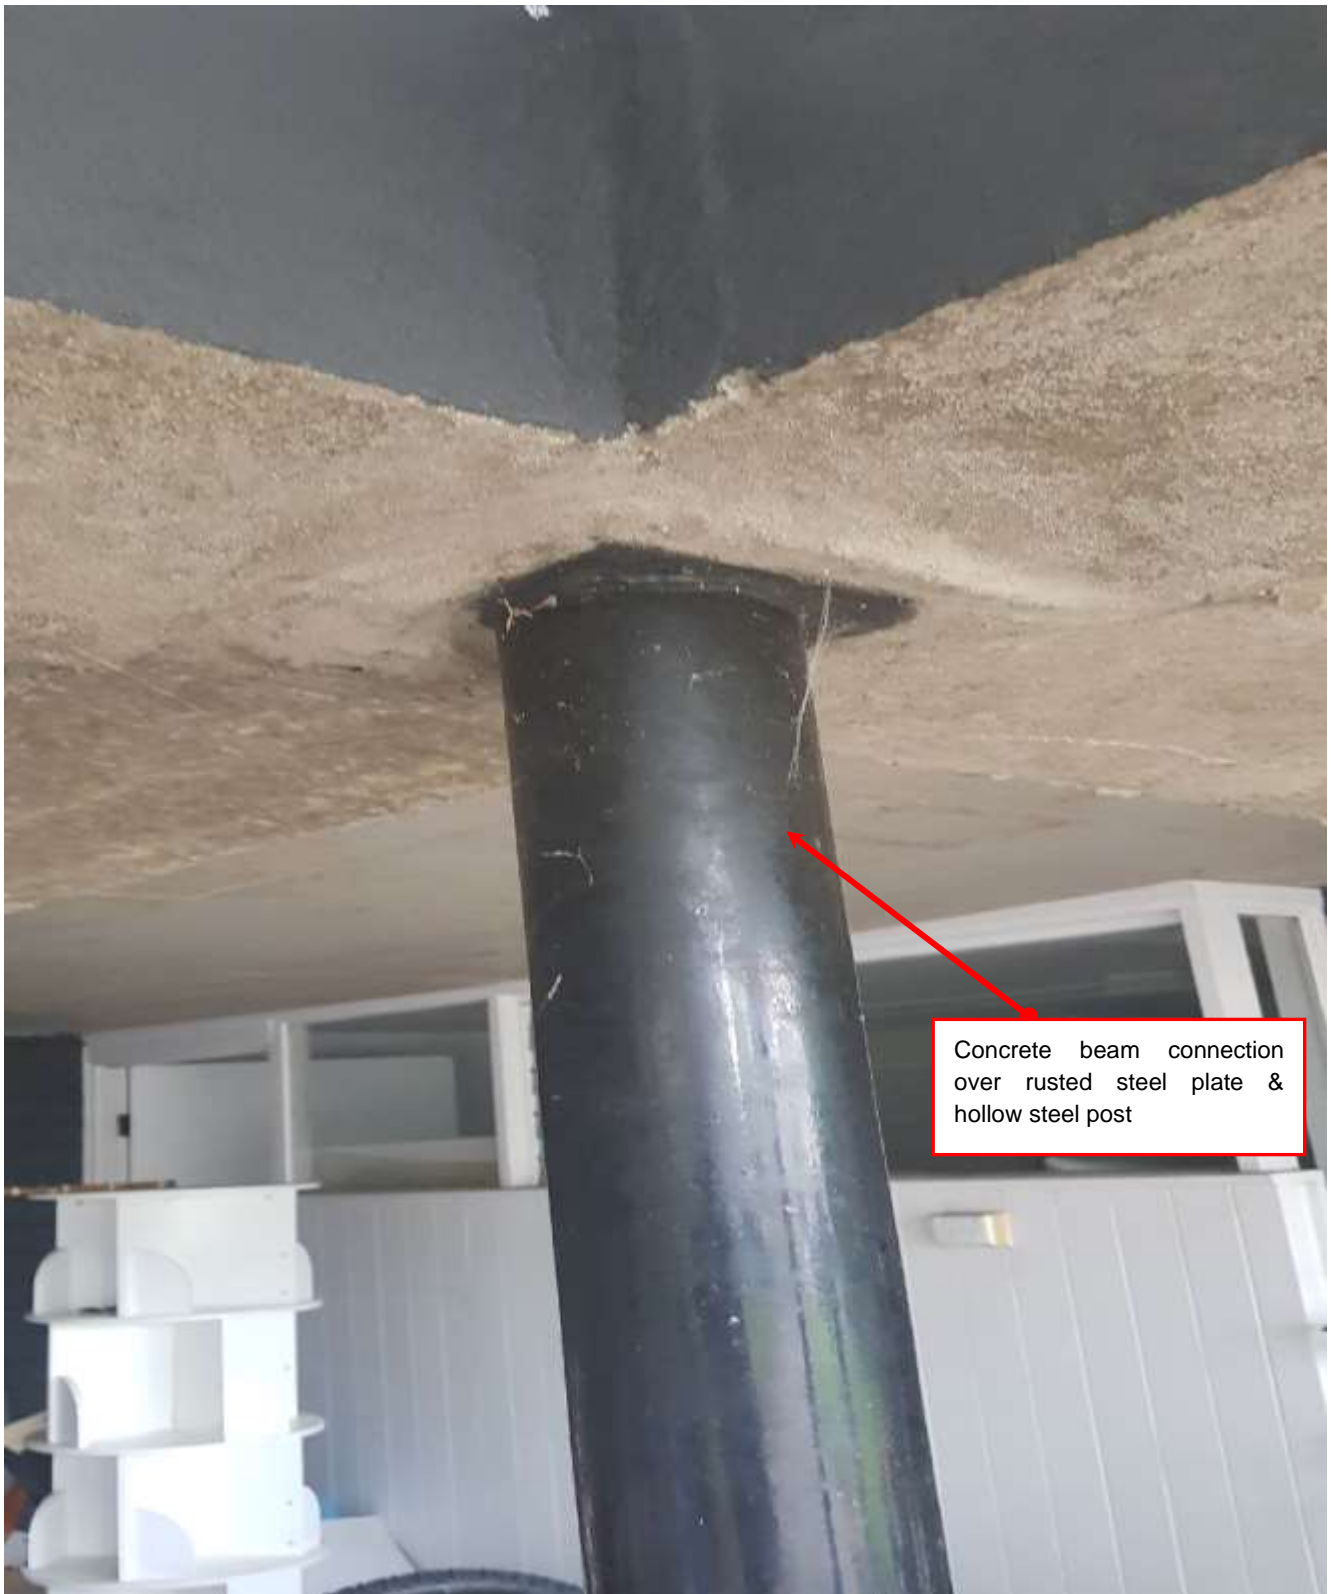
Concrete beam connection
over rusted steel plate &
hollow steel post

Photograph 6 – Concrete slab rusted support

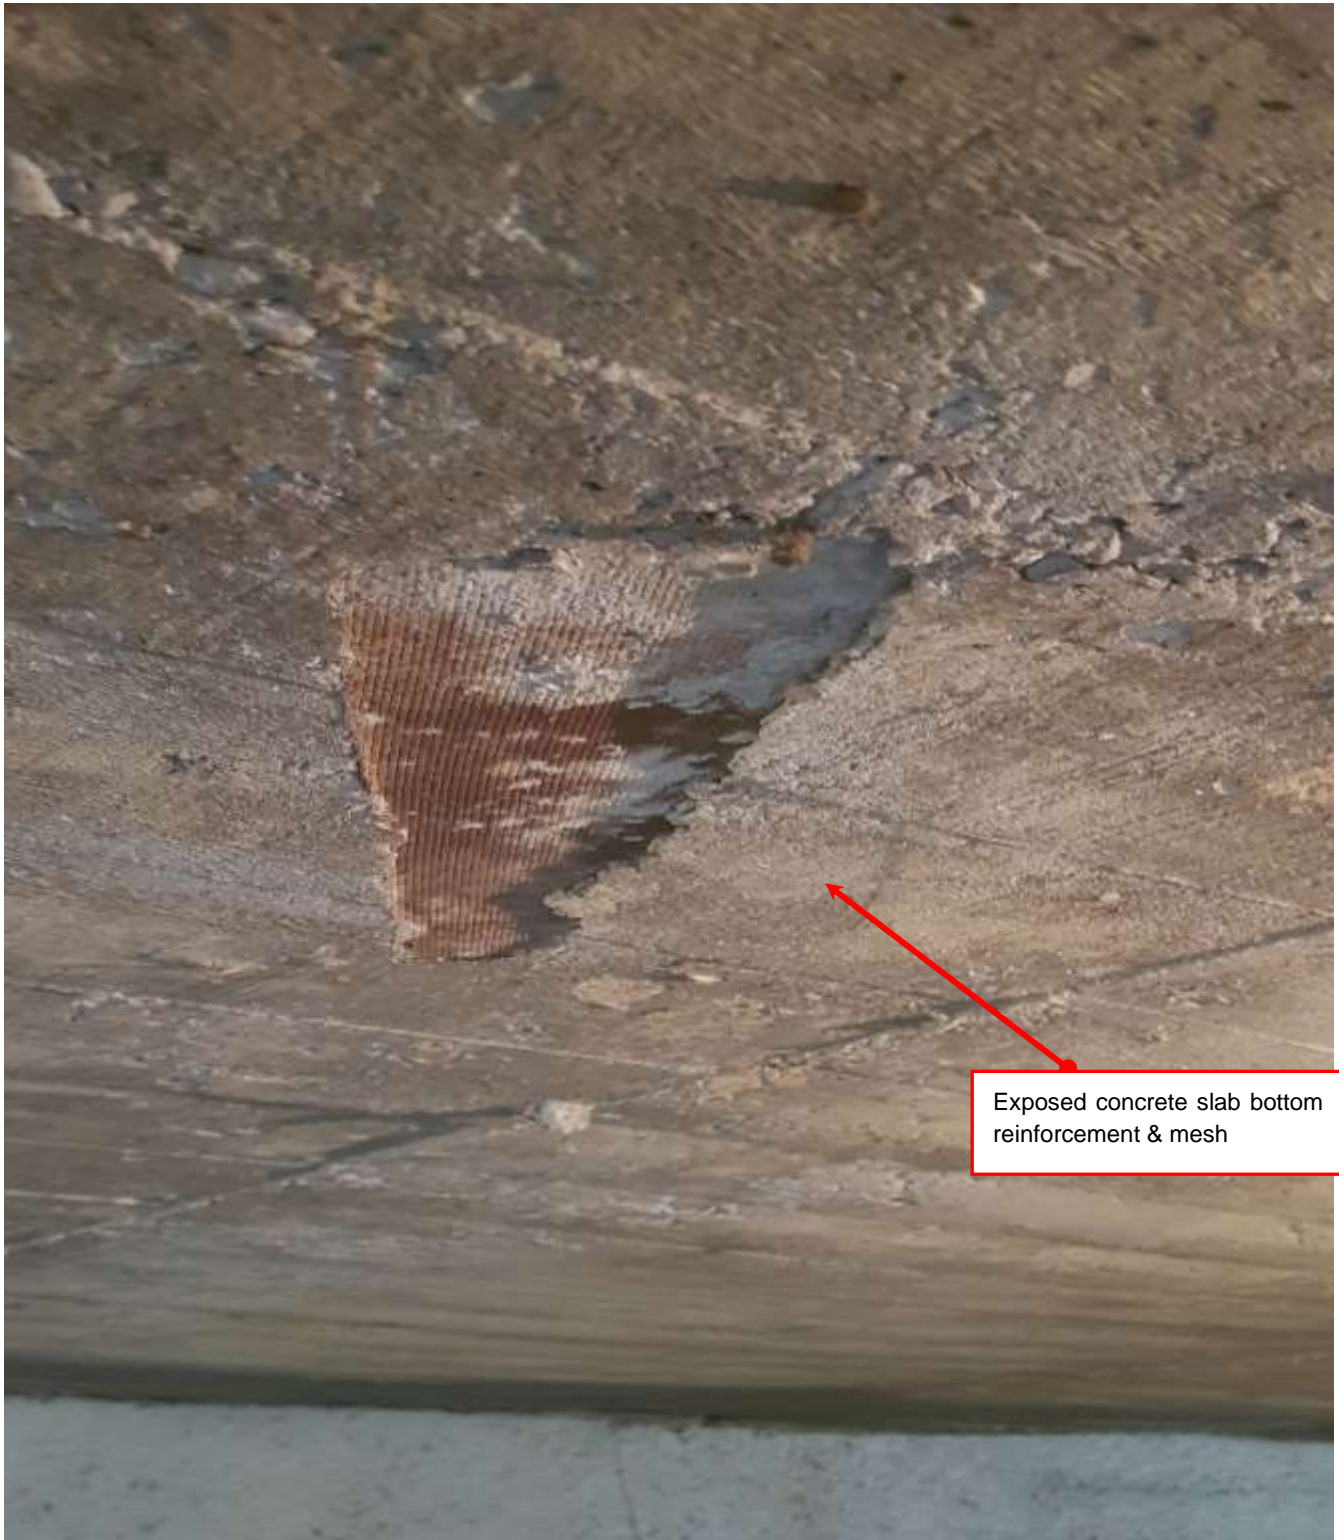
Photograph 7 – Exposed concrete slab reinforcement

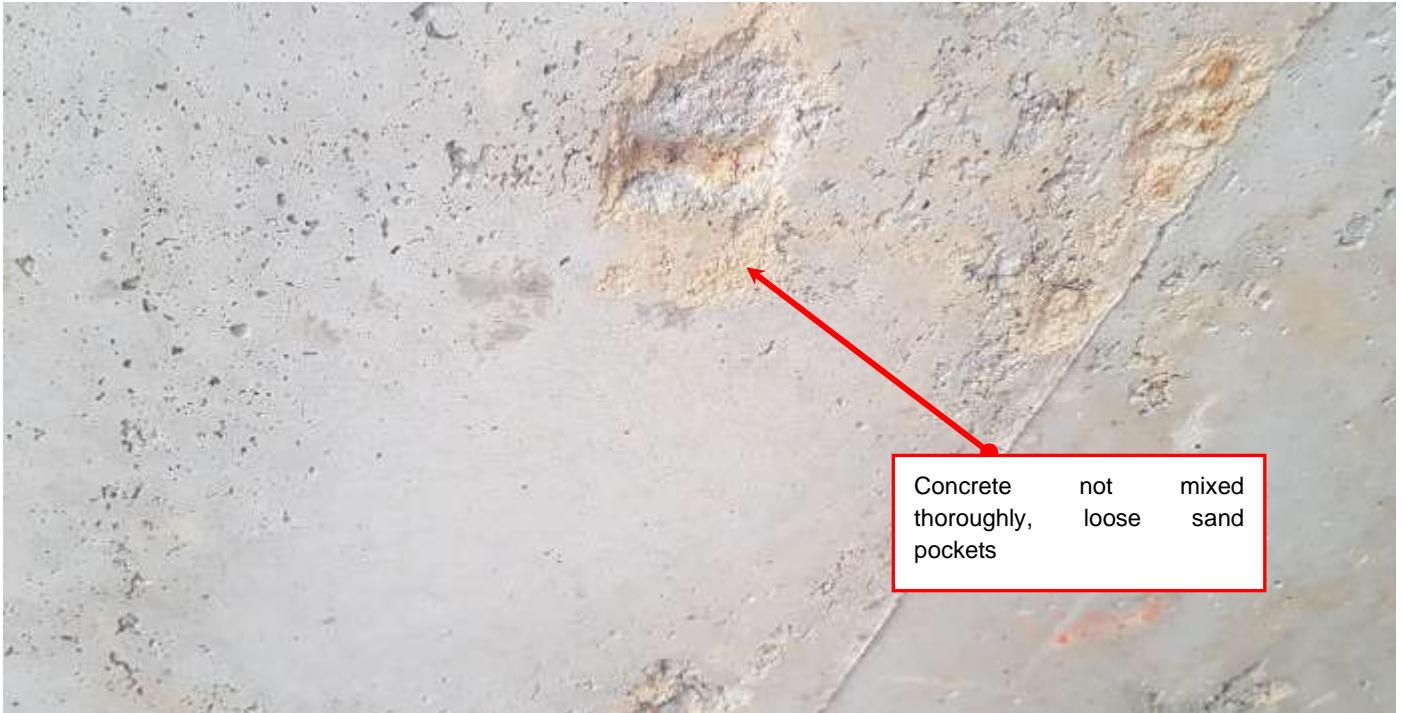
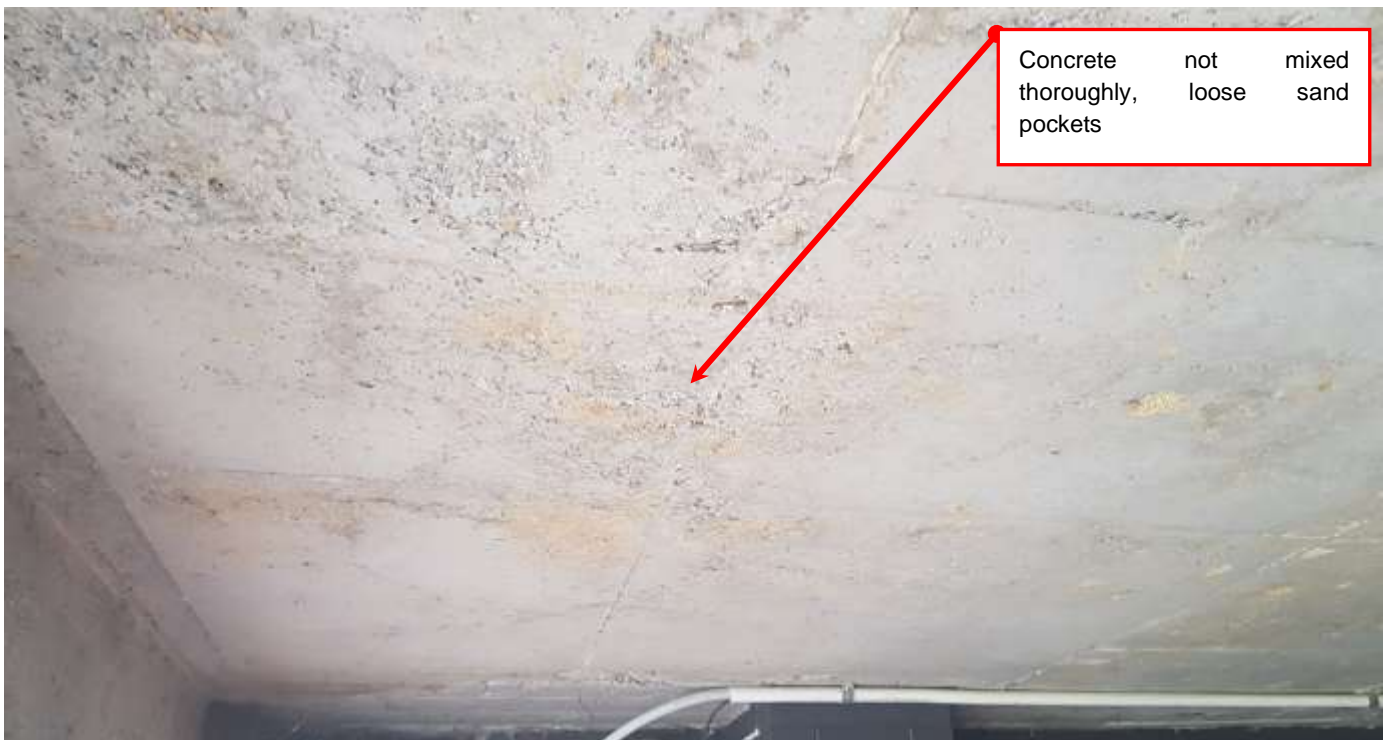
Photograph 8 – Poor quality concrete mix with loose sand pockets

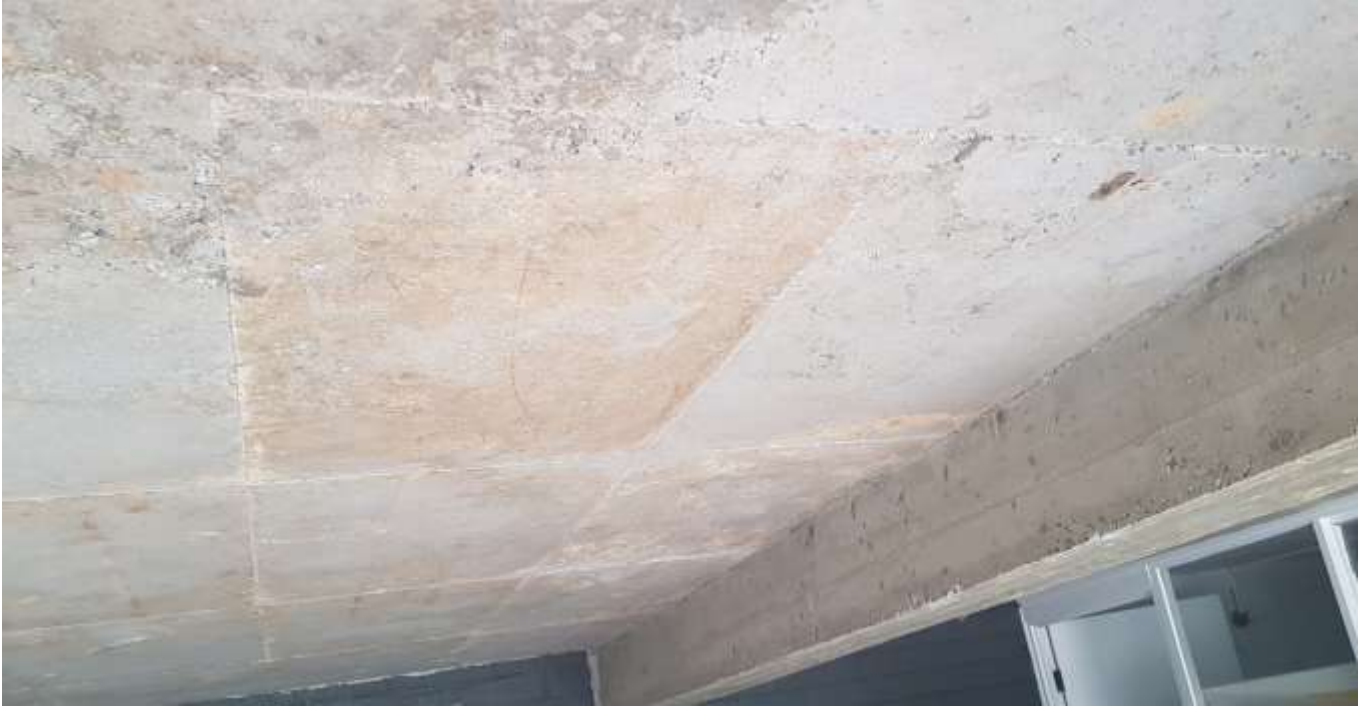
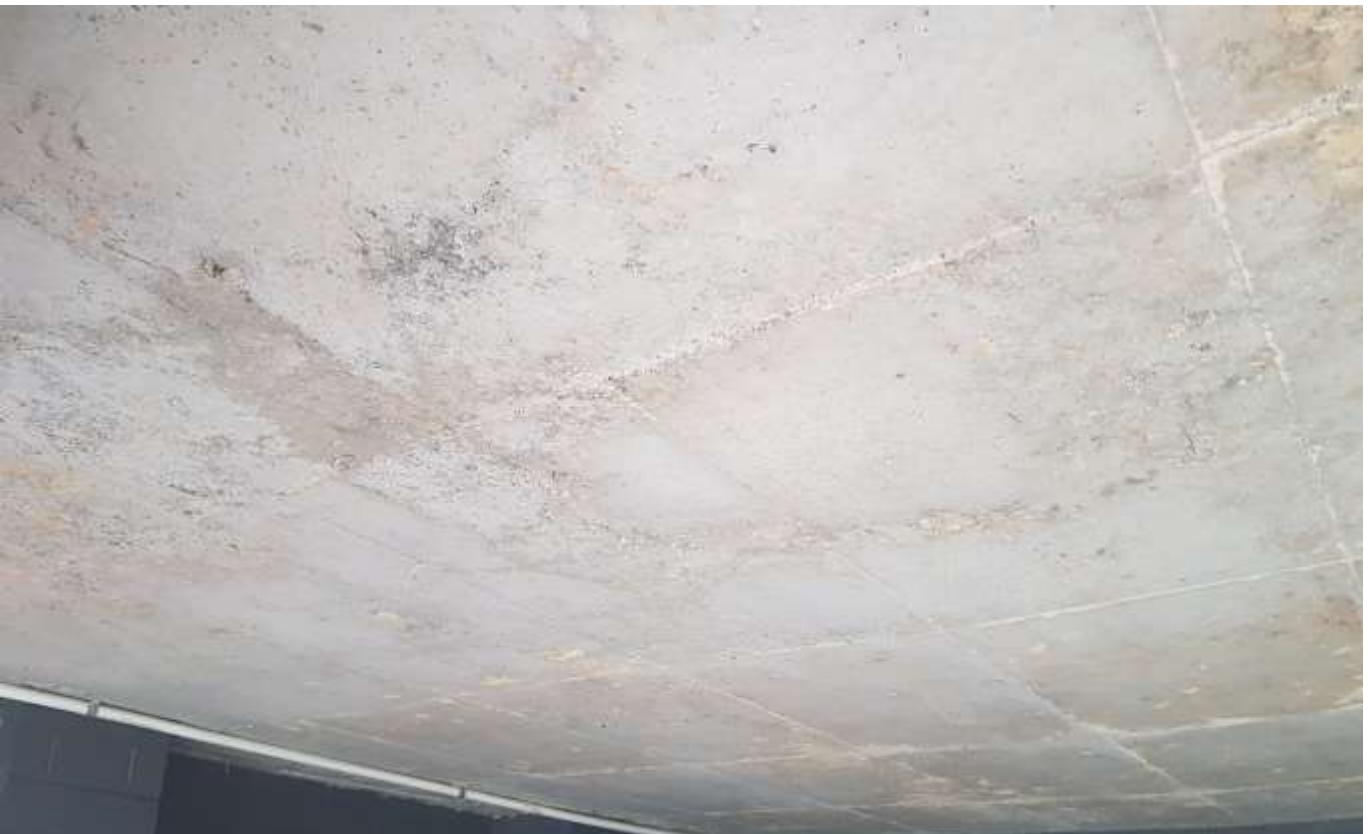
Photograph 9 – Poor quality concrete slab

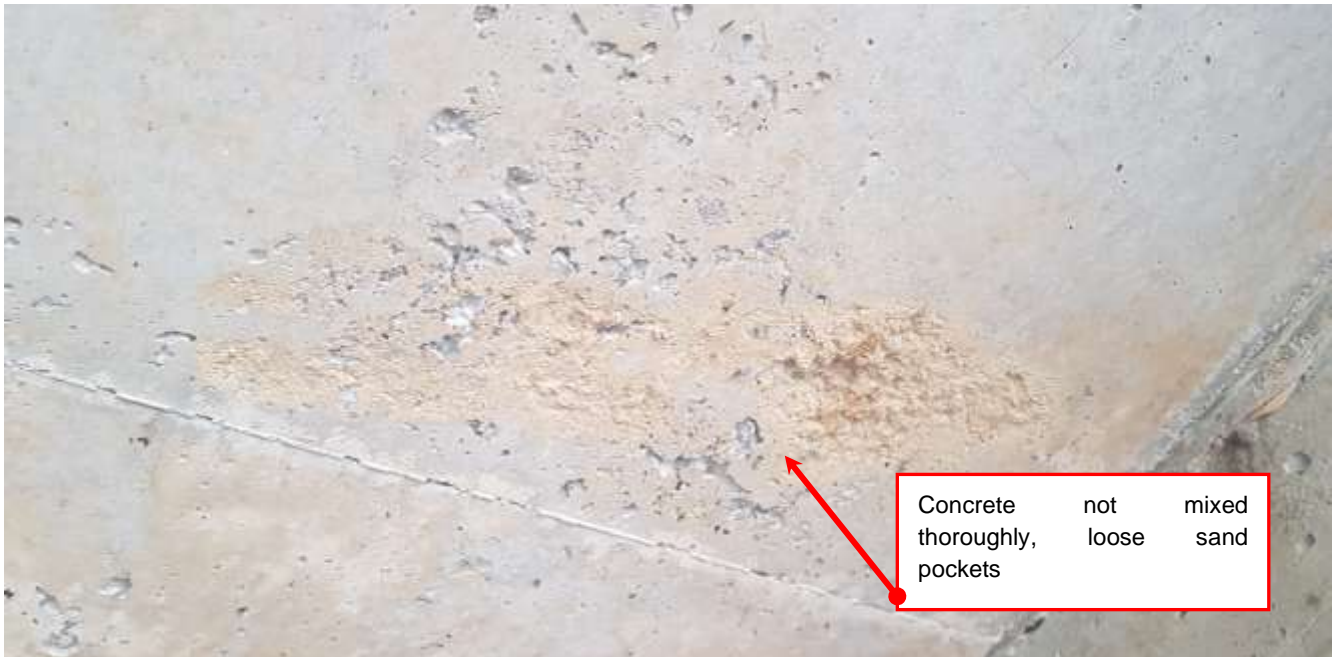
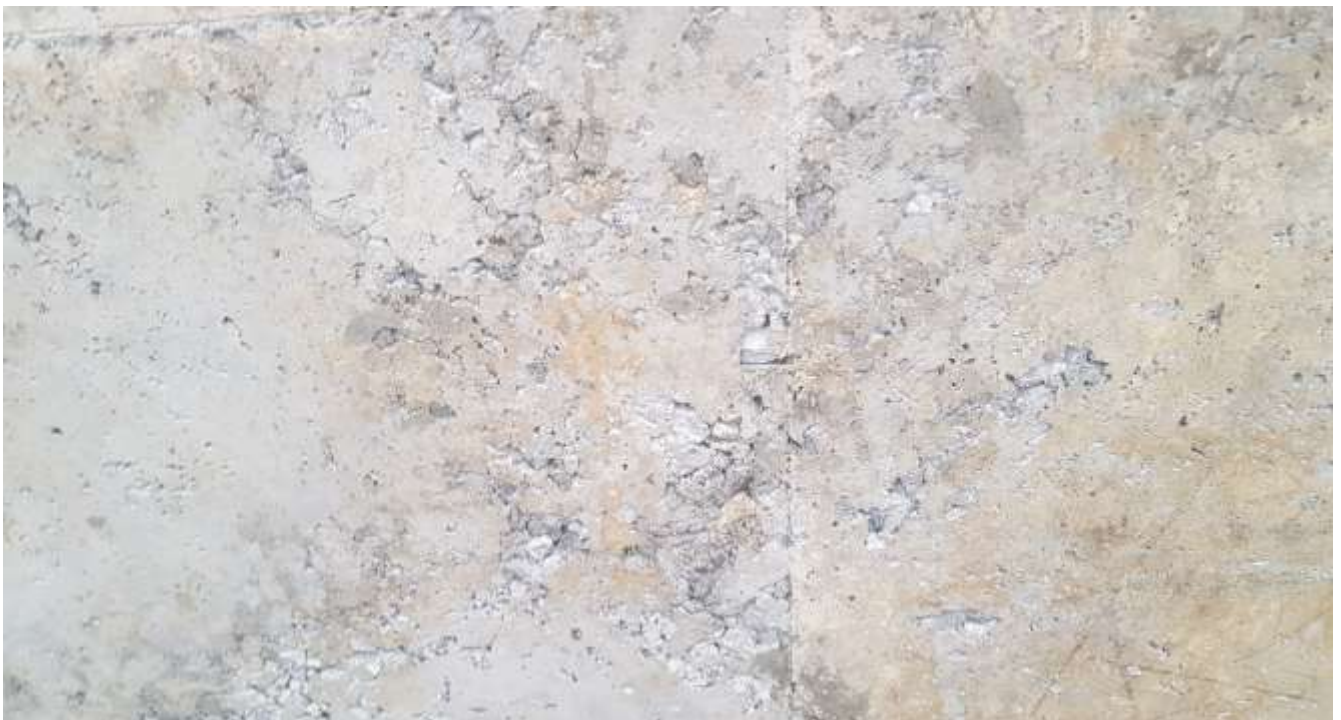
Photograph 10 – Poor quality concrete slab

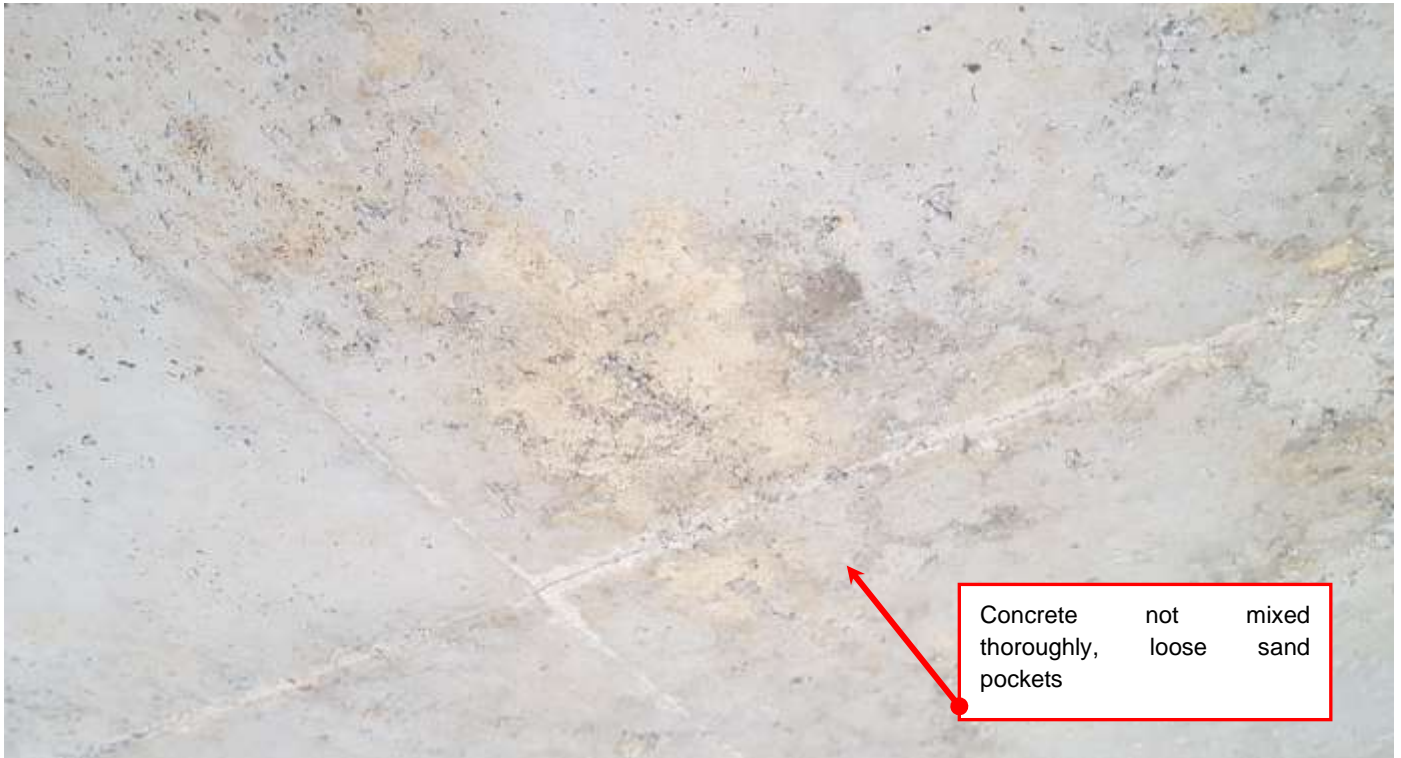
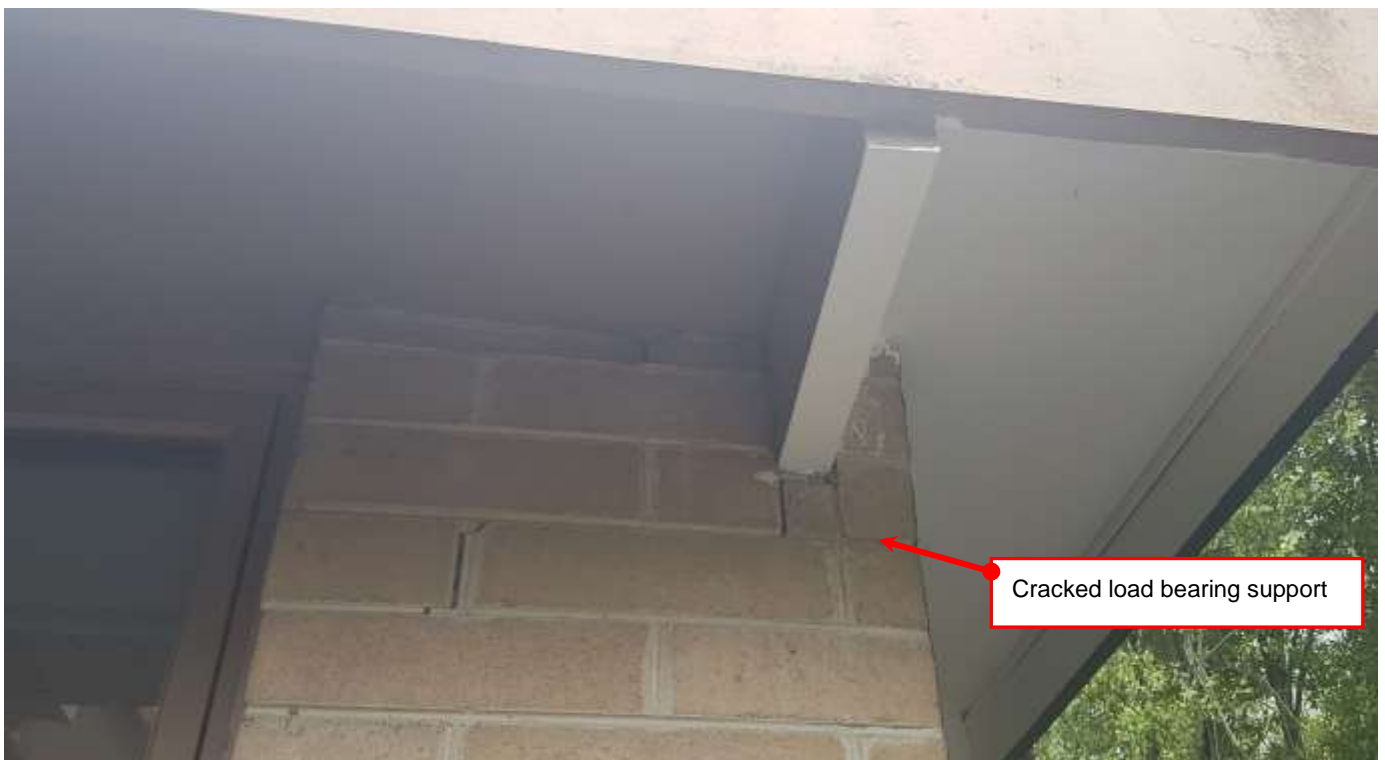
Photograph 11 – wall above basement
