Structural Report

32 Corby Street Balwyn North VIC

Prepared for Sanjiv Vij

Project Ref No.	21294	Version	2	Date	07/10/2021
Version	Issue Description				Date
1	Draft– Issued to Client				07/10/2021
2	Final – Issued to Client				07/10/2021
<p><i>This report has been prepared in accordance with the terms and conditions of appointment. N2K Consulting cannot accept any responsibility for any use of or reliance on the contents of this report by any third party.</i></p>

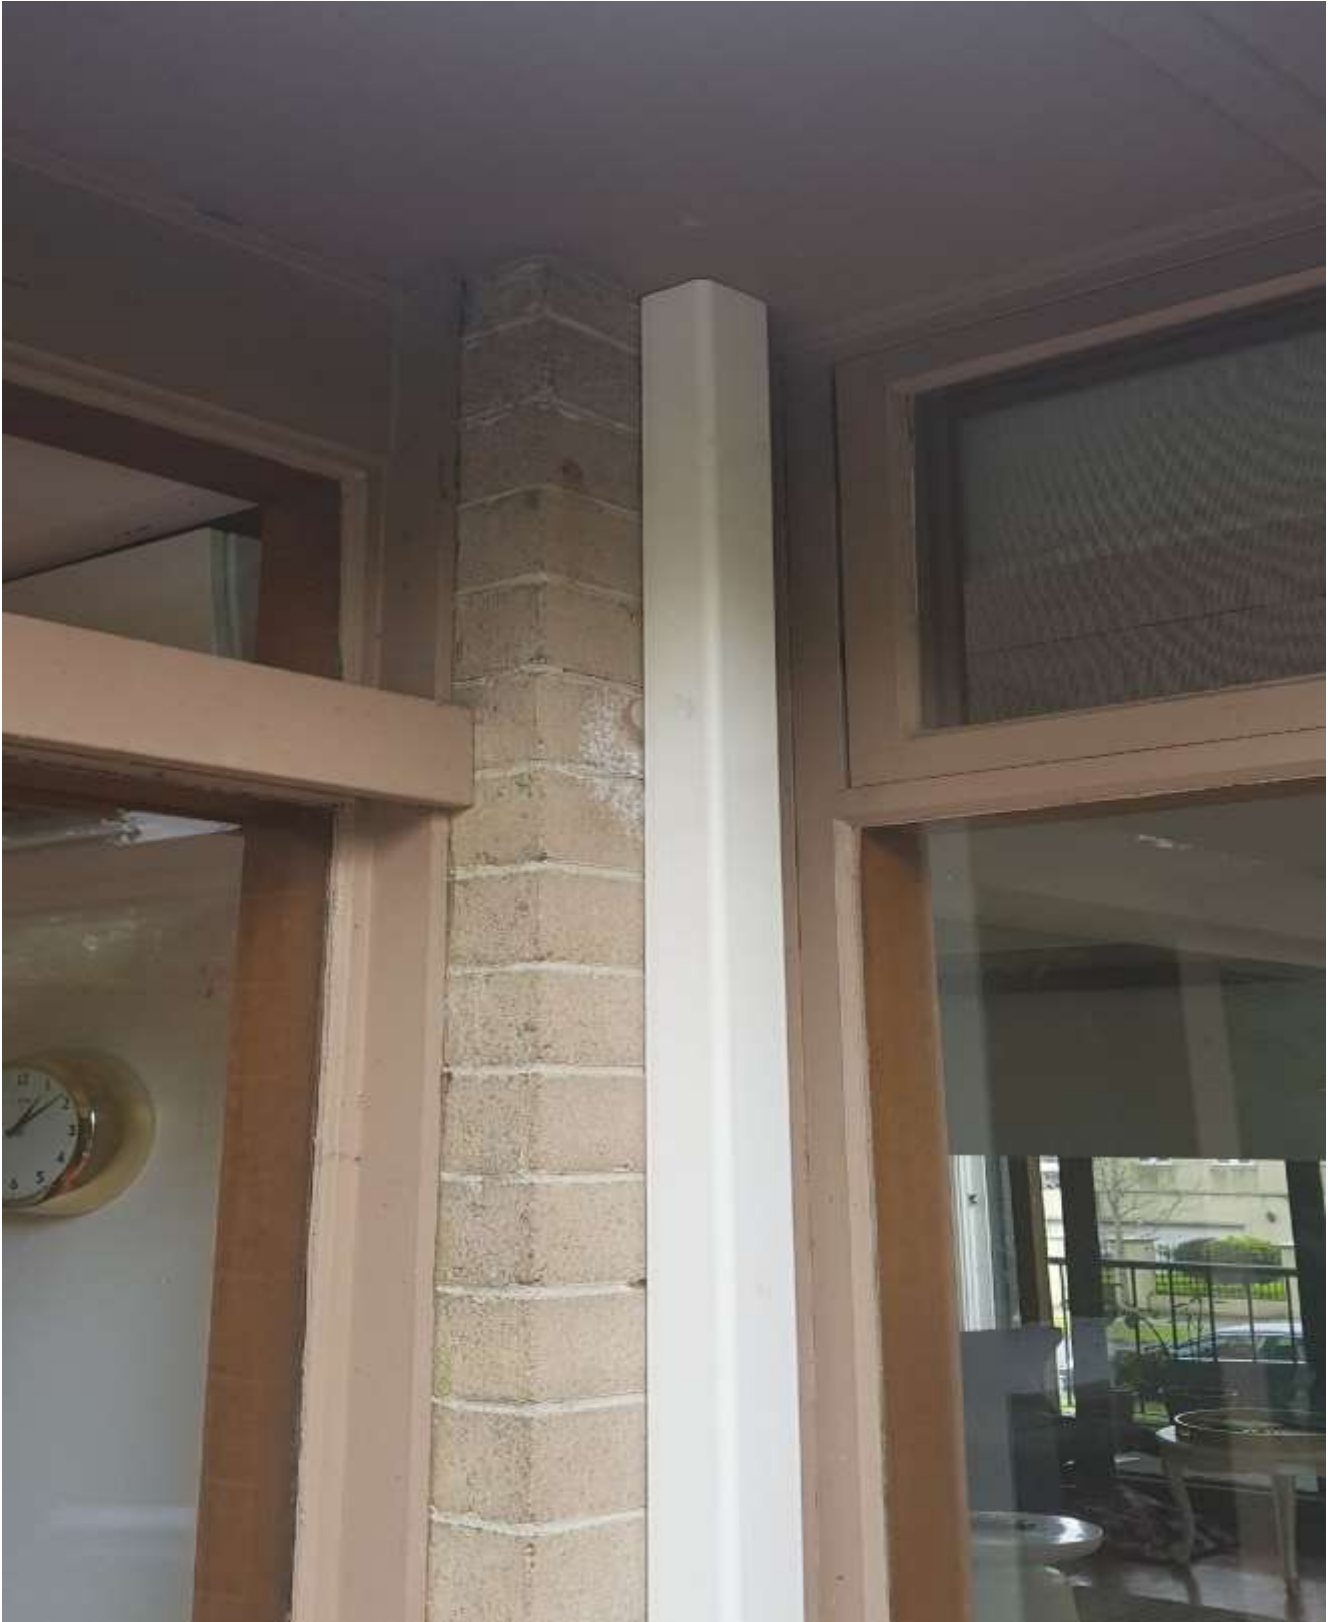
Photograph 12 – wall above basement

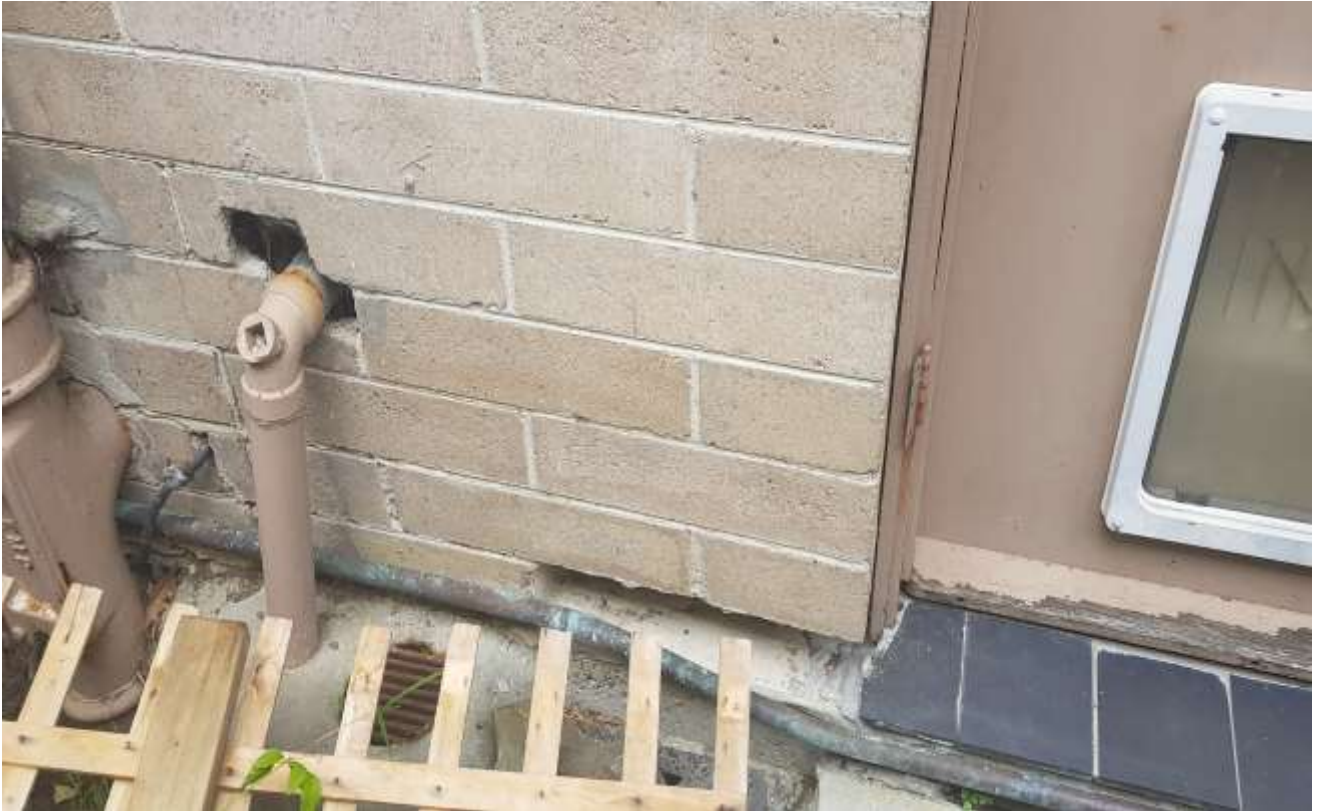
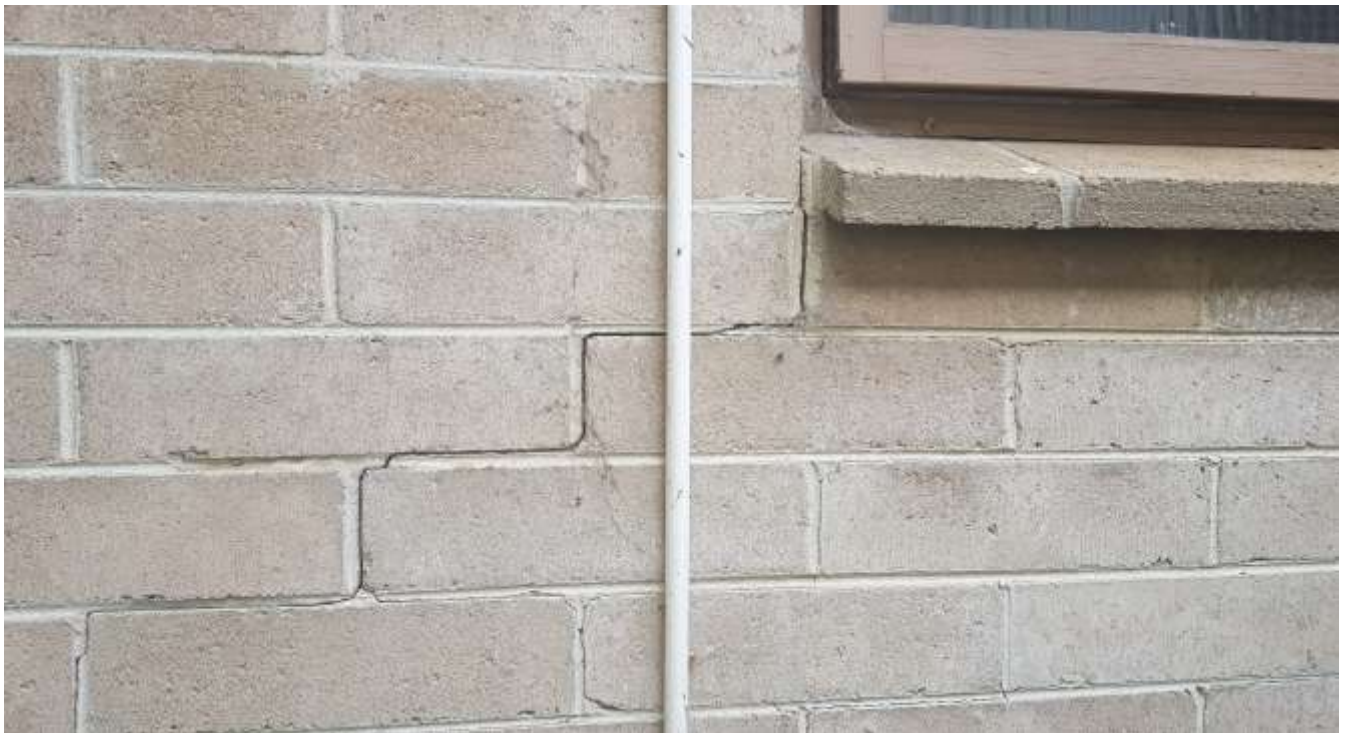
Photograph 13 – wall above basement

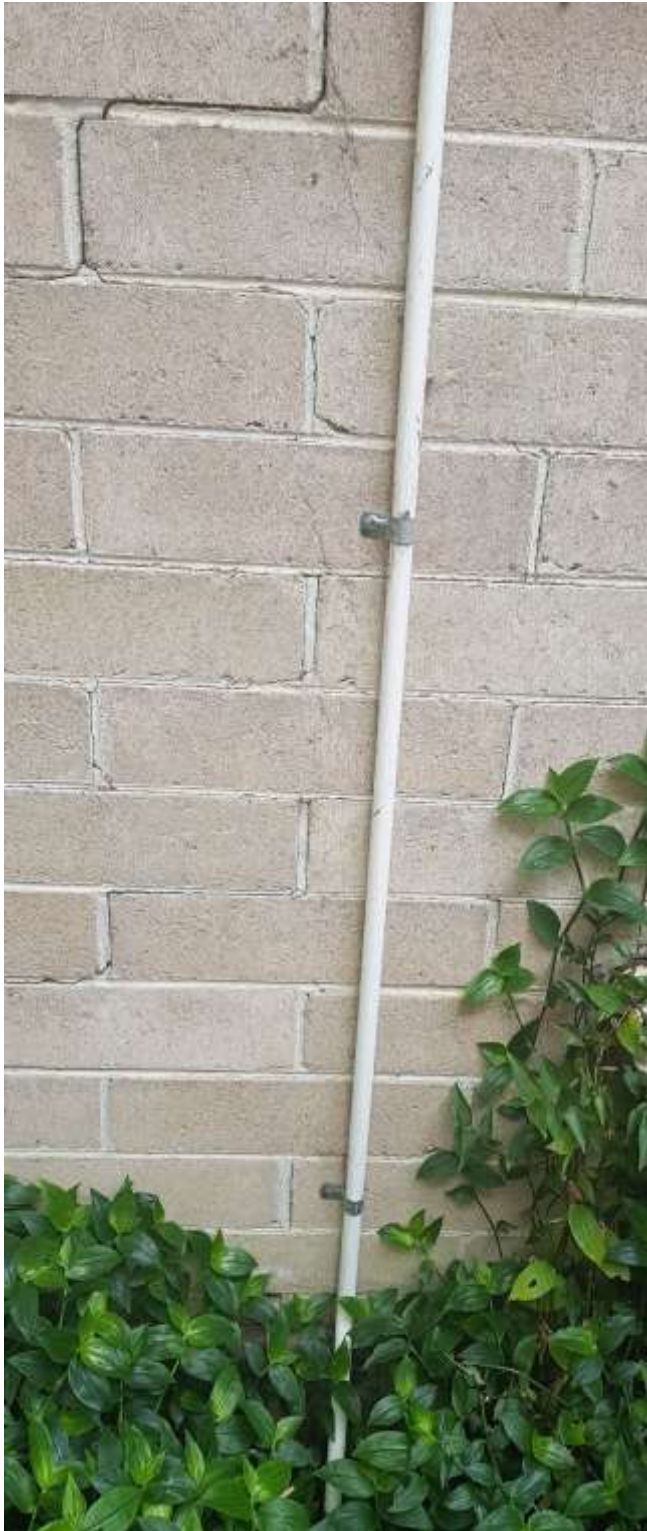
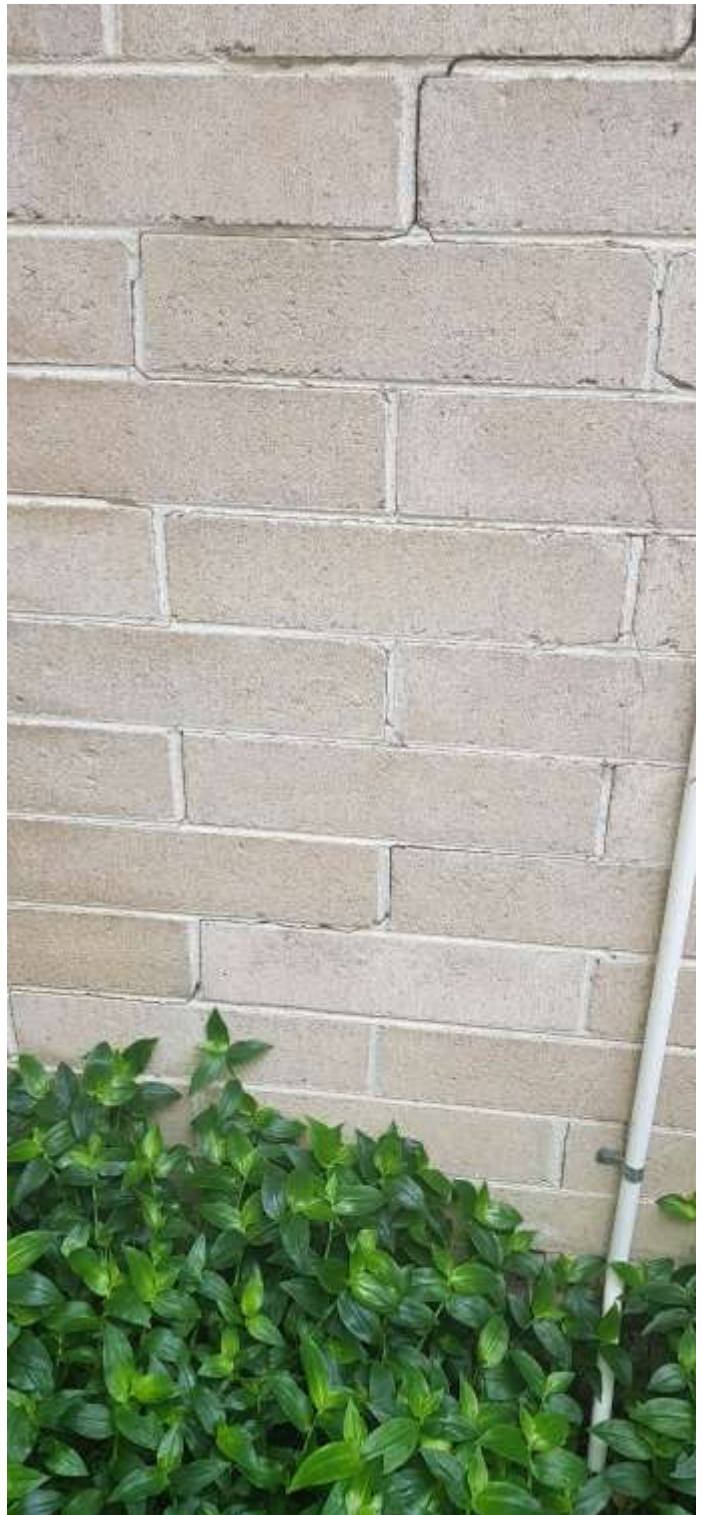
Photograph 14 – wall above basement

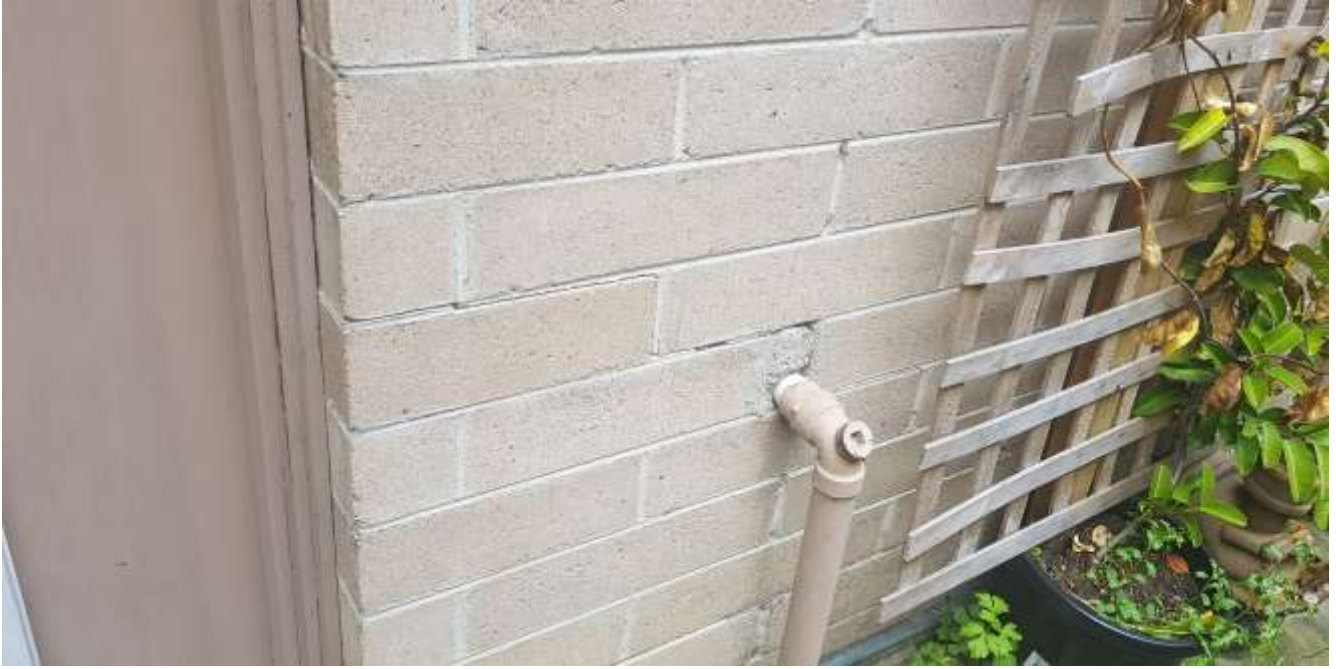
Photograph 15 – Wall above basement

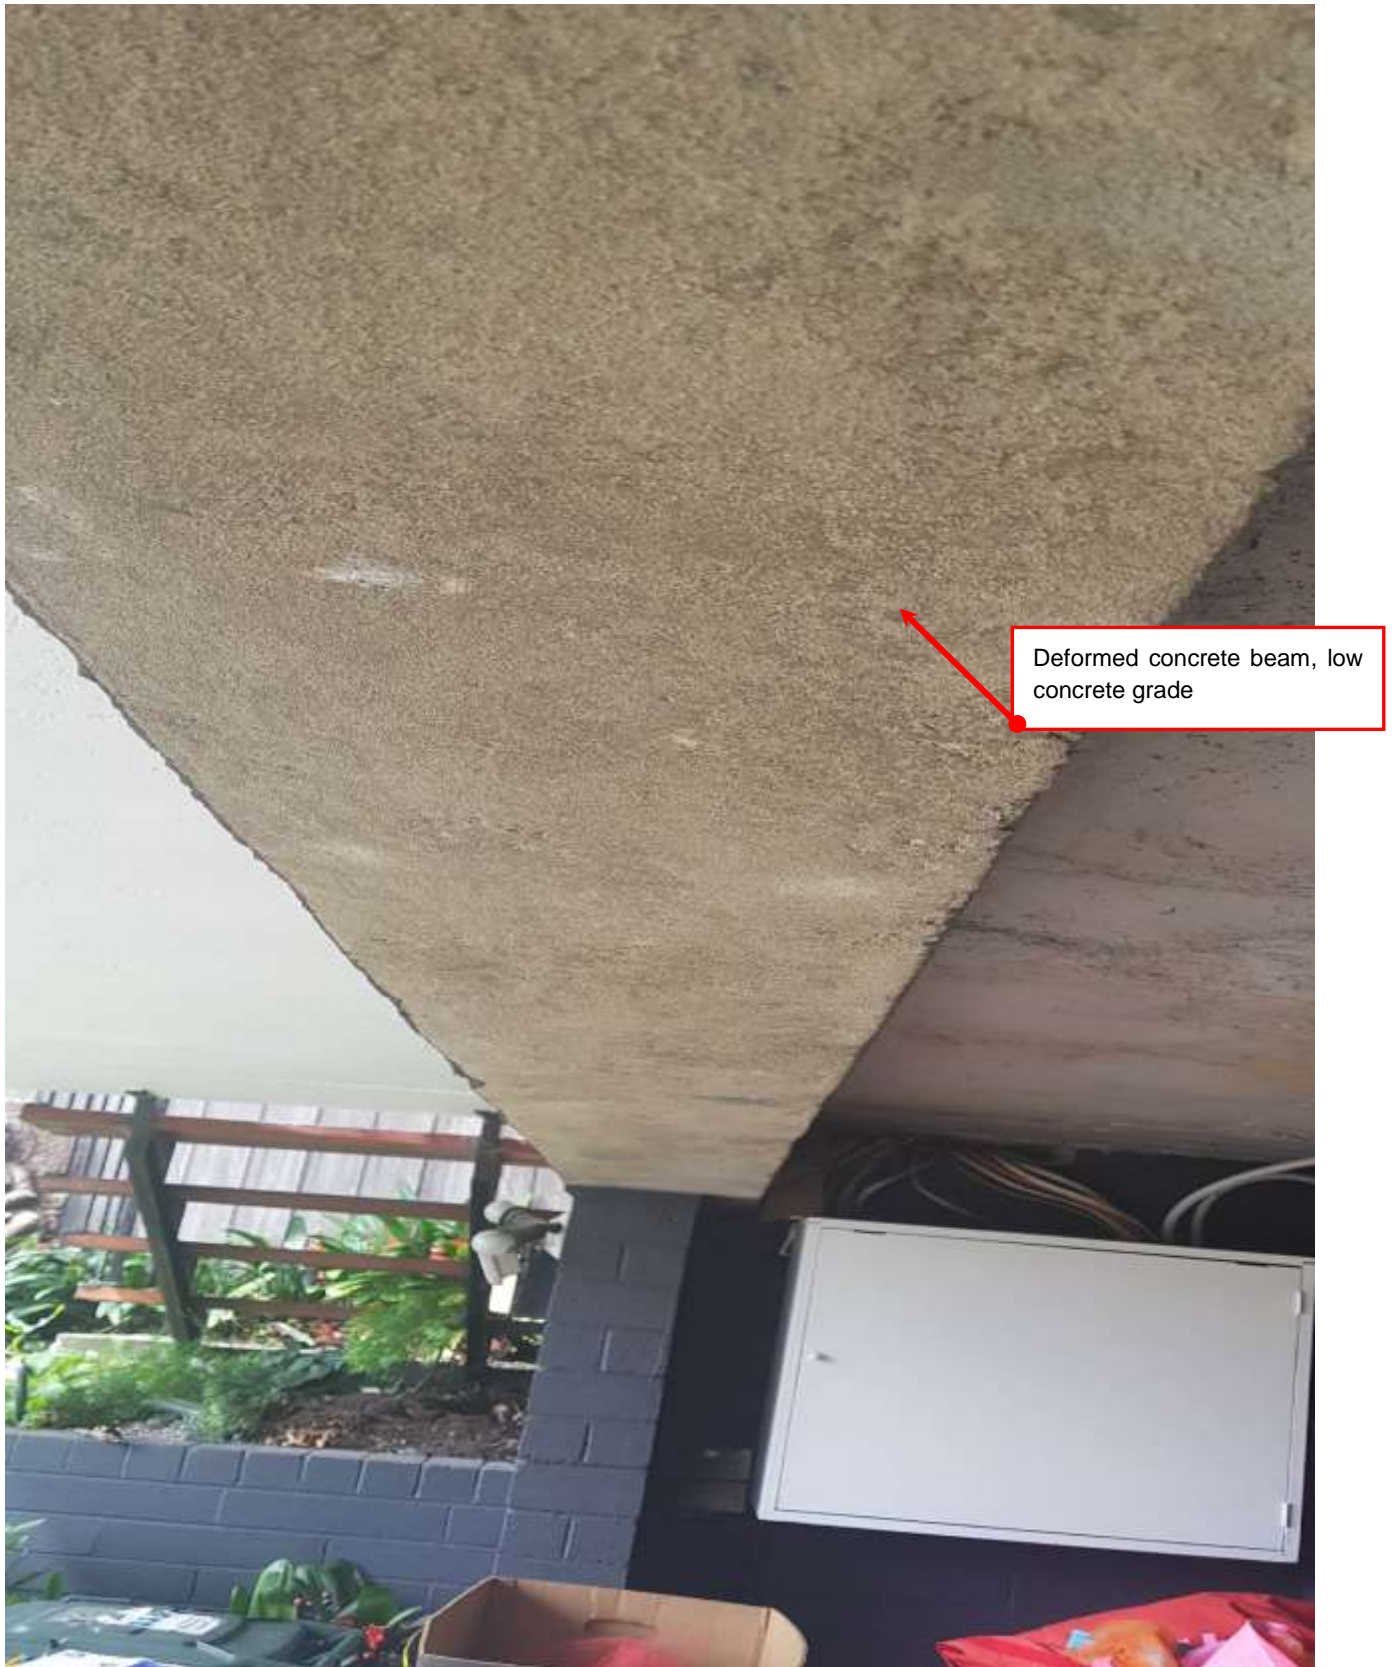
Photograph 16 – Front Basement section

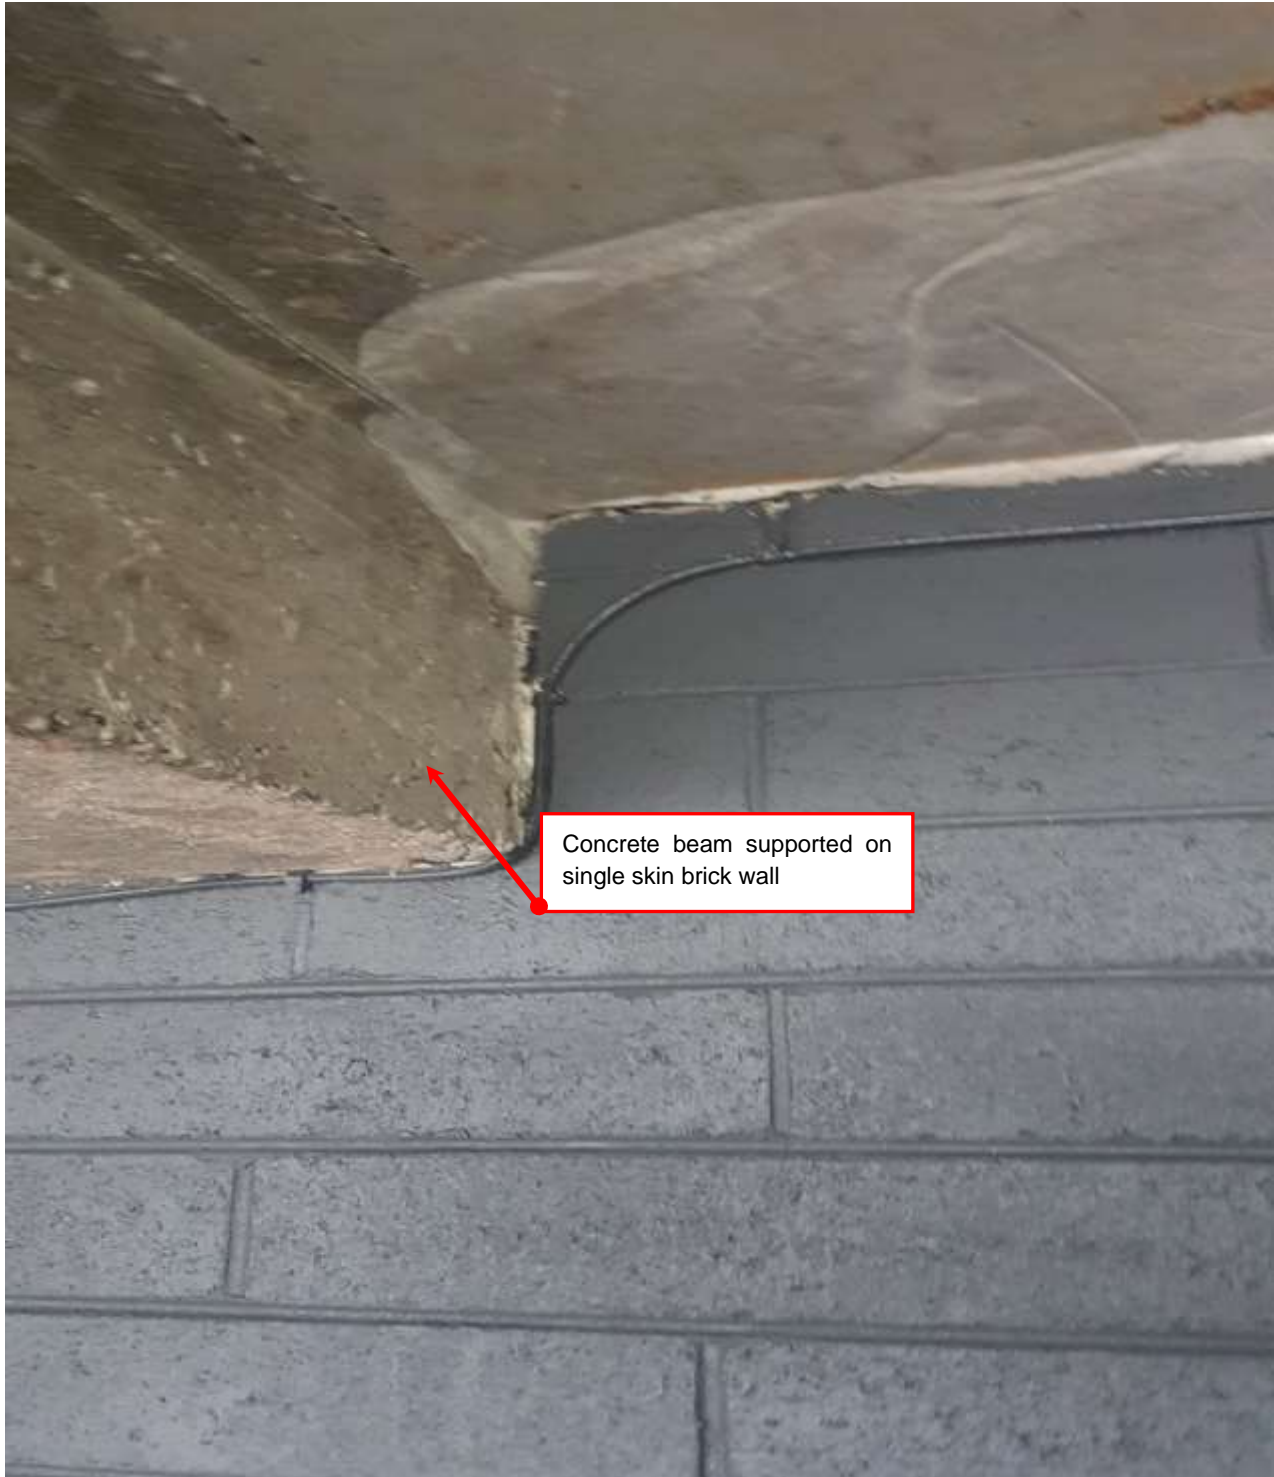
Photograph 17 – Front basement section

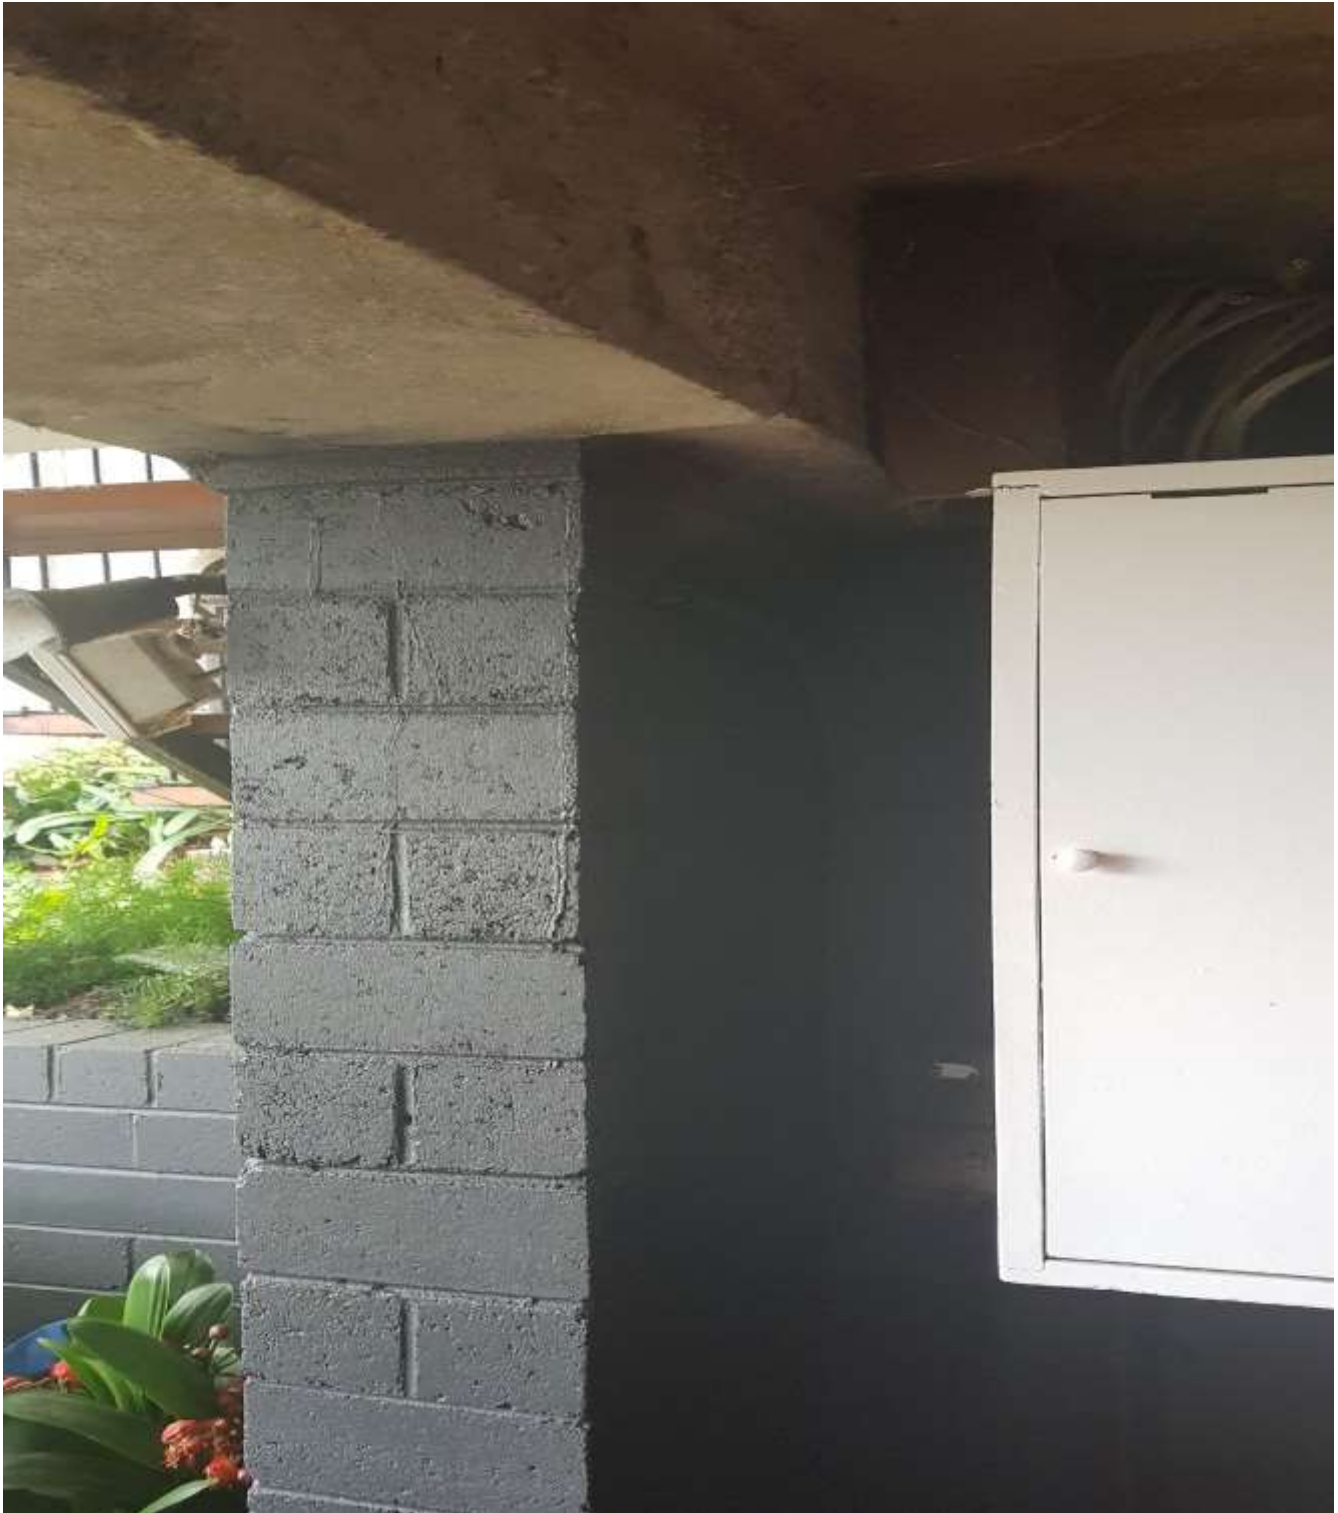
Photograph 18

*Photograph 18 – Front basement
Section*

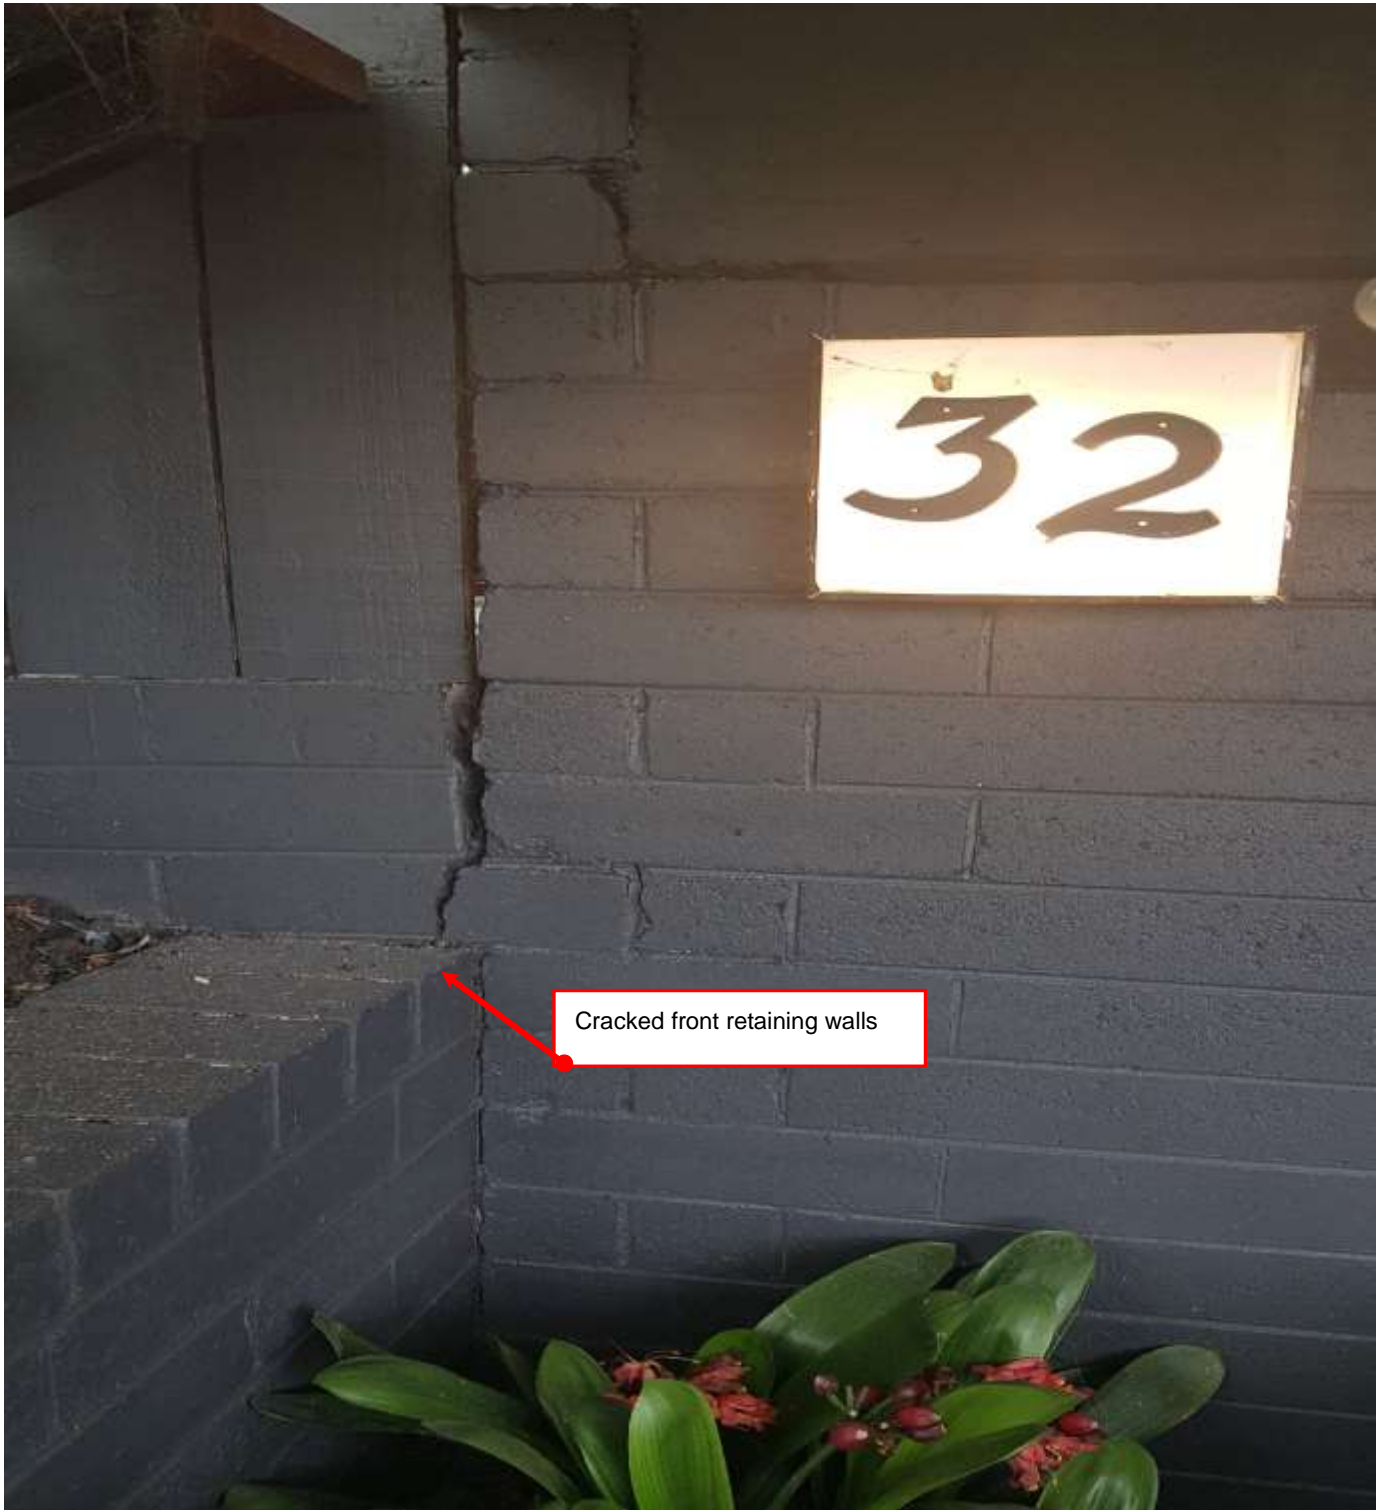
Photograph 19 – Front Section

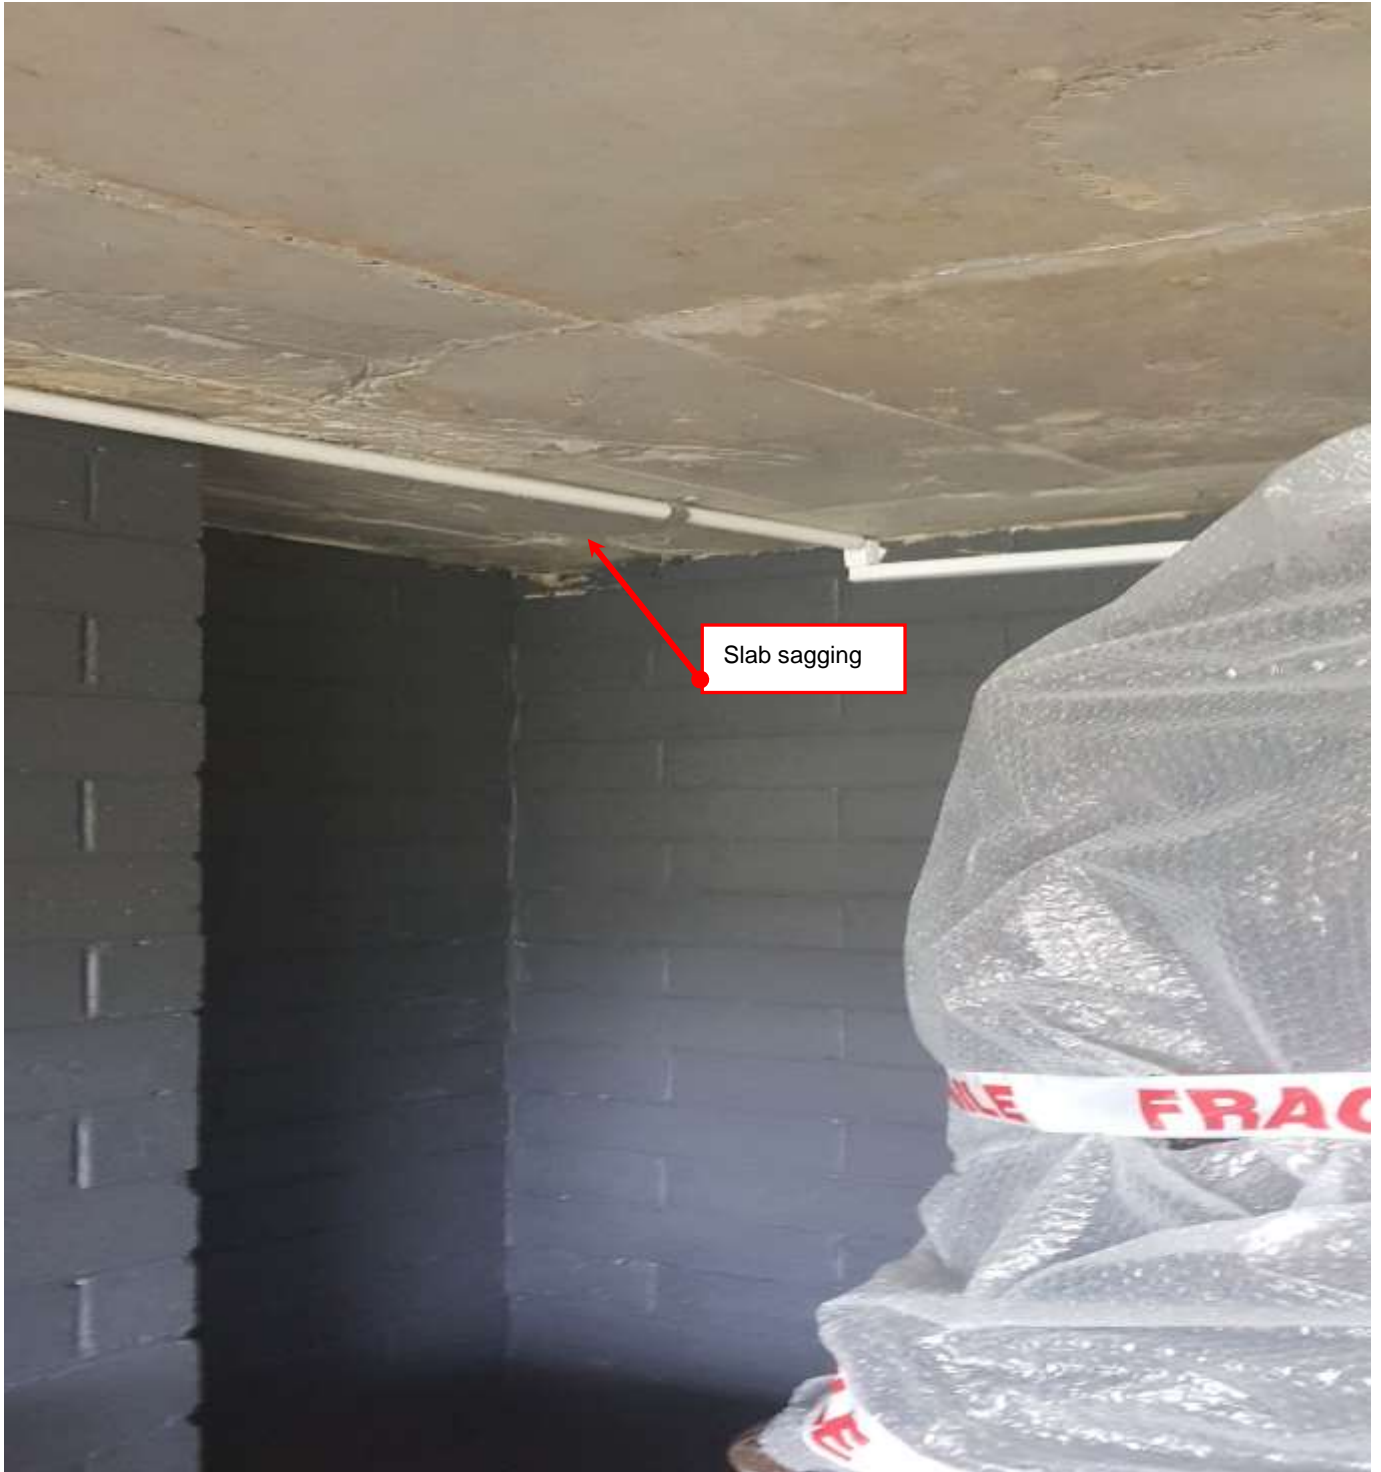
Photograph 20 – Front basement section

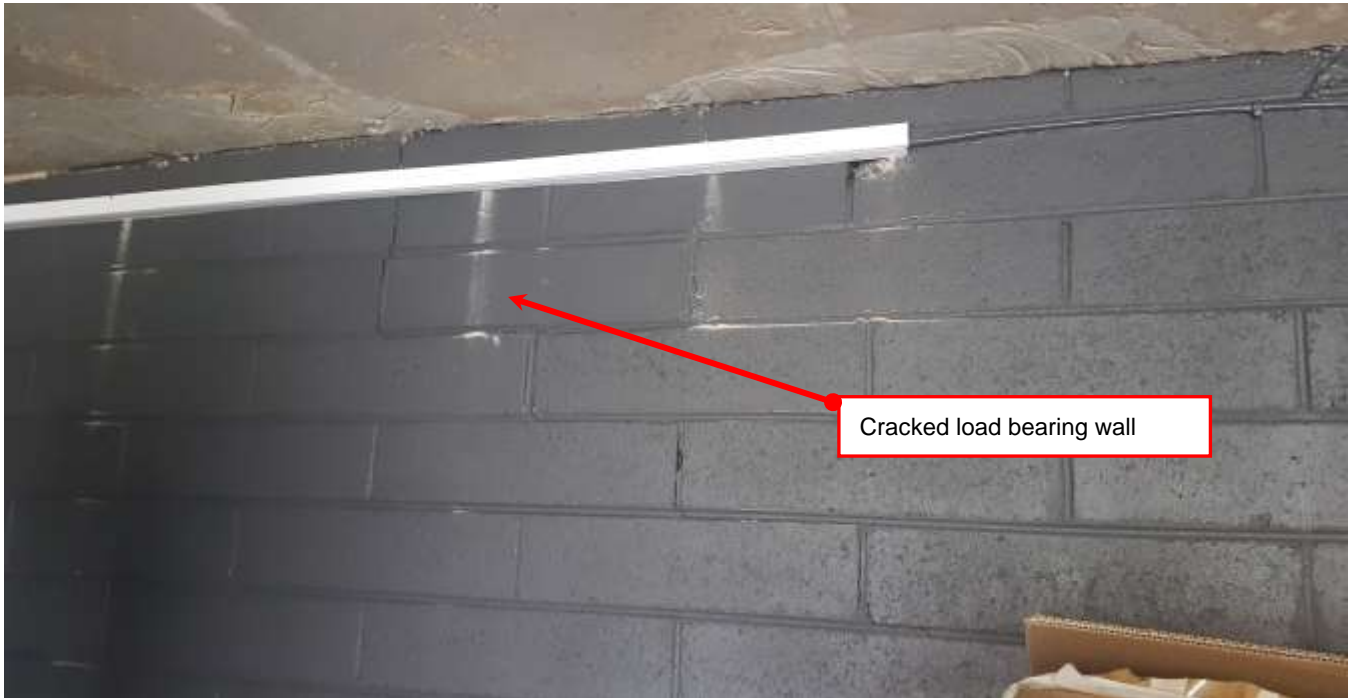
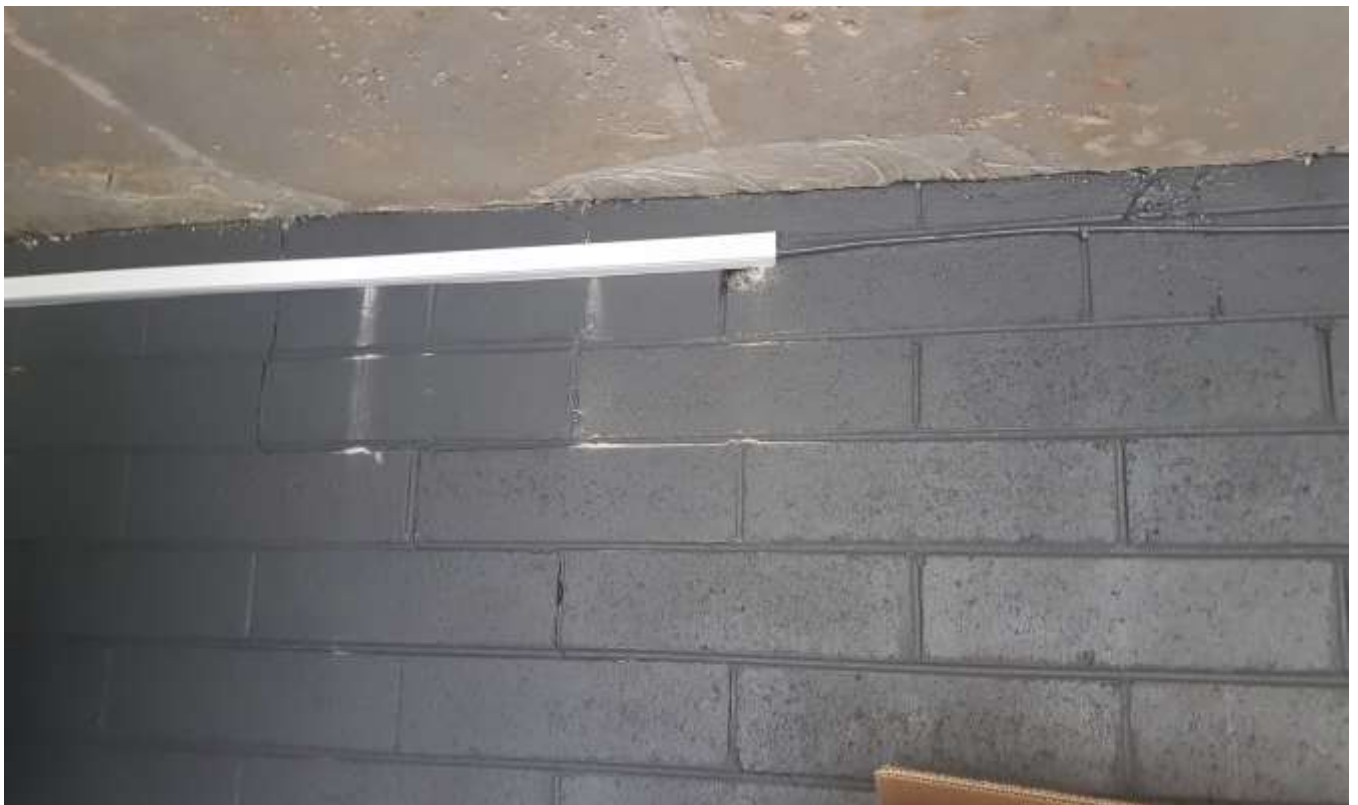
Photograph 21 – internal basement view

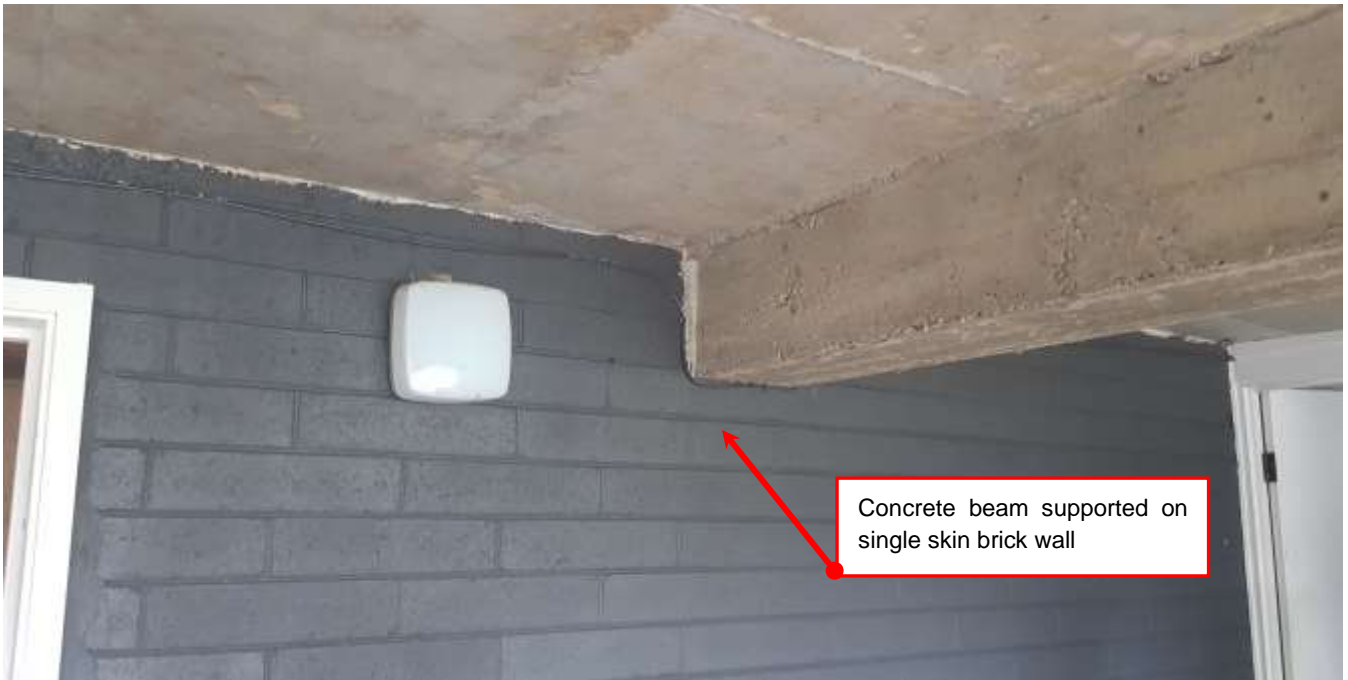
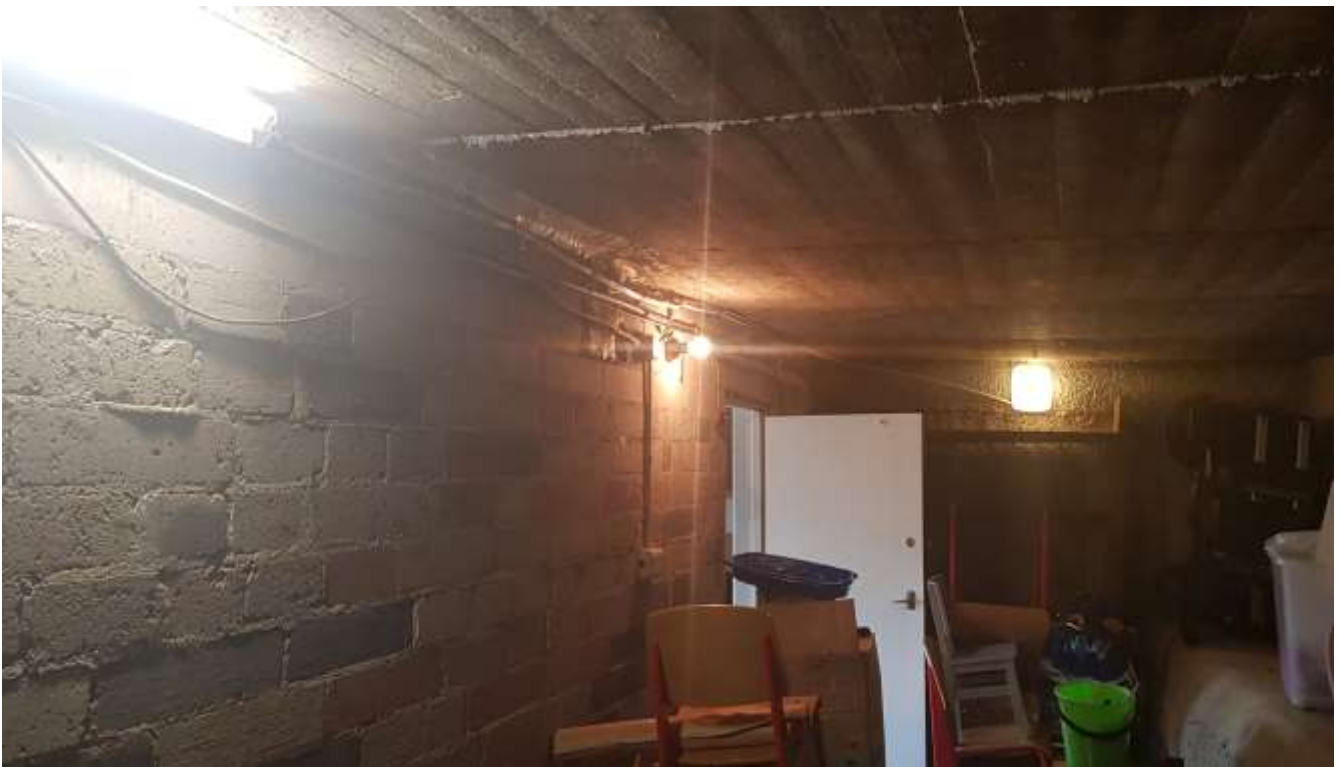
Photograph 22 – internal basement view
