Structural Report

32 Corby Street Balwyn North VIC

Prepared for Sanjiv Vij

Project Ref No.	21294	Version	2	Date	07/10/2021
Version	Issue Description				Date
1	Draft– Issued to Client				07/10/2021
2	Final – Issued to Client				07/10/2021
<p><i>This report has been prepared in accordance with the terms and conditions of appointment. N2K Consulting cannot accept any responsibility for any use of or reliance on the contents of this report by any third party.</i></p>

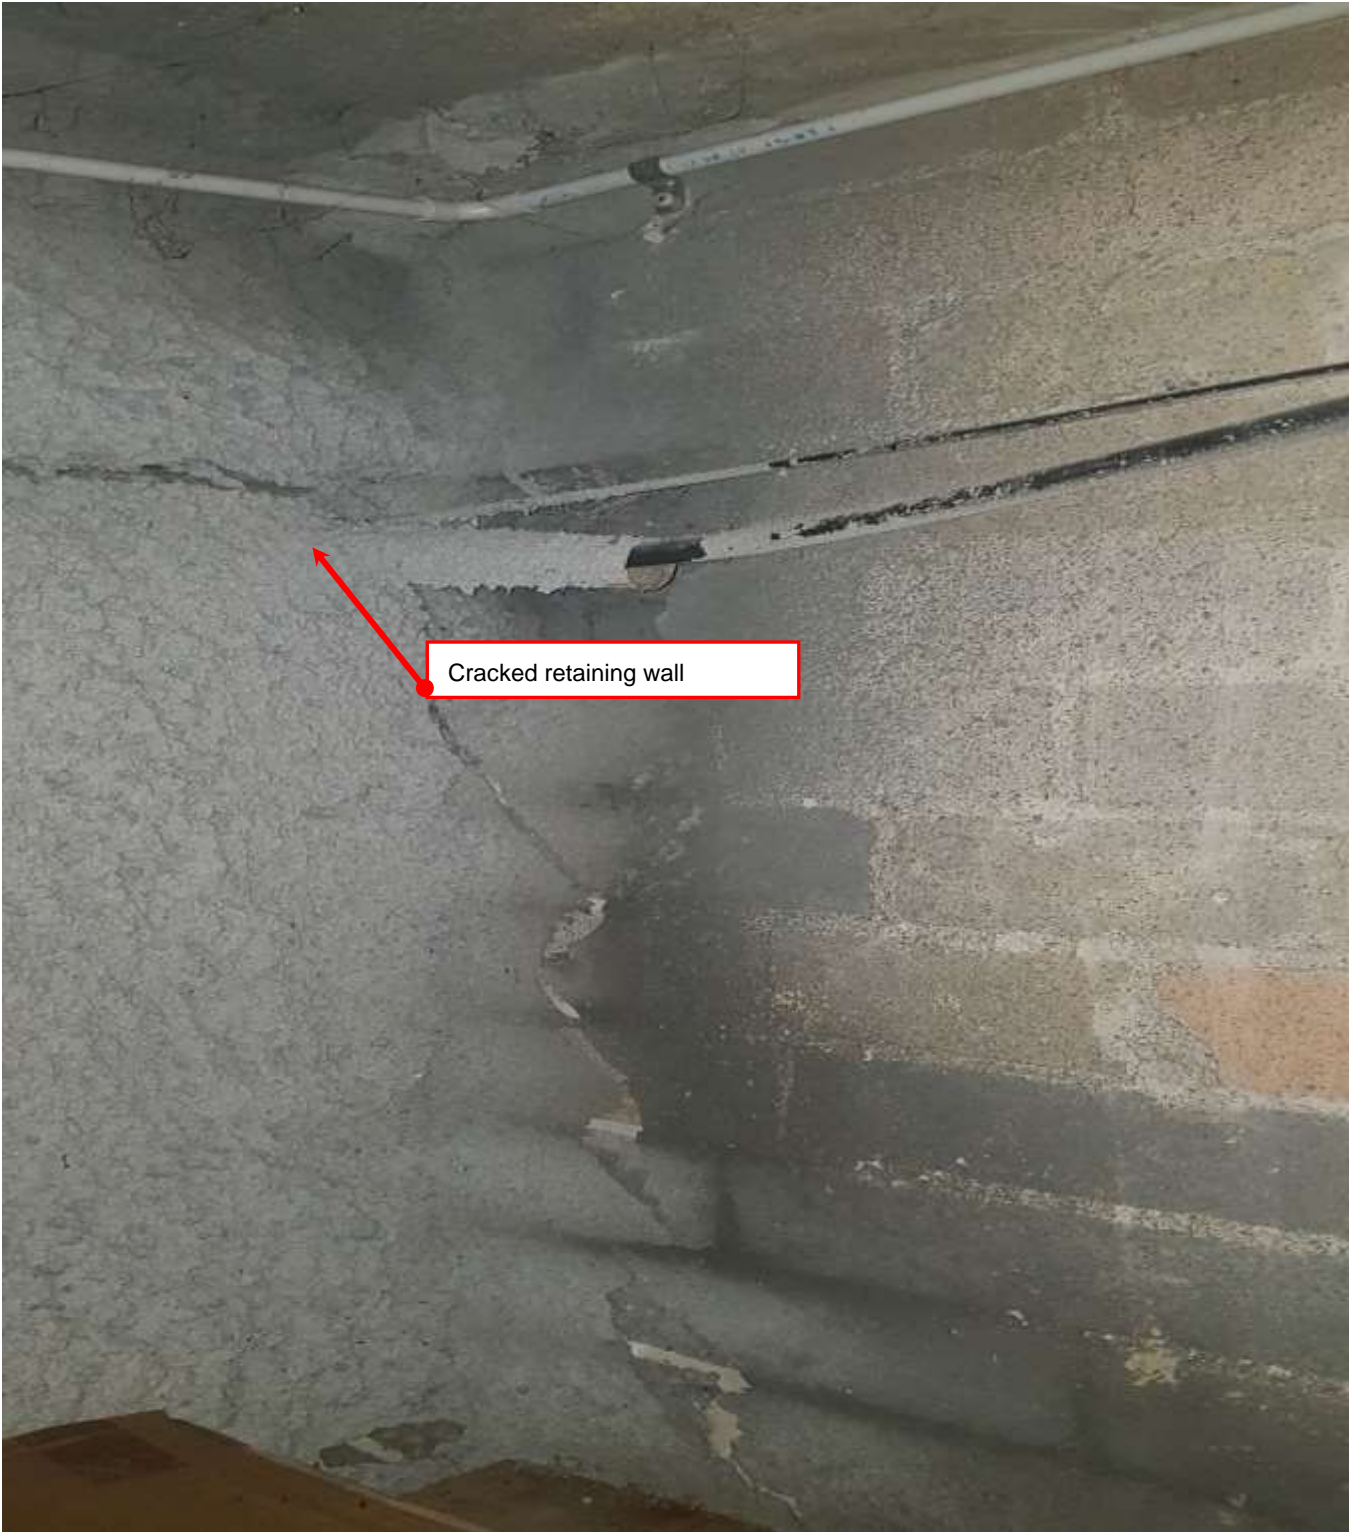
Photograph 23 – internal basement view

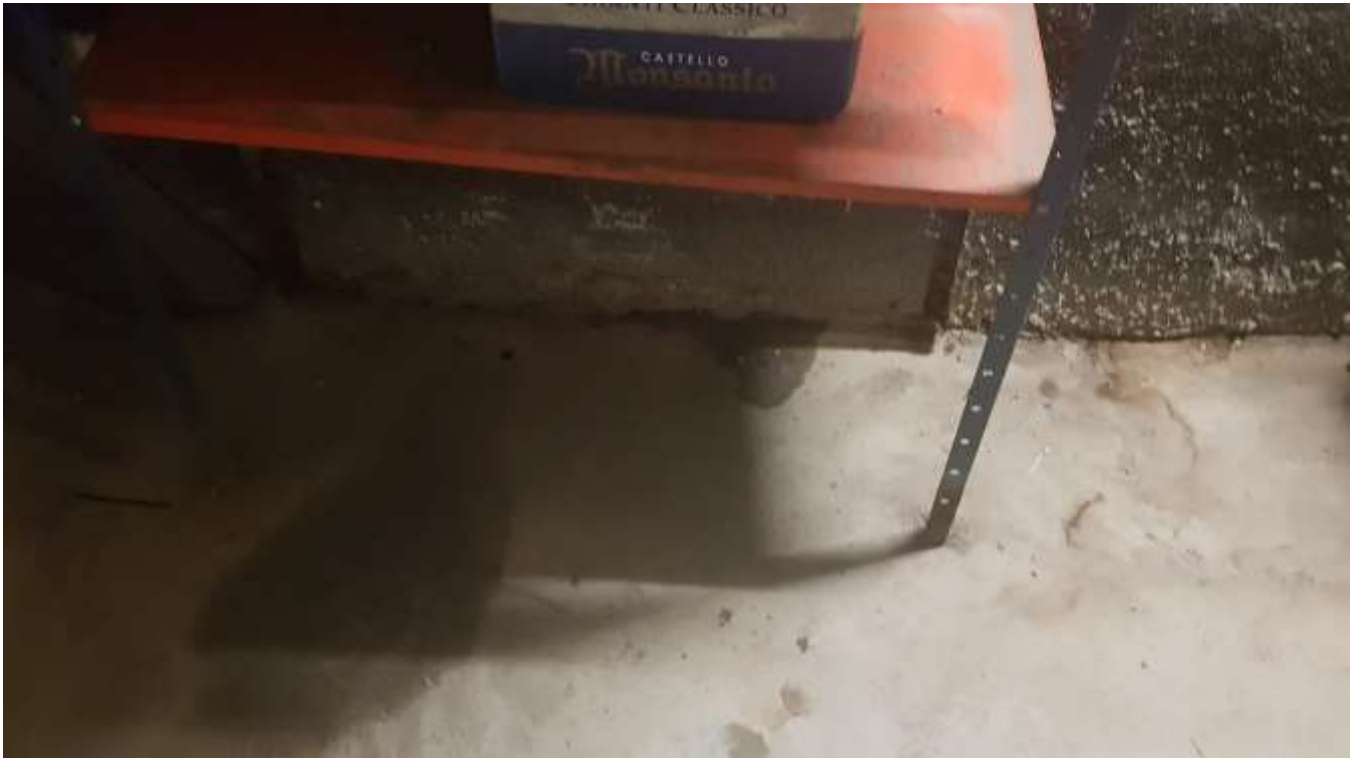
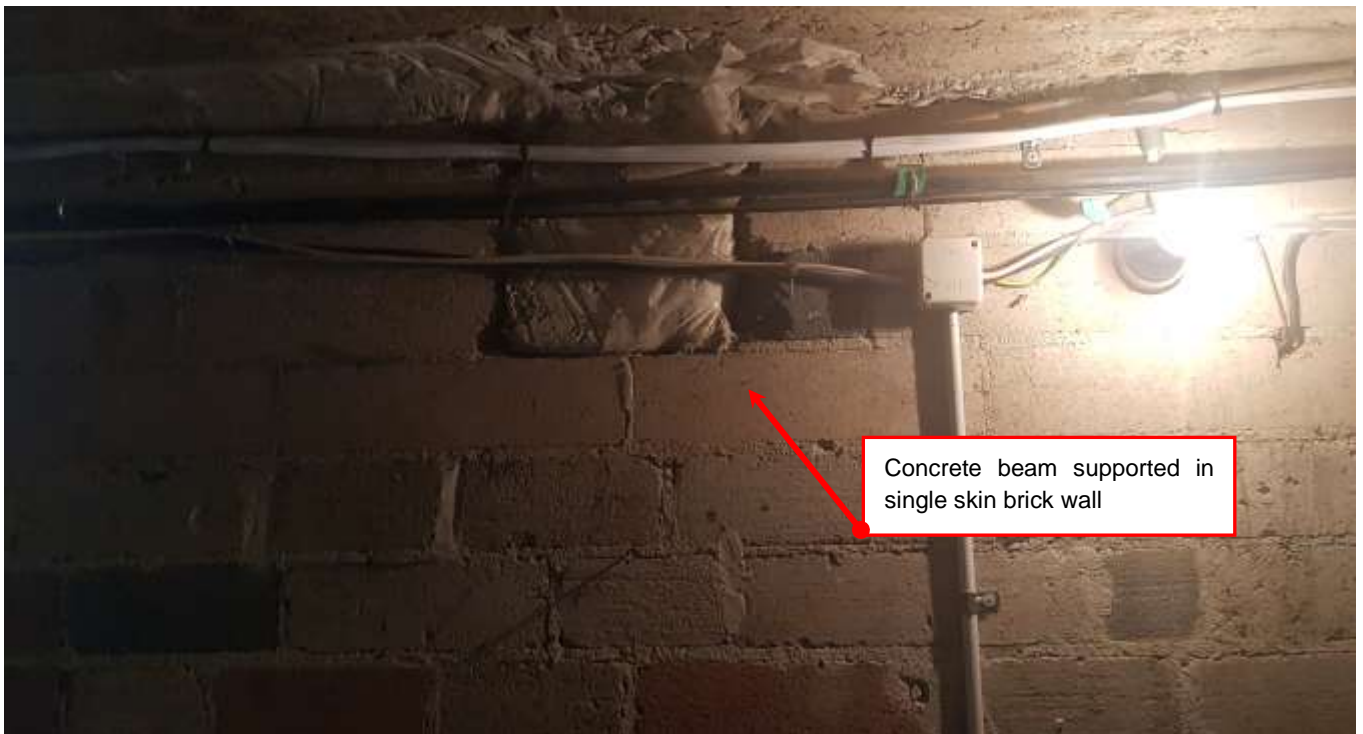
Photograph 24 – internal basement view

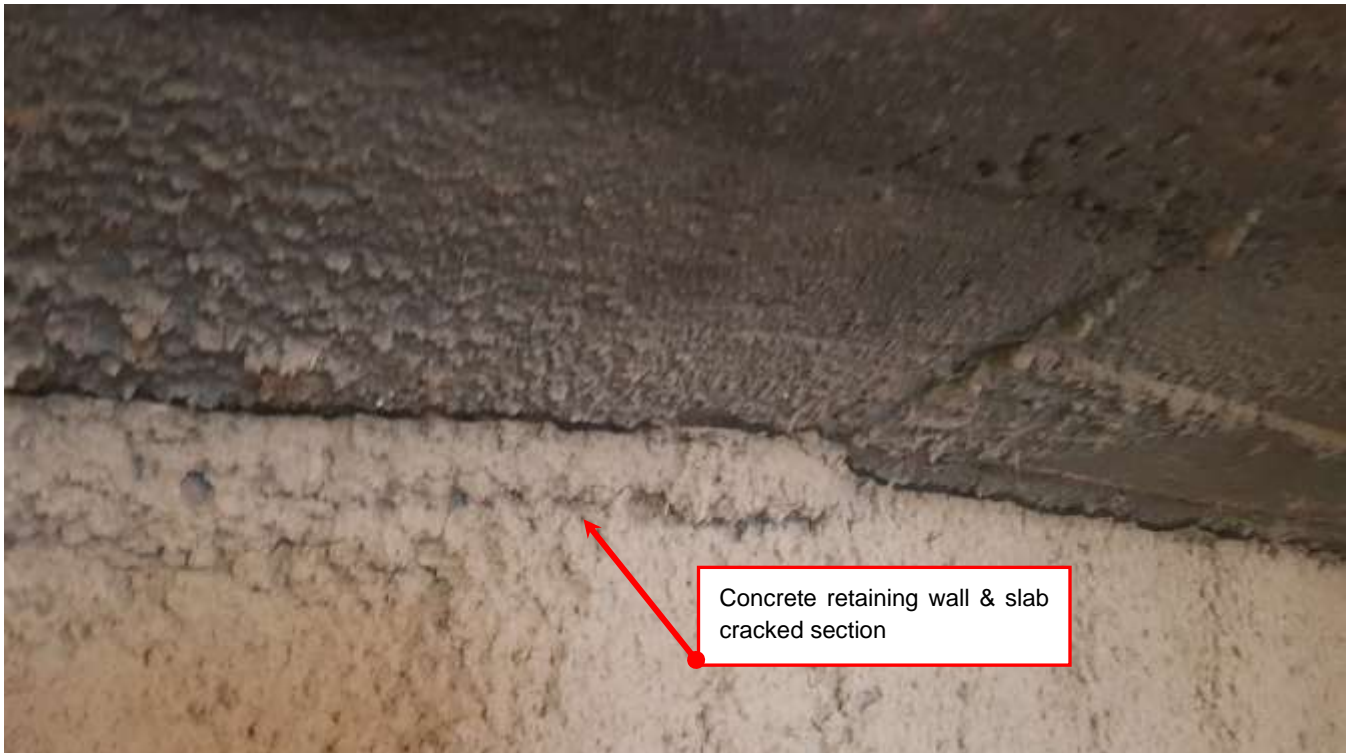
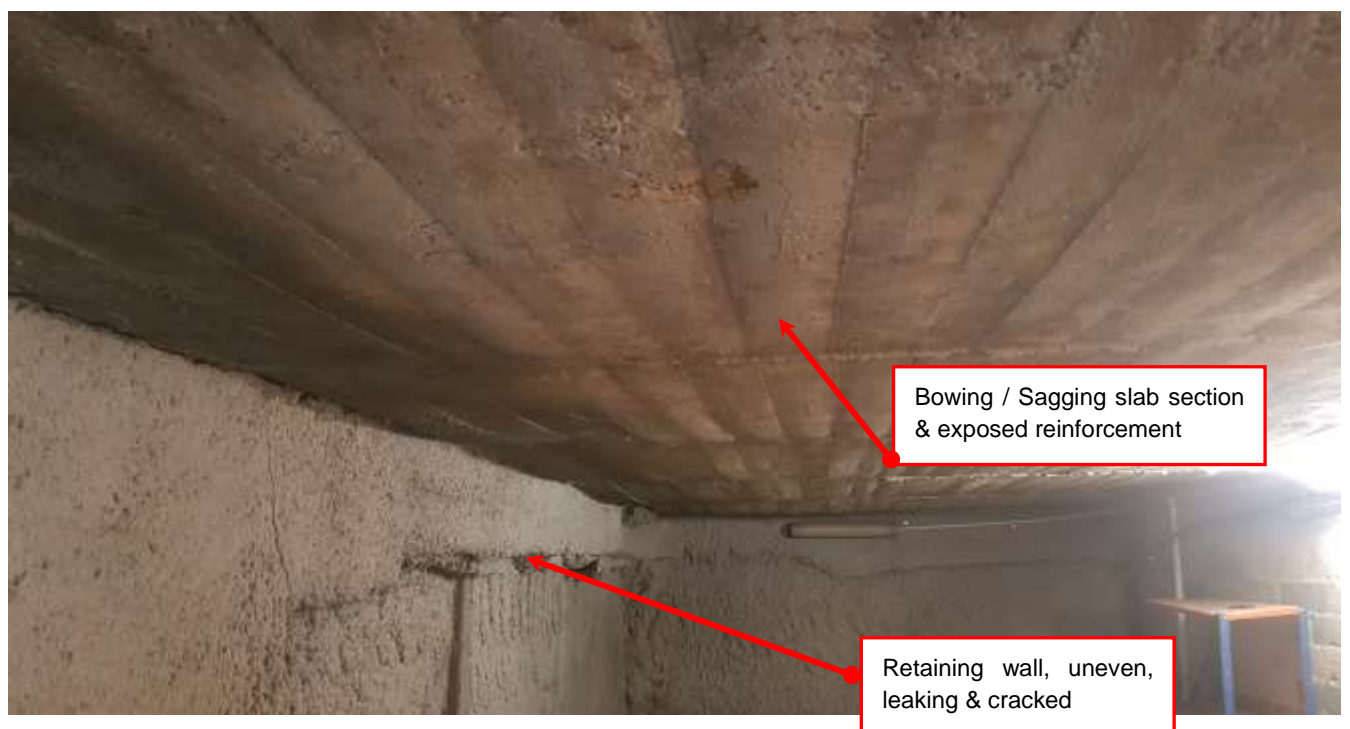
Photograph 25 – internal basement view

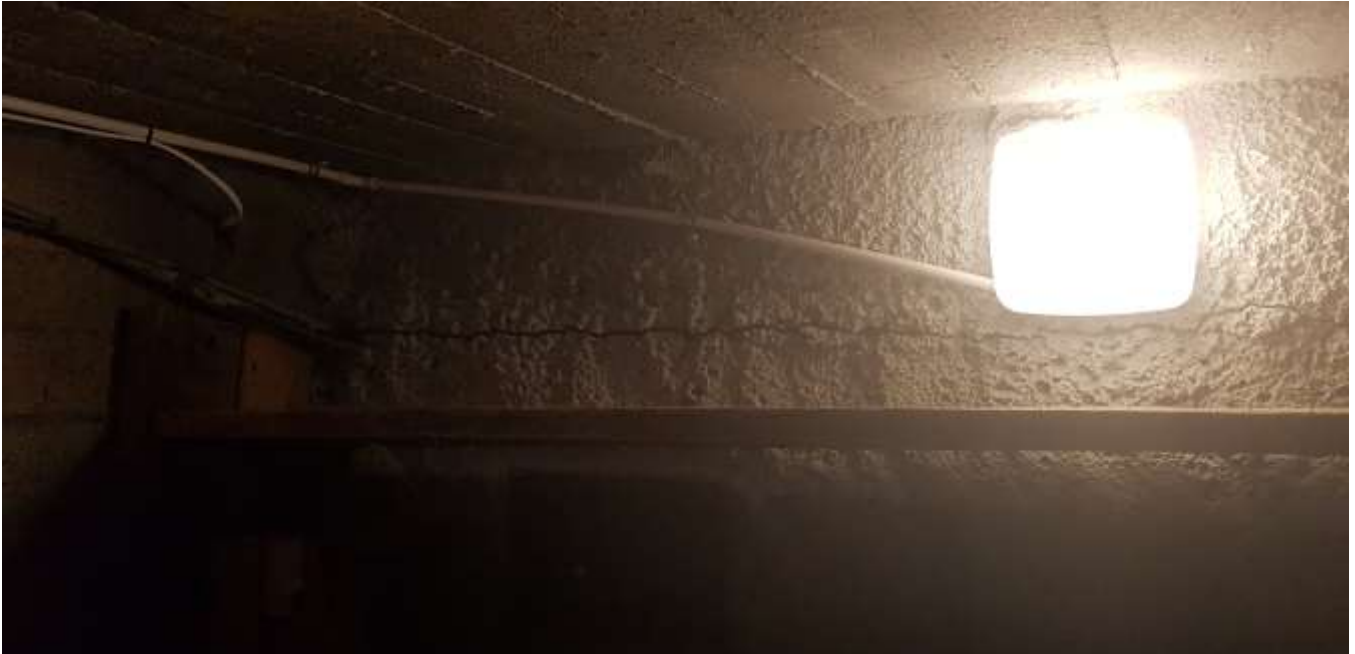
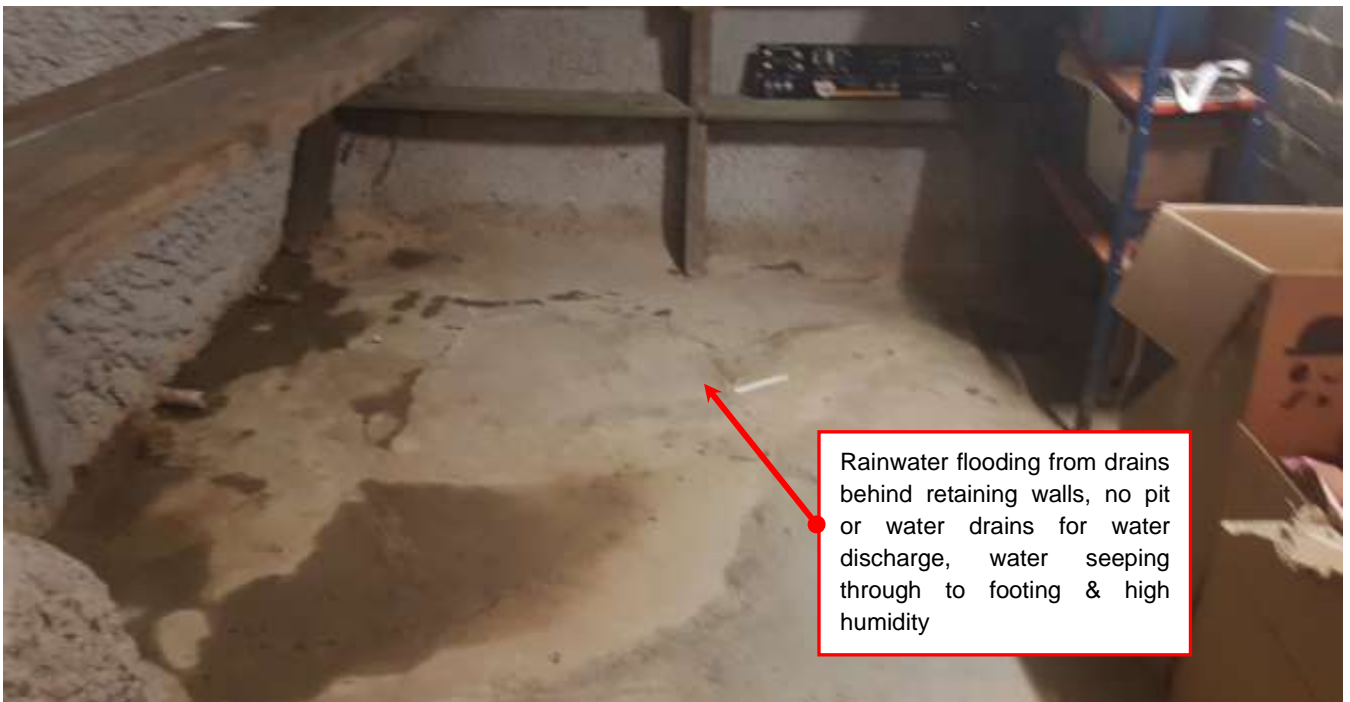
Photograph 26 – internal basement view

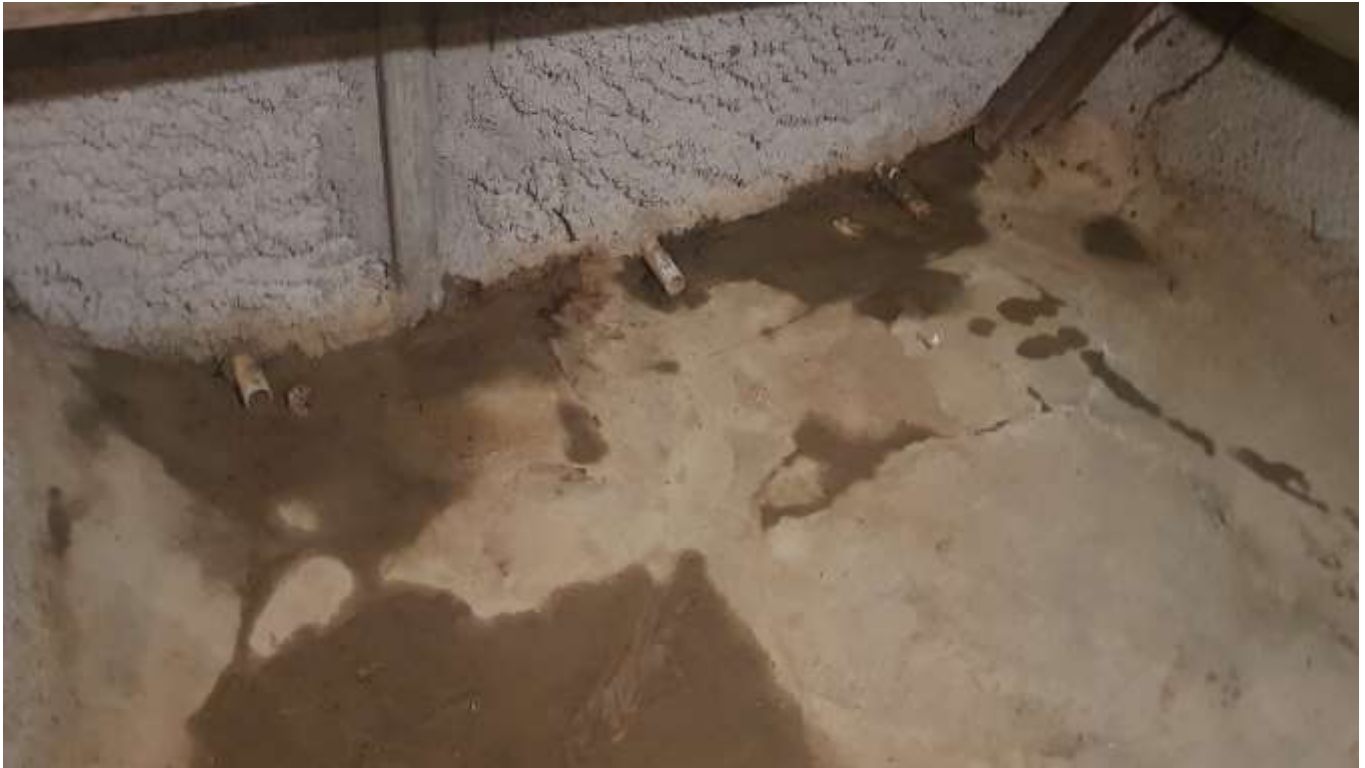
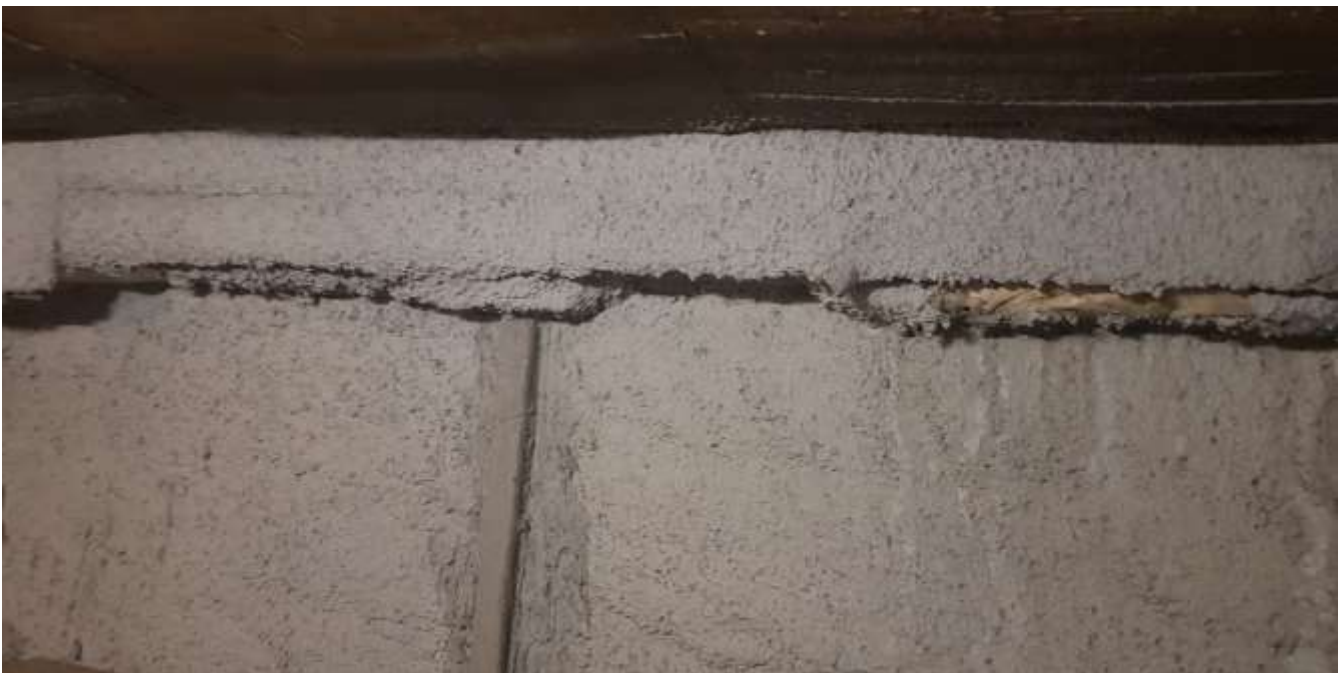
Photograph 27 – internal basement view

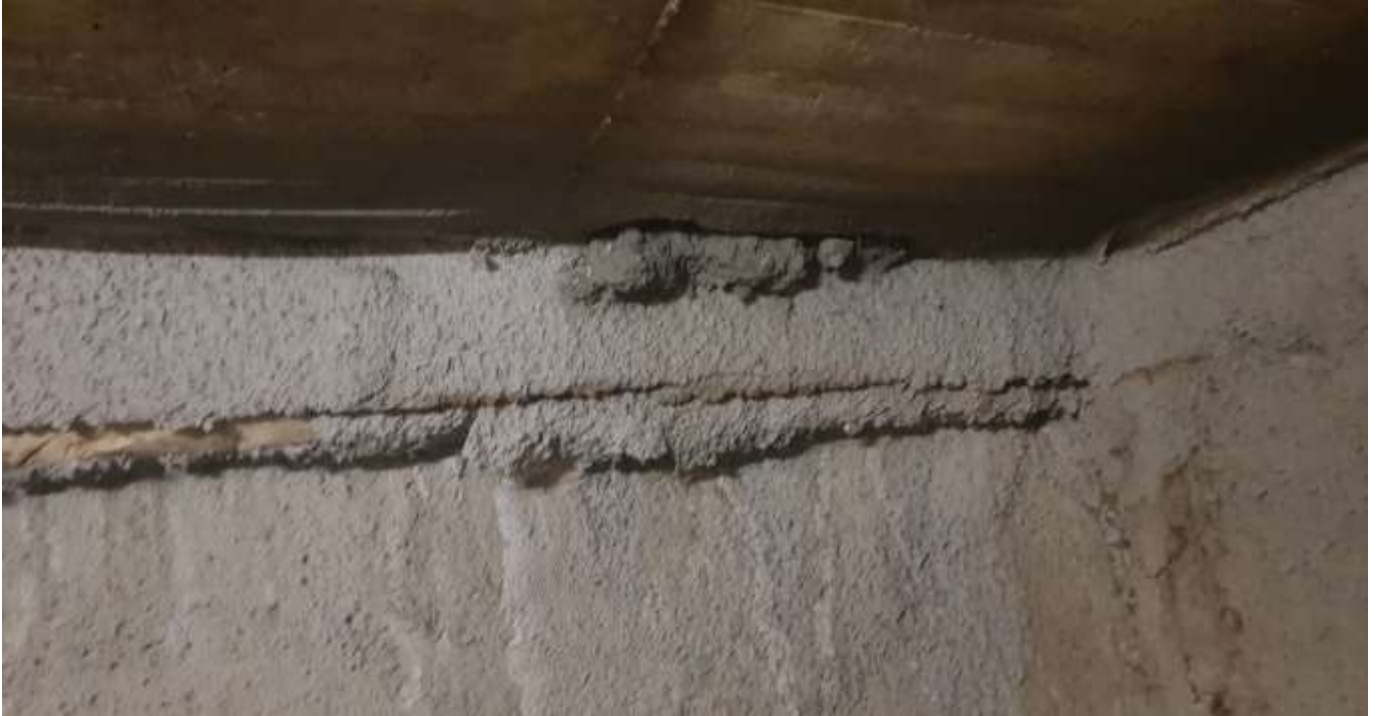
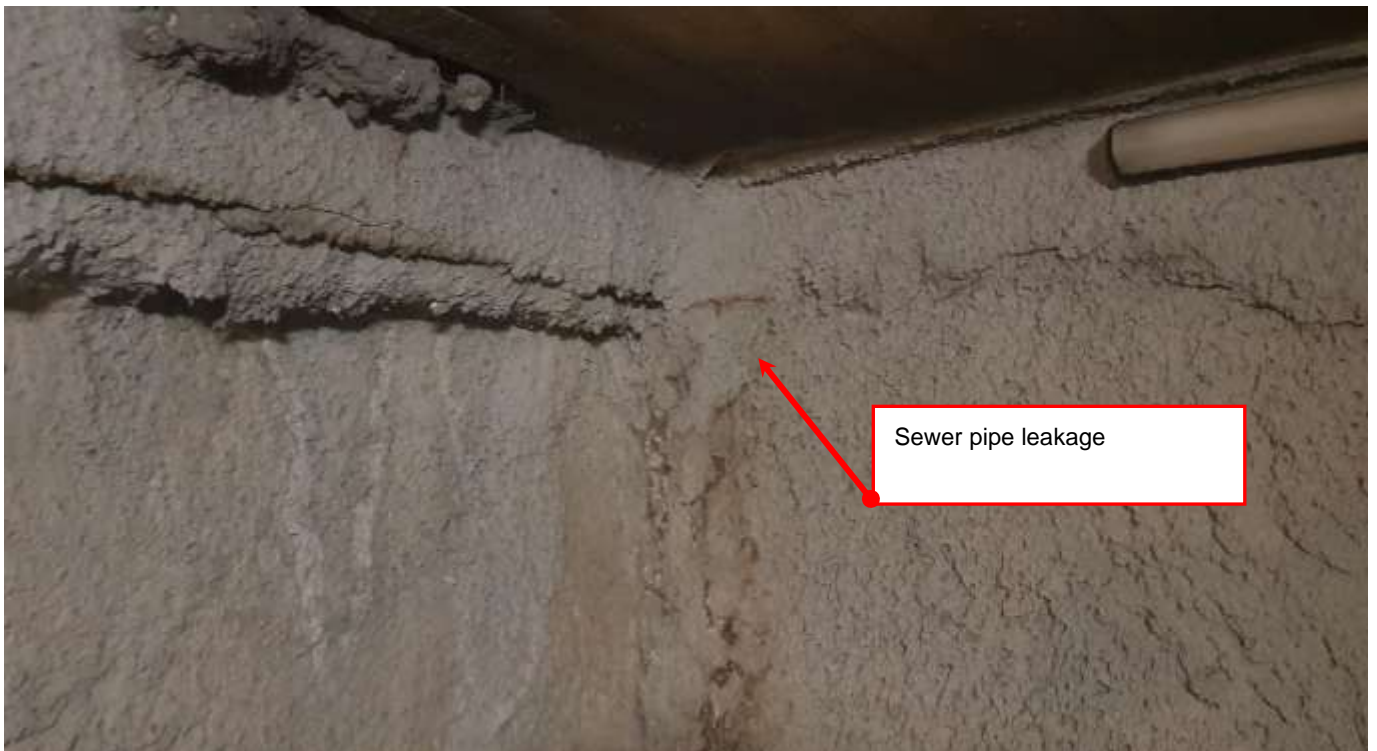
Photograph 28 – internal basement view

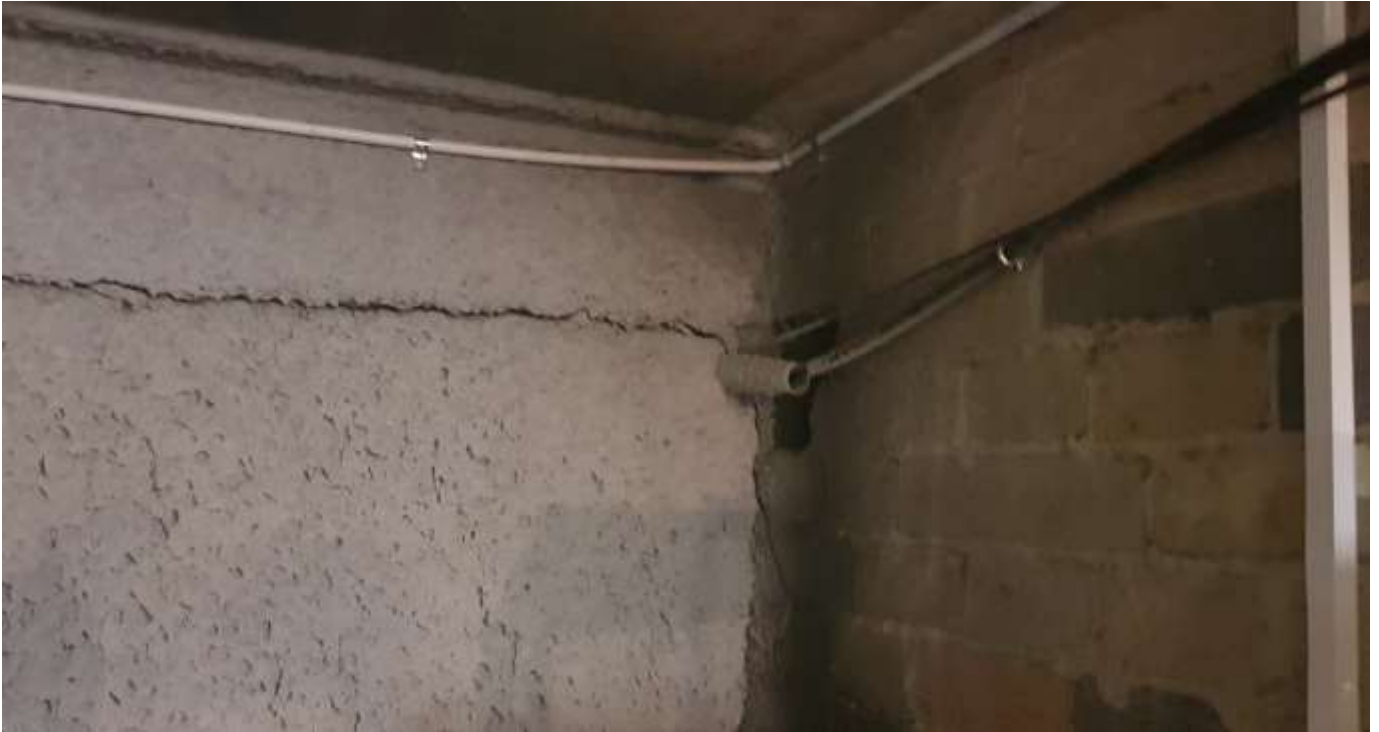
Photograph 29

Photograph 29– internal basement view

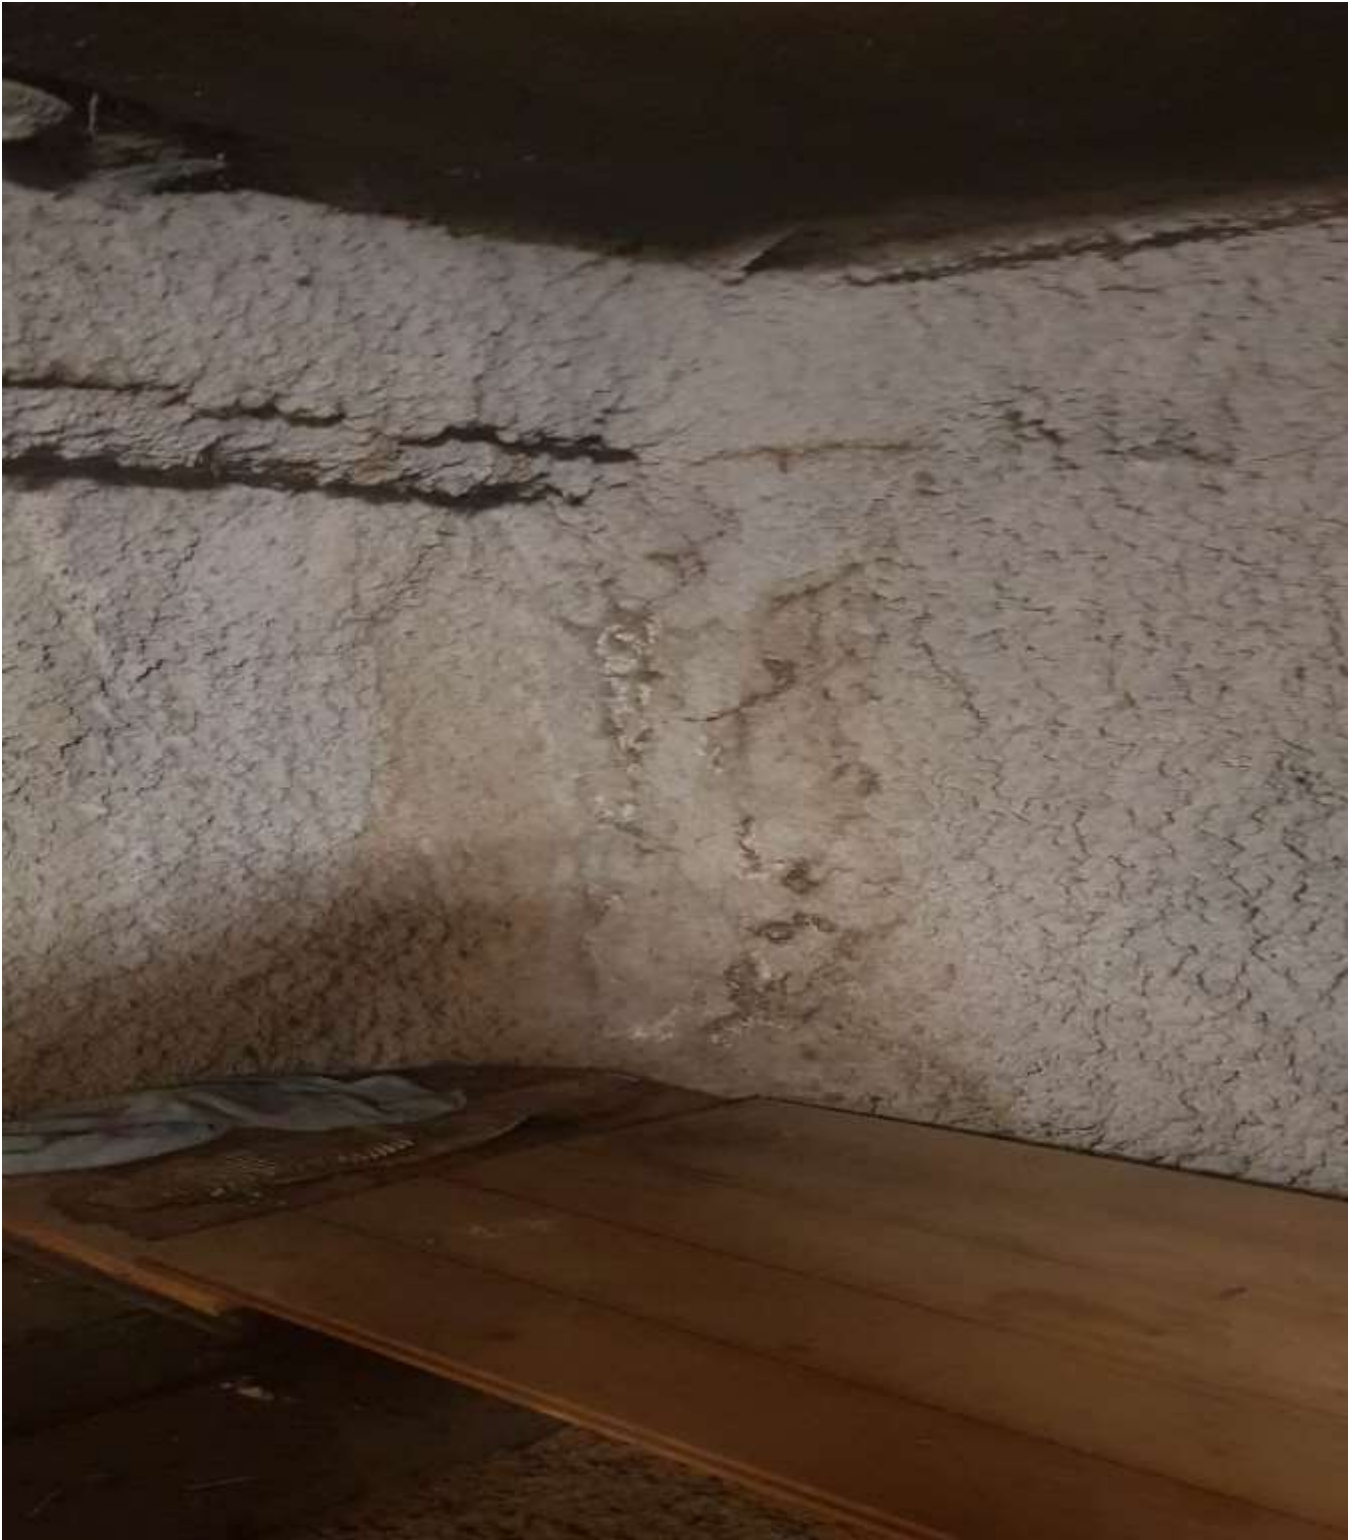
Photograph 30

Photograph 30– internal basement view

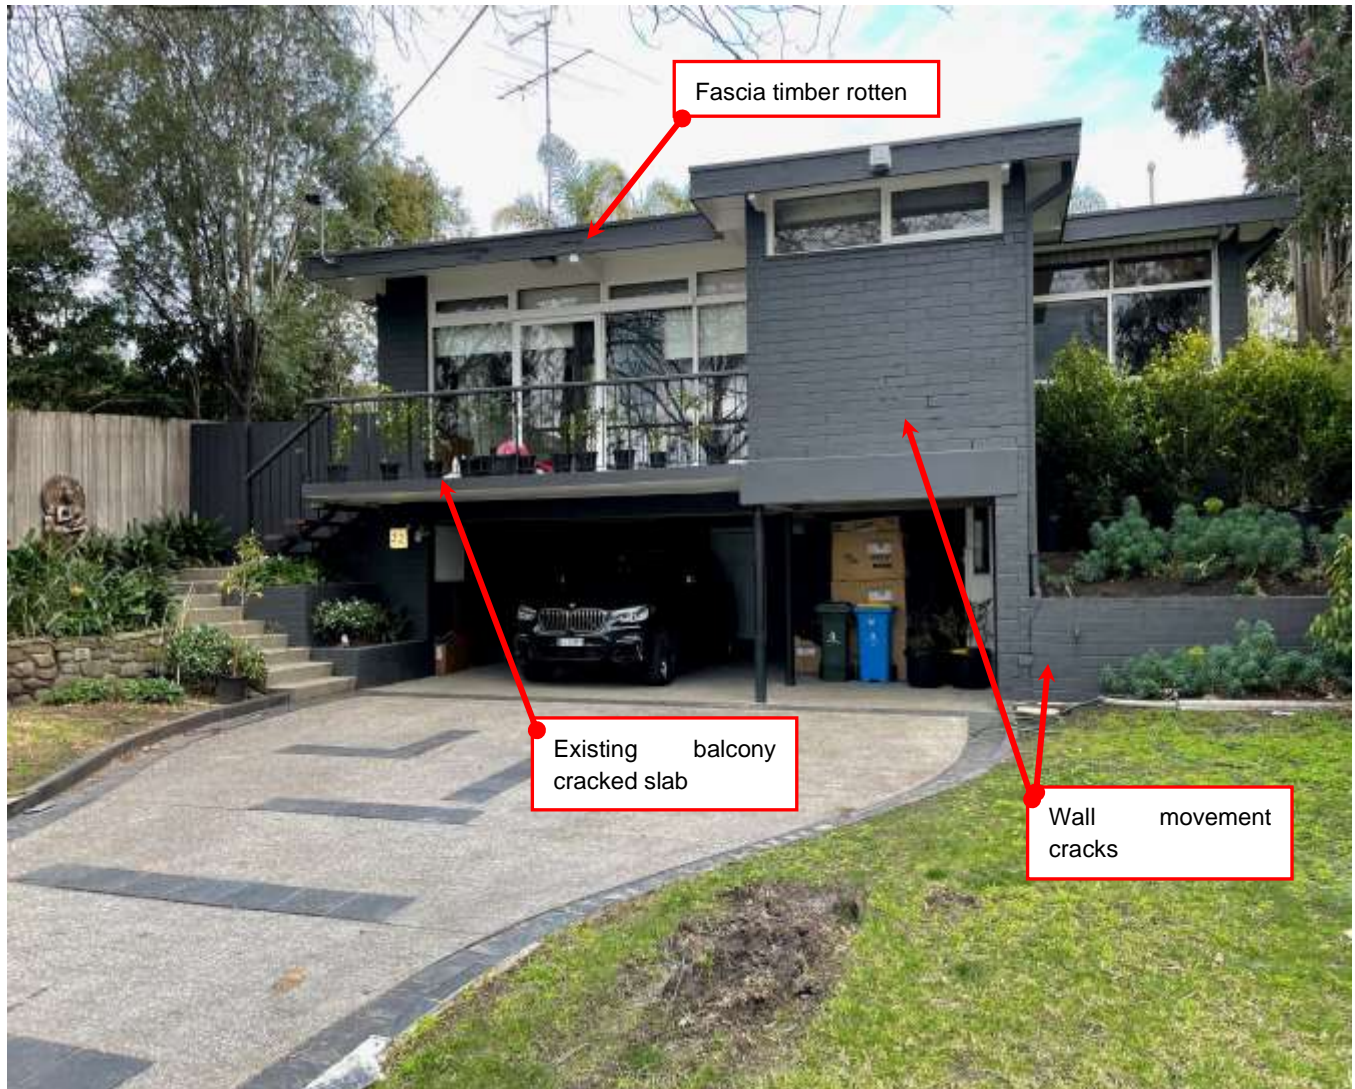
Photograph 31

Photograph 31– Front house view

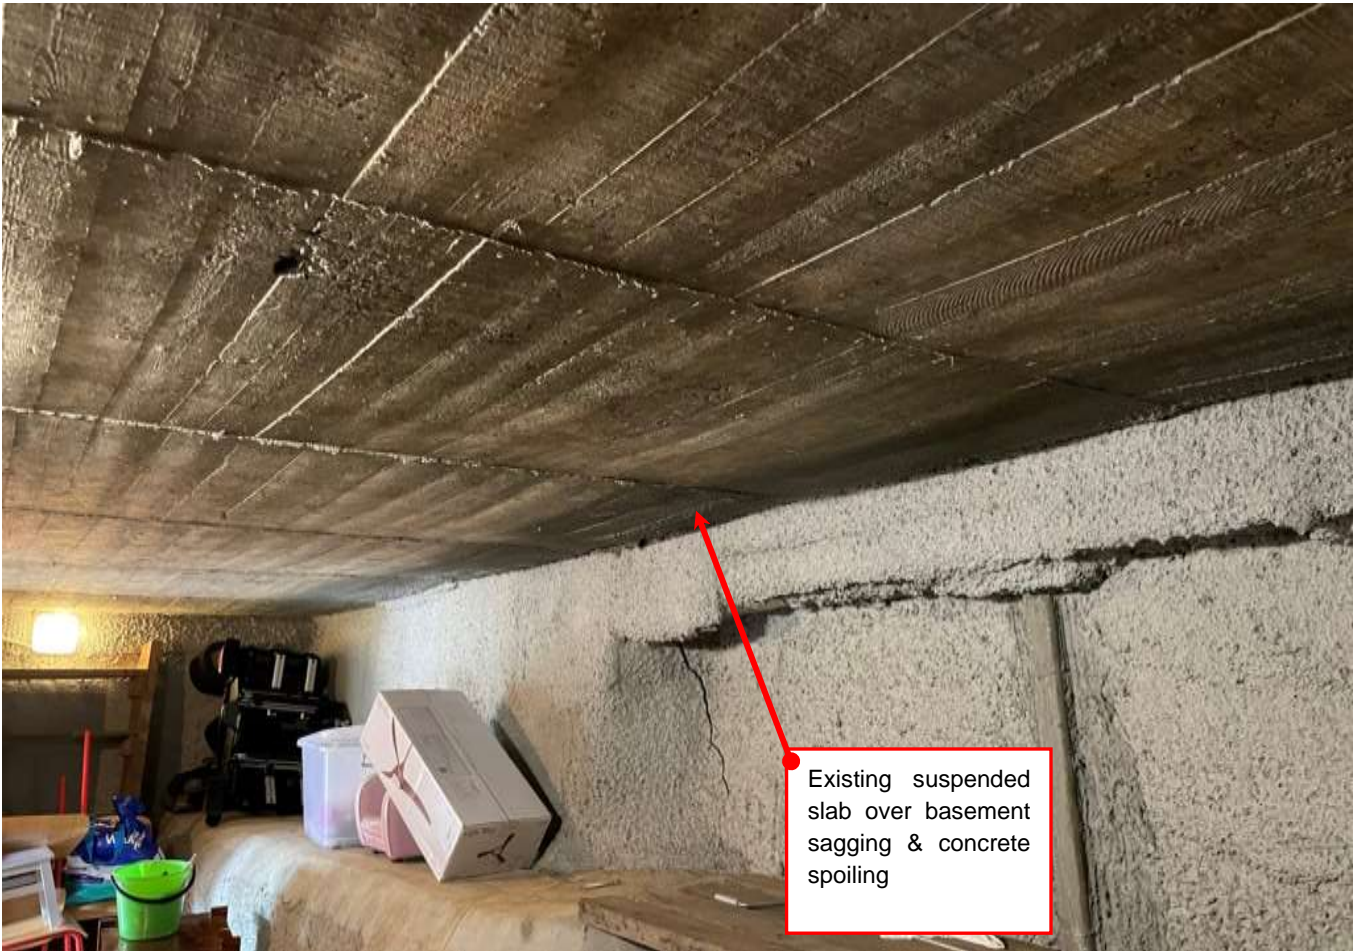
Photograph 32

Photograph 32– internal basement slab view
