Structural Inspection Report

32 Corby Street, Balwyn North VIC 3104

Prepared for Sanjiv Vij

Project Ref No.	16949	Version	2	Date	27/04/2022
Version	Issue Description				Date
1	FINAL – Issued to Client				September 29, 2021
2	FINAL – Issued to Client				April 27, 2022
<i>This report has been prepared in accordance with the terms and conditions of appointment. YG Consulting Engineers cannot accept any responsibility for any use of or reliance on the contents of this report by any third party.</i>

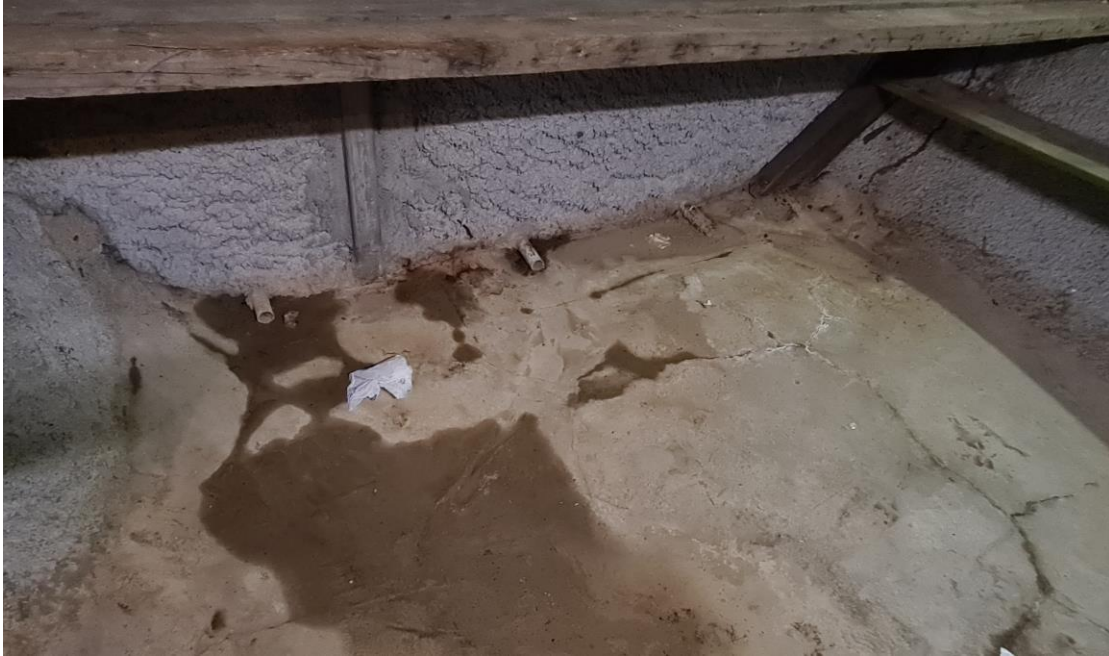
- Strip drains have been installed within the shotcrete walls in the storeroom. The pipe outlets from the strip drains are assumed to be draining subsoil water onto the storeroom floor slab. Drainage is deemed inadequate for this area of the building as there is no sufficient passage for the water to drain out of the building. Excess moisture was observed on the surface of the storeroom floor slab due to frequent ponding of the subsoil water. A floor grate pit is required for the storeroom area to effectively drain subsoil water away from the building via a pipe installed beneath the storeroom slab. Installing a new pipe beneath the storeroom slab may require cutting the existing concrete footing beneath the storeroom brick wall. Our concern with this solution is that cutting the concrete footing may affect the stability of the building.

Photograph 1 – Pipes at the base of shotcrete wall for subsoil drainage

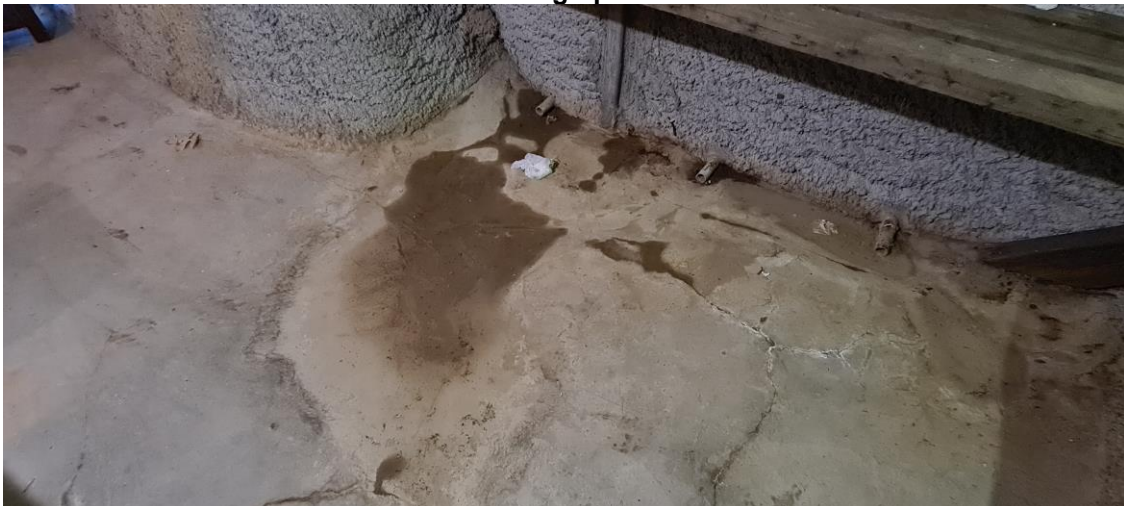
Photograph 2 – Subsoil drain pipes are draining into the storeroom area

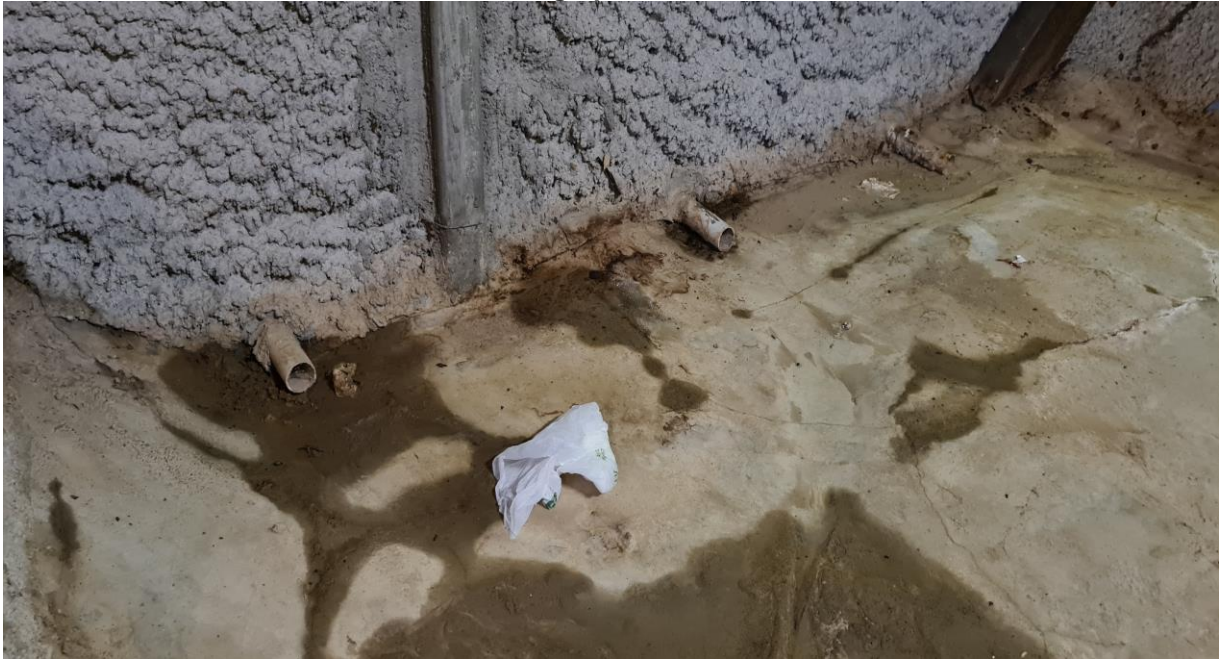
Photograph 3 – Excess moisture from shotcrete drain pipes

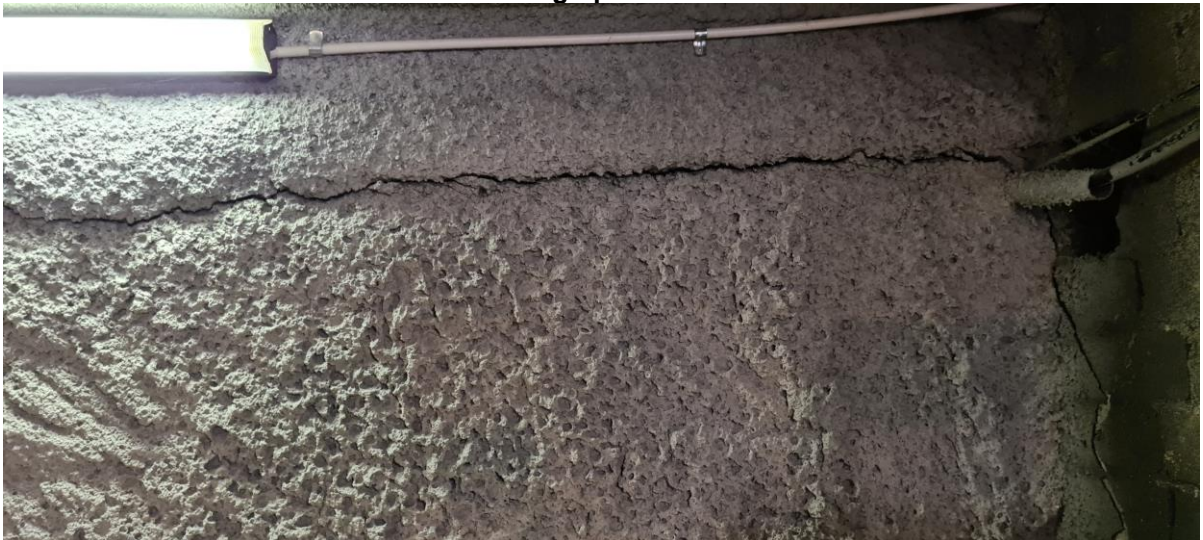
Photograph 4 – Crack along storeroom shotcrete wall assumed to be between capping beam and piles

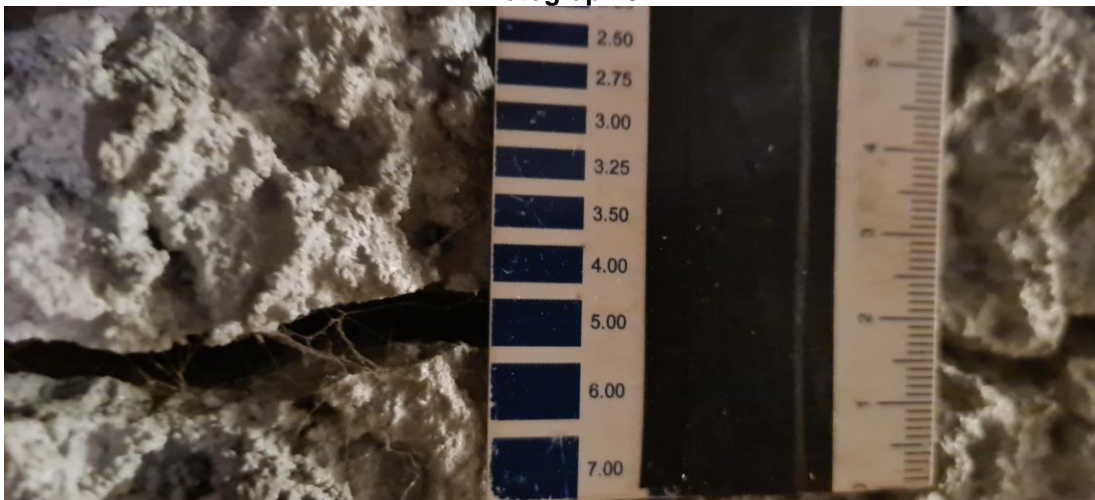
- The shotcrete wall within the storeroom consists of several cracks that were measured to be wider than the acceptable limit. Only three drain outlets are visible in the storeroom area, and it is assumed that there are no more outlets – the storeroom shotcrete walls require more than three drain outlets to ensure that hydrostatic pressure is not exerted onto the shotcrete walls.

Photograph 5 – Horizontal cracks of up to 5mm were measured in the storeroom area

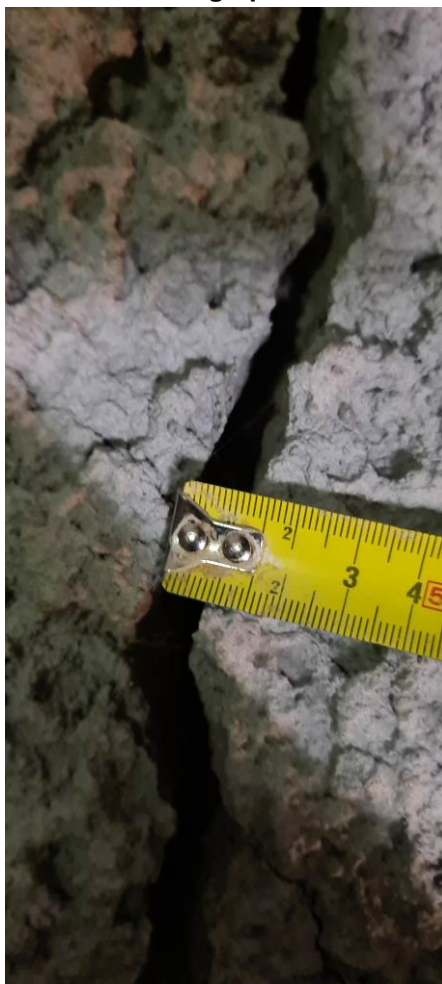
Photograph 6 – Vertical crack in the storeroom area shotcrete wall measured at 10mm

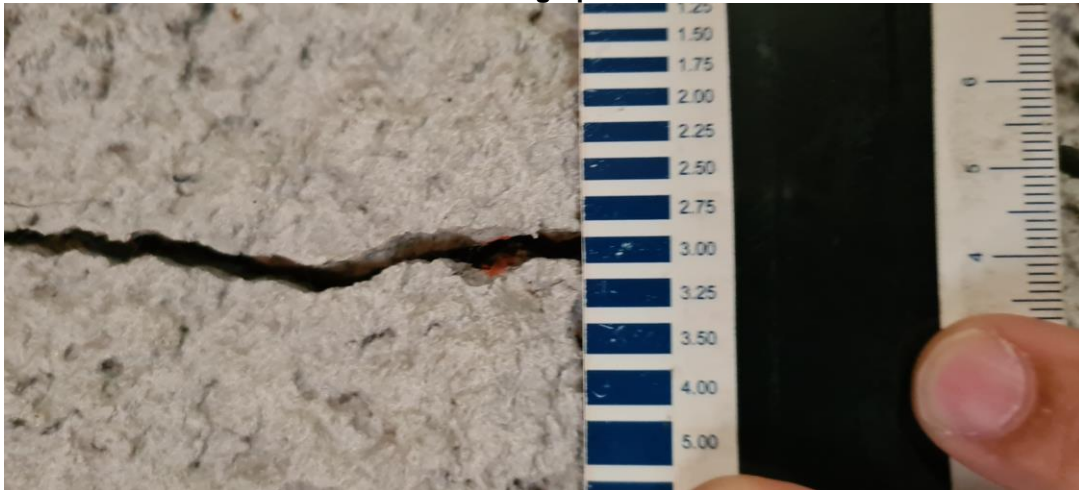
Photograph 7 – Shotcrete wall crack in the storeroom area measured at 3mm

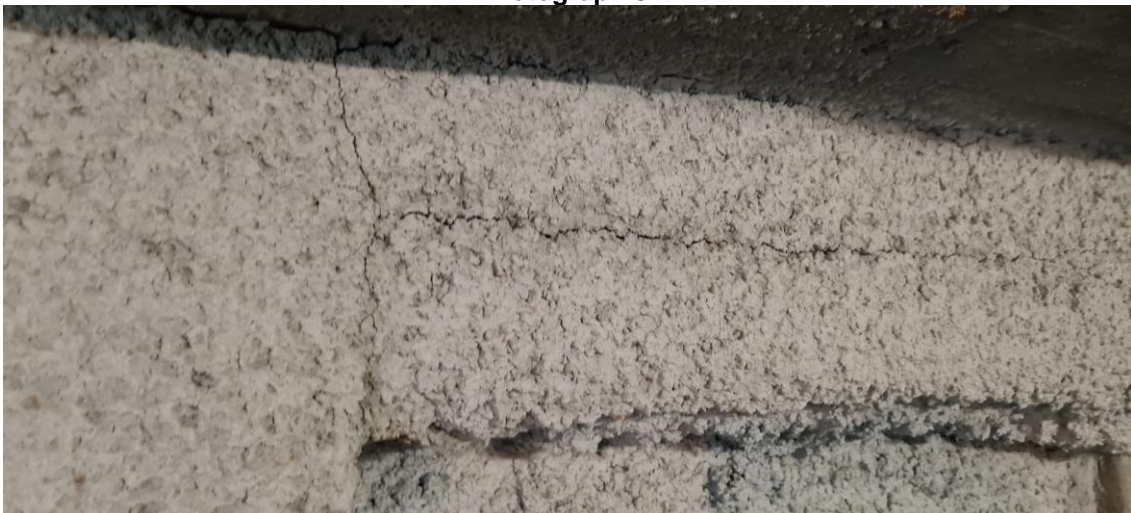
Photograph 8 – Cracks of up to 1mm appear throughout the surface of the shotcrete wall

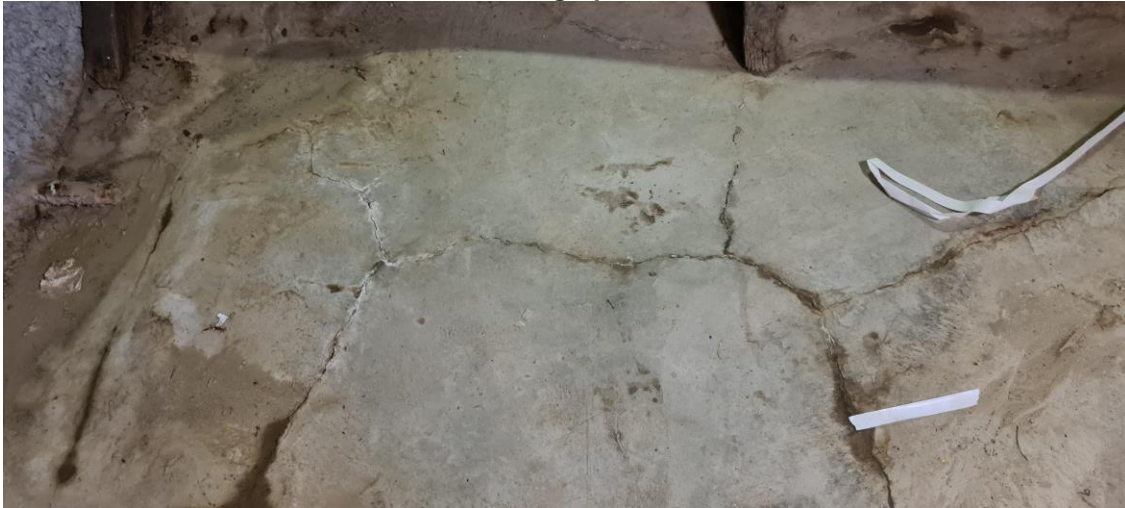
- Several cracks are evident throughout the surface of the storeroom floor slab. We believe that the subsoil water draining into the storeroom is seeping through the joint between the floor slab and shotcrete wall and absorbing into the underlying clay soil. We believe that the clay soil could be expanding due to excess moisture (clay soil is slow draining) and therefore causing the slab to crack.

Photograph 9 – Surface cracks throughout the floor slab of the storeroom area

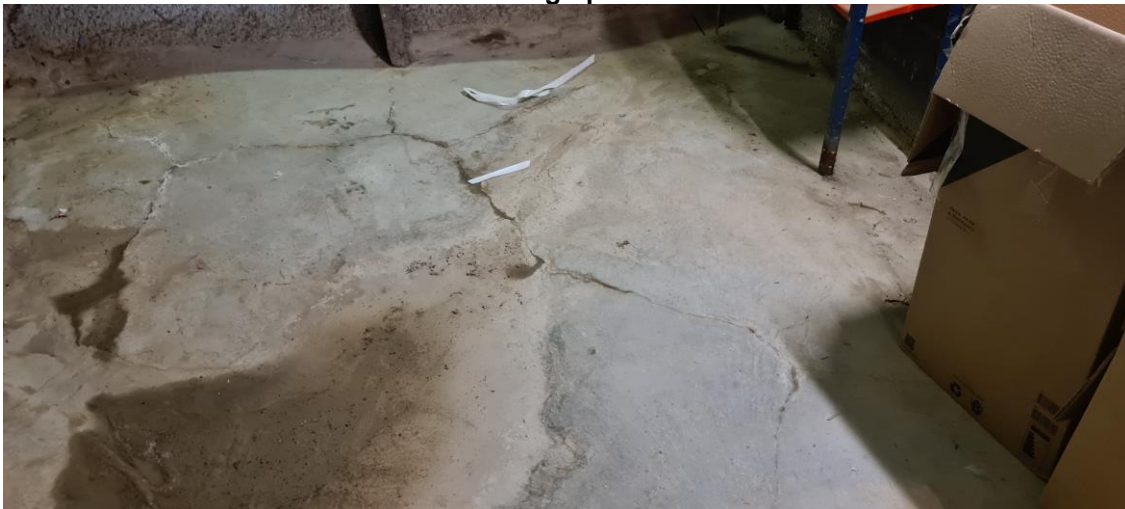
Photograph 10 – Water is ponding in areas where the floor slab has cracks

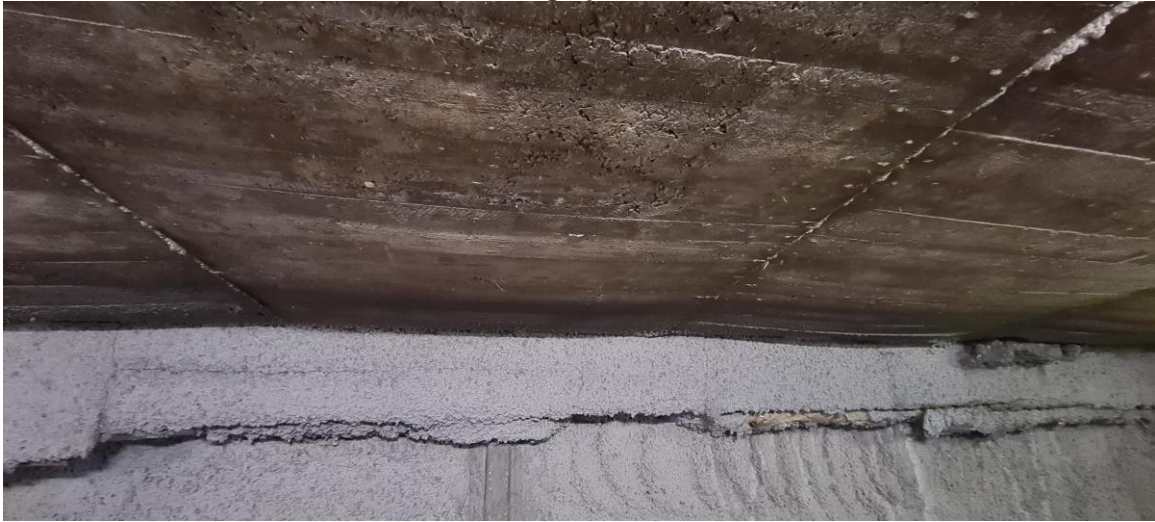
- The suspended concrete slab supporting the upper floor was measured to be approximately 130mm thick, however the thickness varies throughout the slab. Visible sag is present for the suspended slab in the storeroom and carport areas. Several areas of the slab show signs of spalling and honeycombing. We believe that the sag in the concrete slab could be caused as a result of the steel reinforcement corroding due to moisture seeping into the concrete. Honeycombing in concrete can potentially causes moisture vapour to seep into the concrete. Consequently, the corroded steel reinforcement loses bending strength which leads to a sag in the concrete slab. A sag of 28mm was recorded for the suspended concrete slab above the carport area over a length of 2m. The concrete slab for the building spans approximately 4.5m between supporting members. Given that the concrete slab is supporting masonry walls, the maximum allowed deflection over a span of 4.5m is 9mm (Table 2.3.2 AS3600-2018). The actual sag of the slab is more than three times the allowable limit for a slab supporting a masonry wall.

Photograph 11 – Upper floor concrete slab sagging

It is our opinion that the existing defects of the building could lead to structural failure and therefore the building is currently not safe for occupancy. We are concerned with the sag of the upper floor concrete slab, which we believe is a result of the steel reinforcement losing strength due to corrosion. Due to the difficulty of assessing the loss of strength of the reinforcement, we advise that the building is demolished to prevent the likelihood of structural failure.

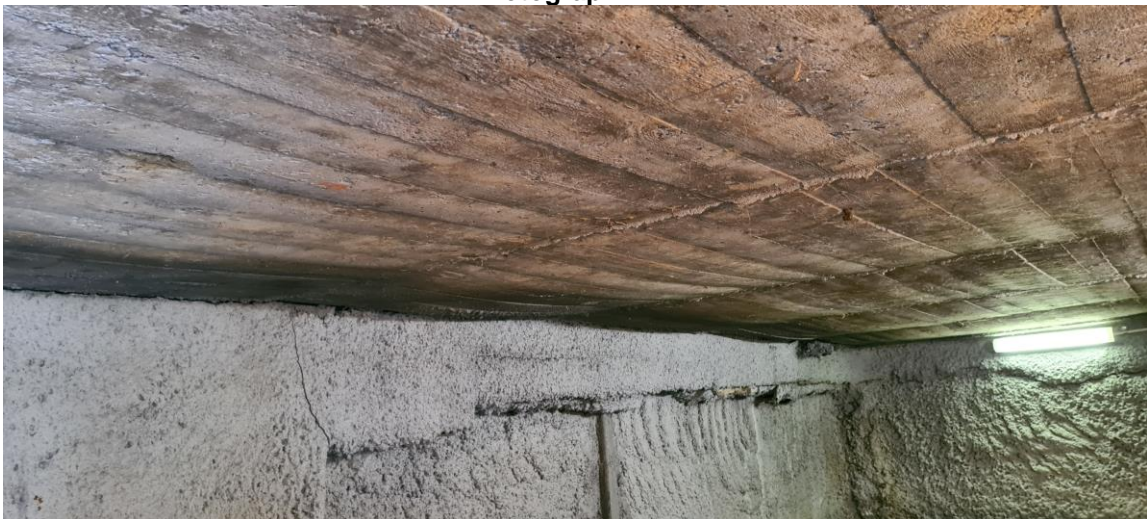
Photograph 12 – Upper floor concrete slab sagging

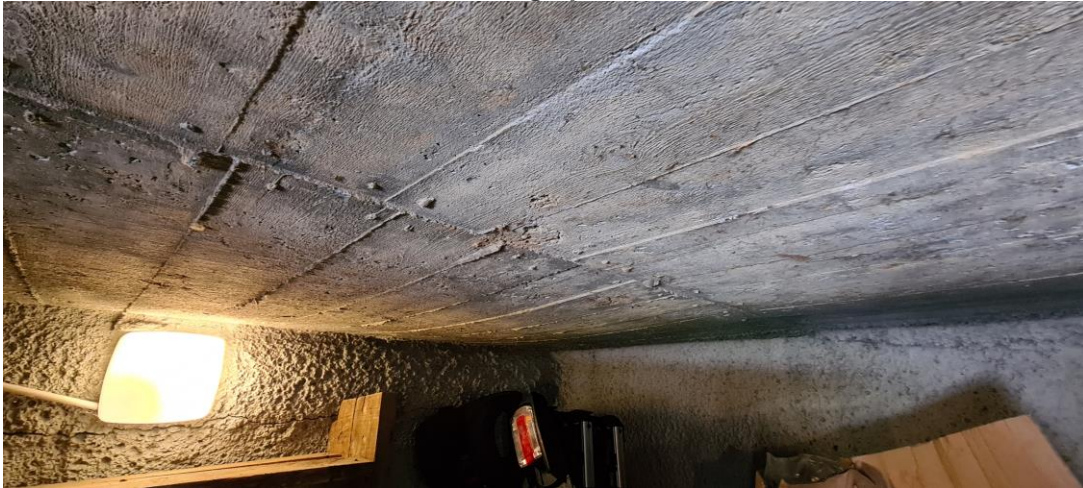
Photograph 13 – Upper floor concrete slab sagging

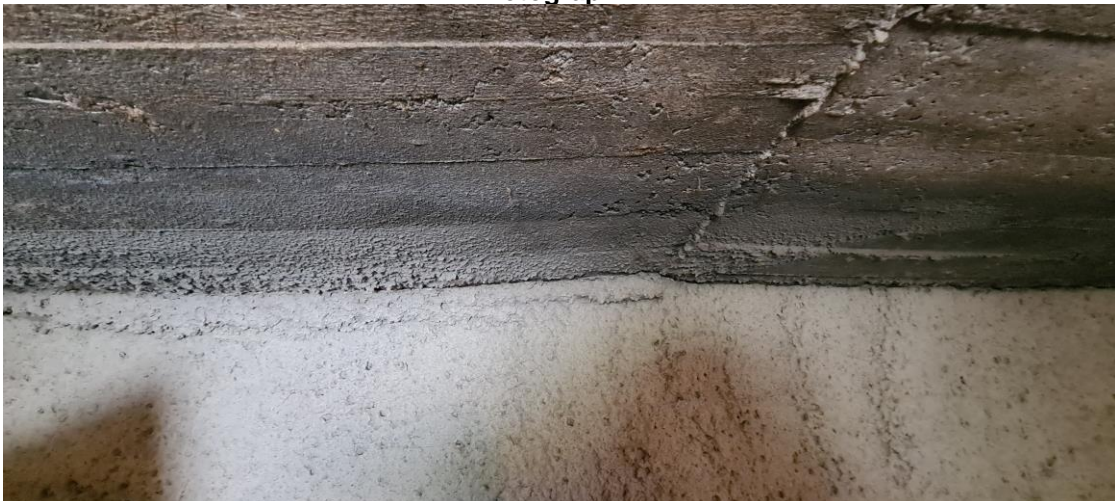
Photograph 14 – Upper floor concrete slab sagging

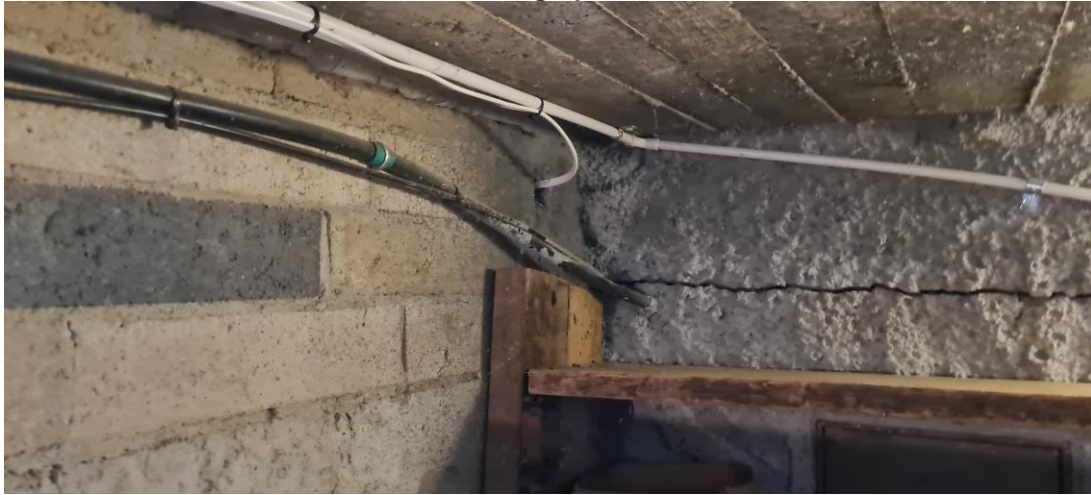
Photograph 15 – Horizontal crack along shotcrete wall

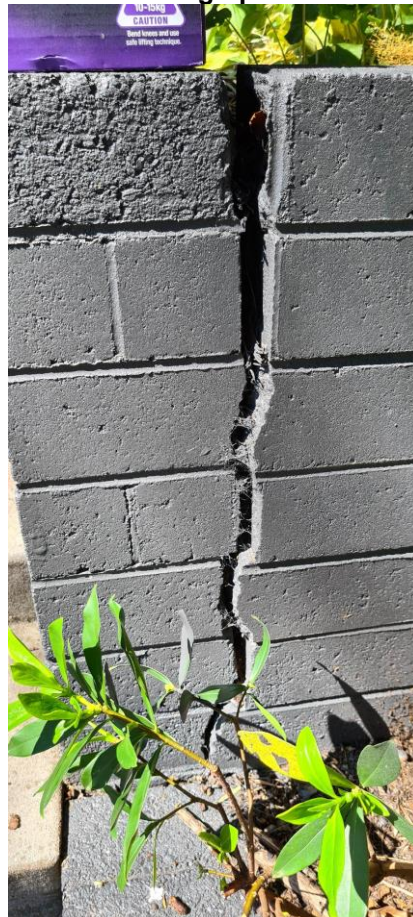
Photograph 16 – Brick wall separation between retaining wall and carport wall

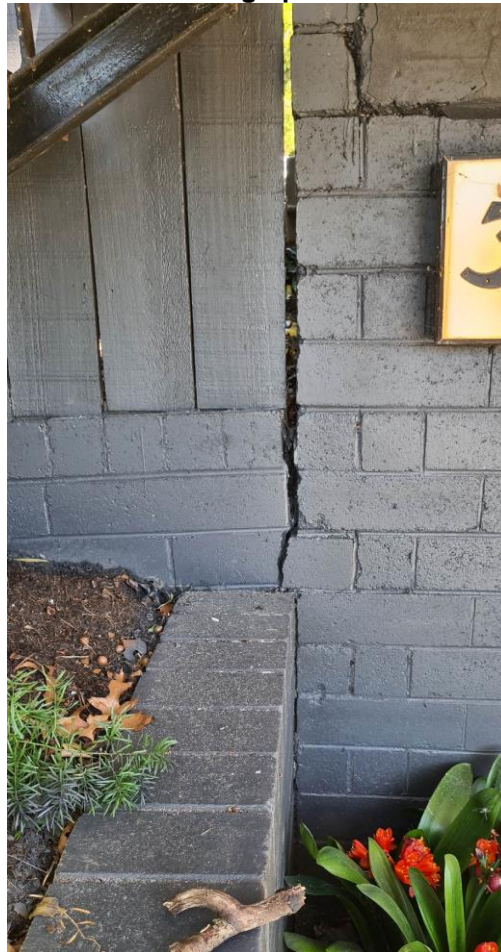
Photograph 17 – Brick wall separation between retaining wall and carport wall

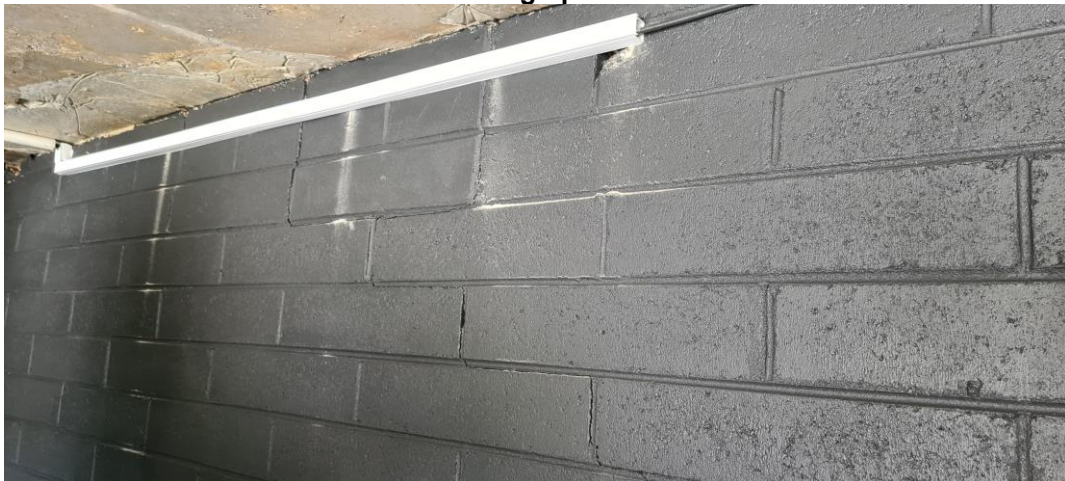
Photograph 18 – Stepped crack in brick wall between carport and storeroom

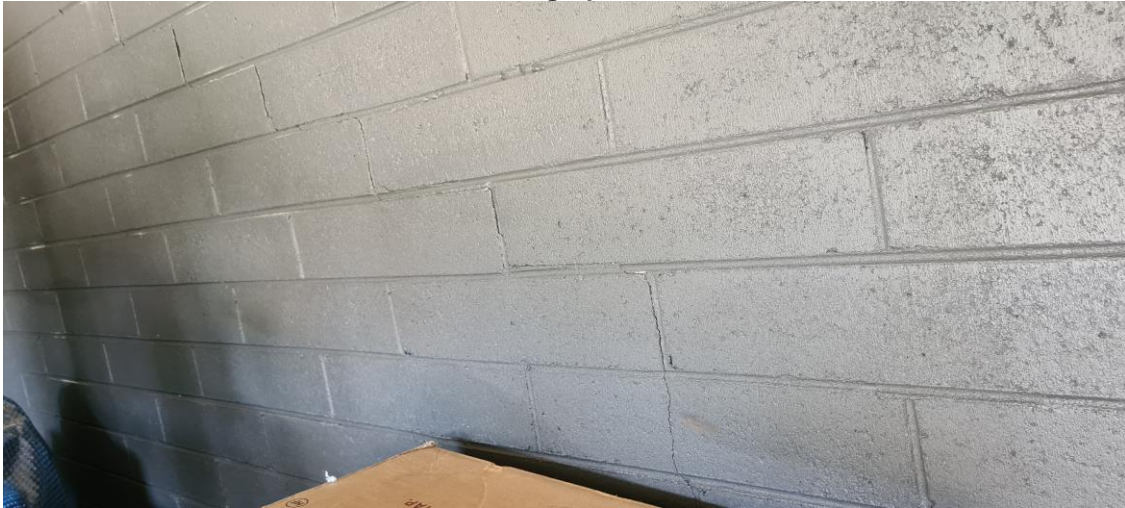
Photograph 19 – Stepped crack in brick wall between carport and storeroom

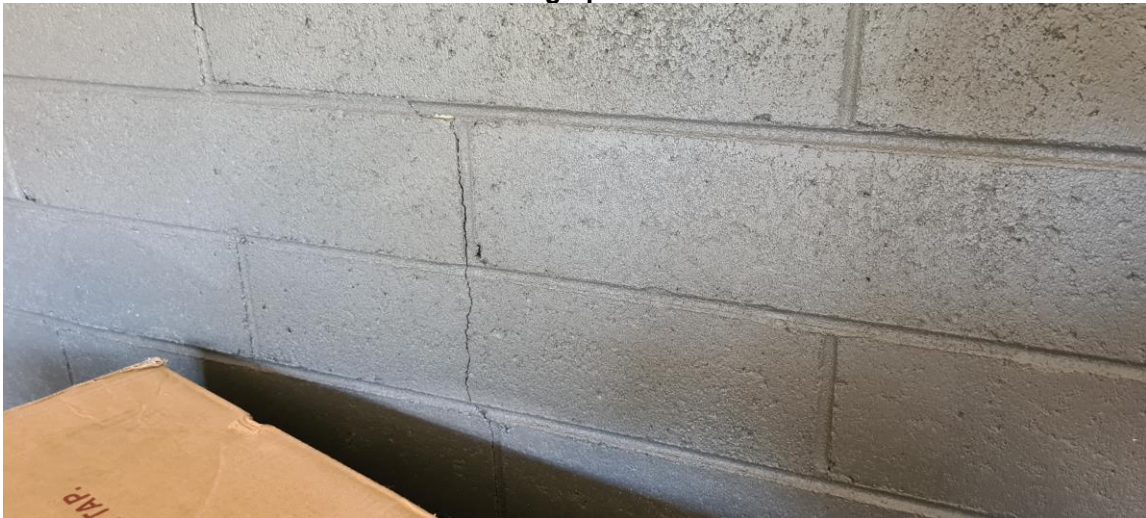
Photograph 20 – Stepped crack in brick wall between carport and storeroom

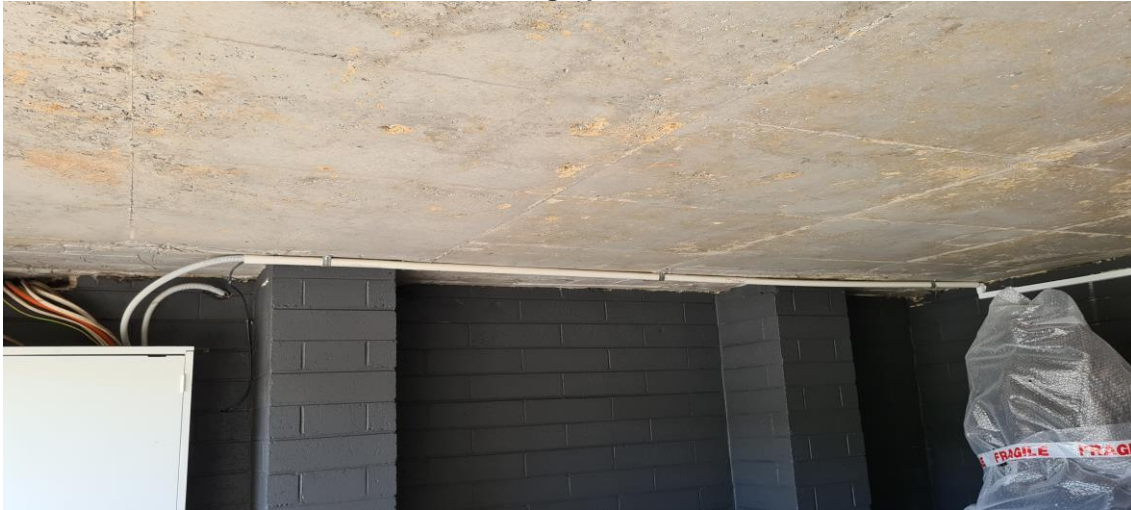
Photograph 21 – Concrete spalling and honeycombing present along the slab soffit in the carport area

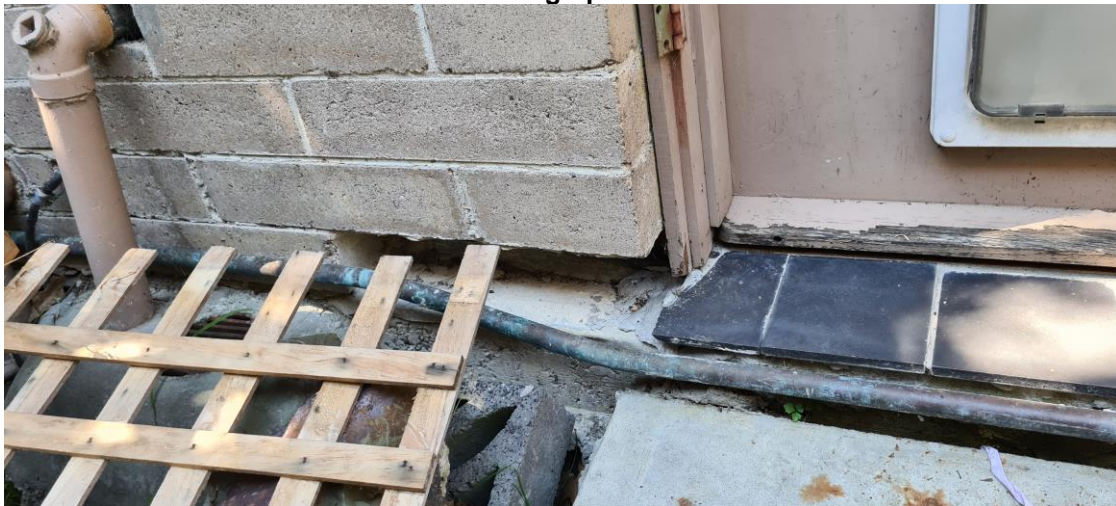
Photograph 22 – Missing brickwork along bottom course of west brick wall

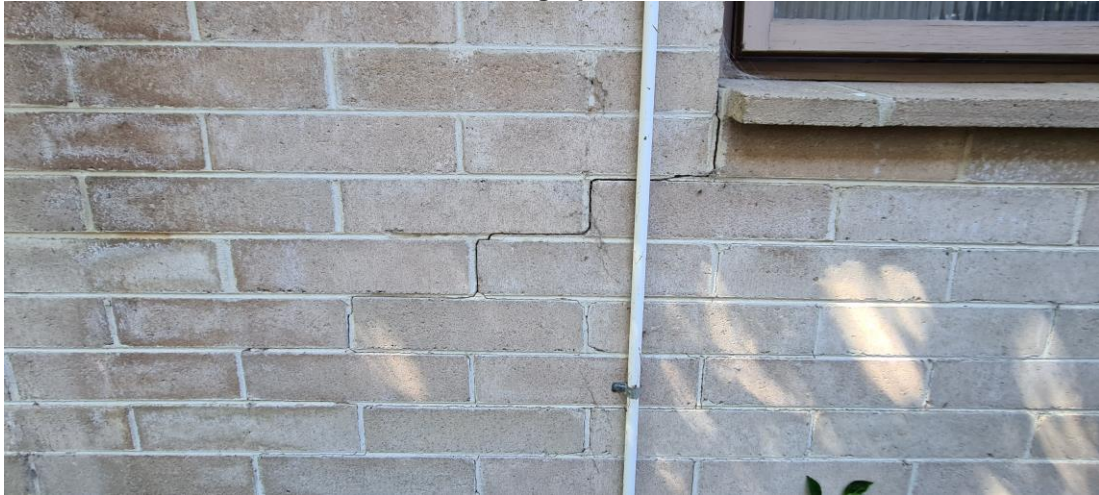
Photograph 23 – Stepped crack along west brick wall

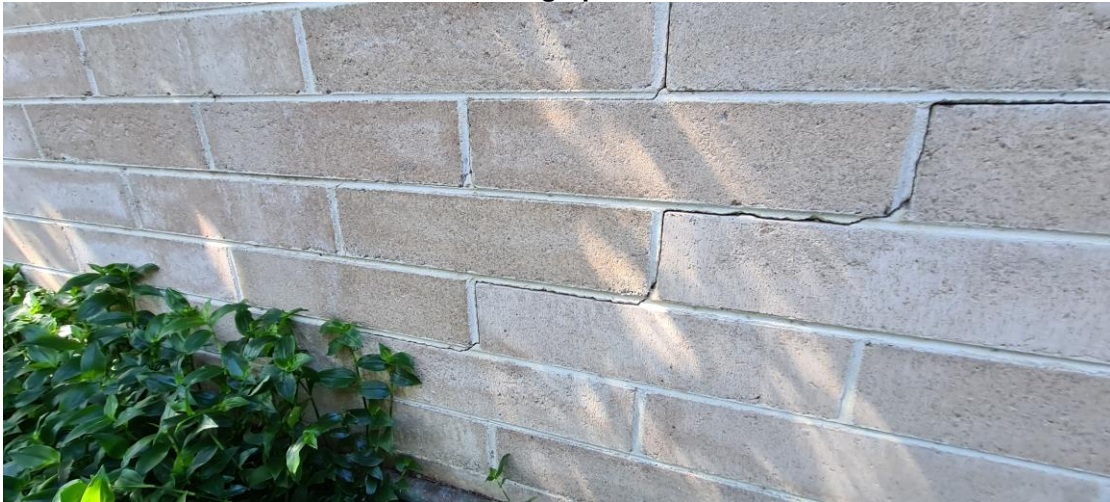
Photograph 24 – Continuation of stepped crack along west brick wall

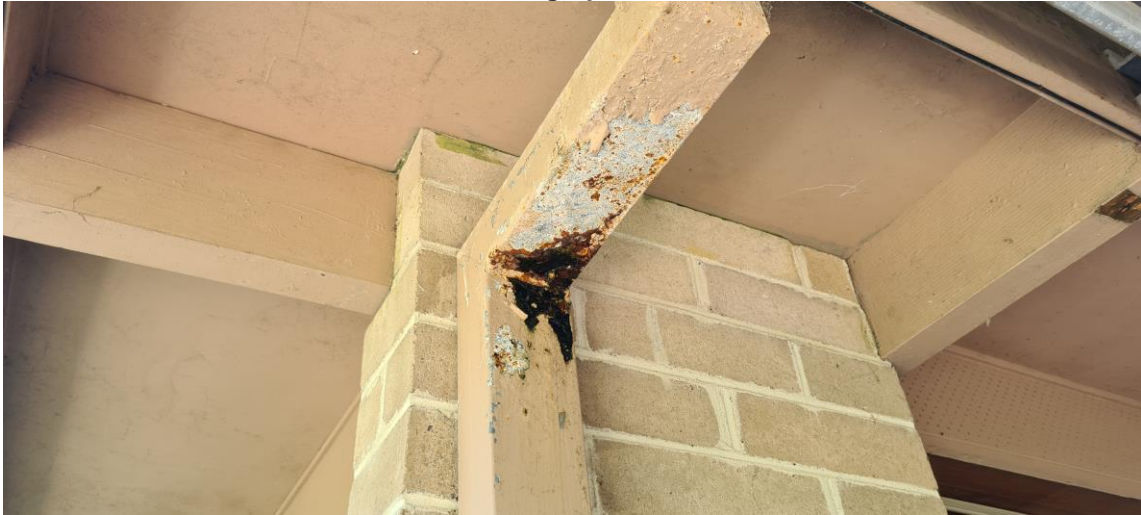
Photograph 25 – Corrosion of downpipe on east side of building

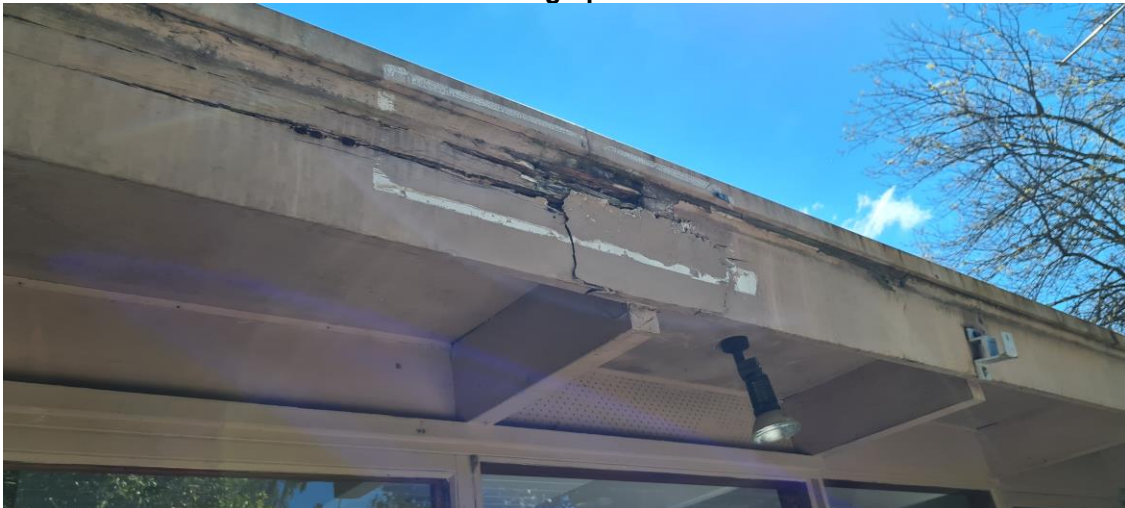
Photograph 26 – Timber fascia rot on east side of building

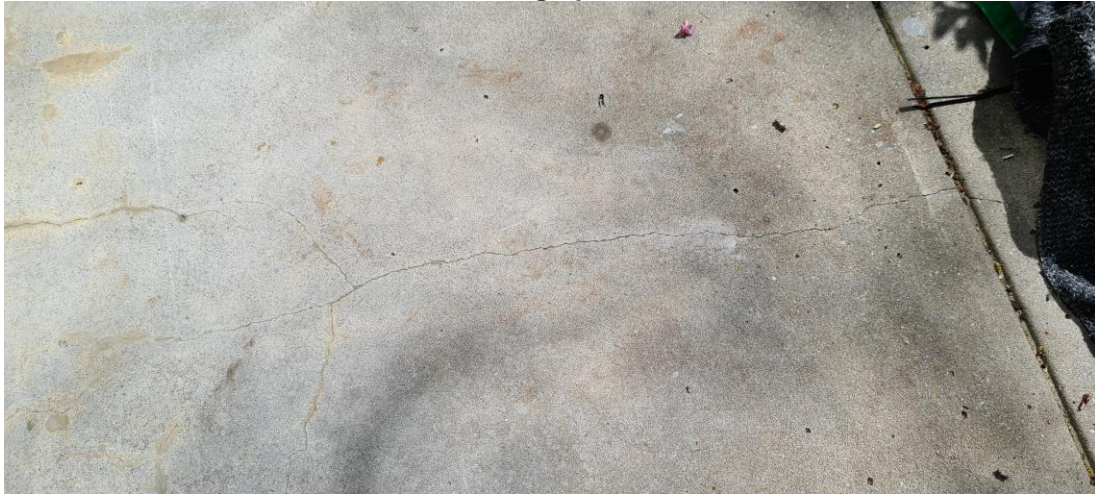
- Hairline cracks were observed along the surface of the balcony floor slab. Due to floor coverings, we could not inspect the slab in the internal areas of the upper floor. However, it is likely that the hairline cracks are present throughout the entire surface of the upper floor slab.
- Stepped cracks were observed along the brick wall supported by the upper floor slab.
- Brick retaining walls in landscaped areas have separated from the building wall. The separation could be a result of inadequate drainage at the rear of the retaining walls causing excessive hydrostatic pressure on the walls.
- Corrosion of downpipe and rotting of timber fascia was observed along the north and east walls of the building.

Photograph 27 – Hairline cracks on balcony floor slab

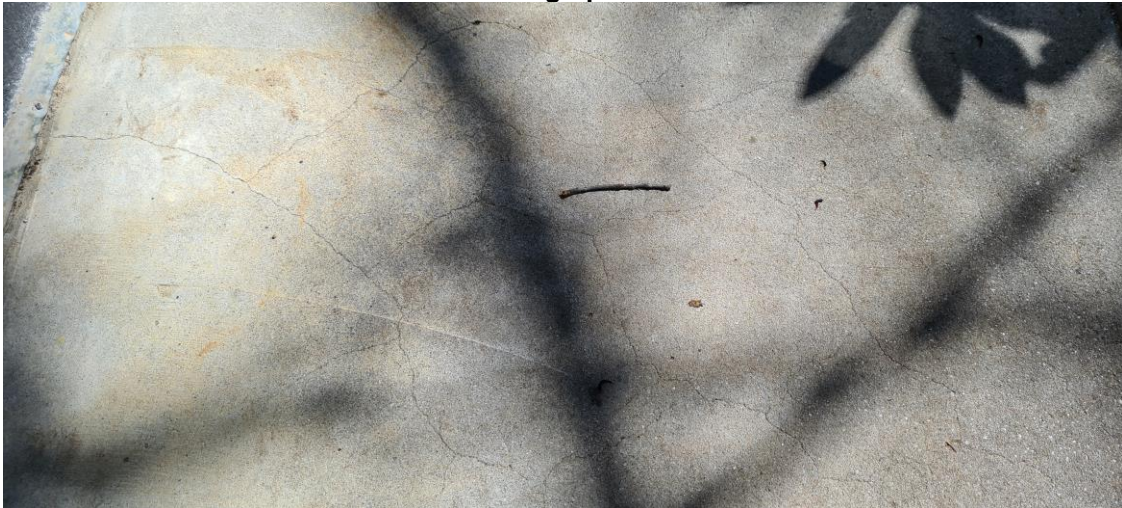
Photograph 28 – Hairline cracks on balcony floor slab
