Public Housing Renewal Project - Bills Street and Robinson Road, Hawthorn

Supplementary Geotechnical Investigation

20145767-022-R-Rev0

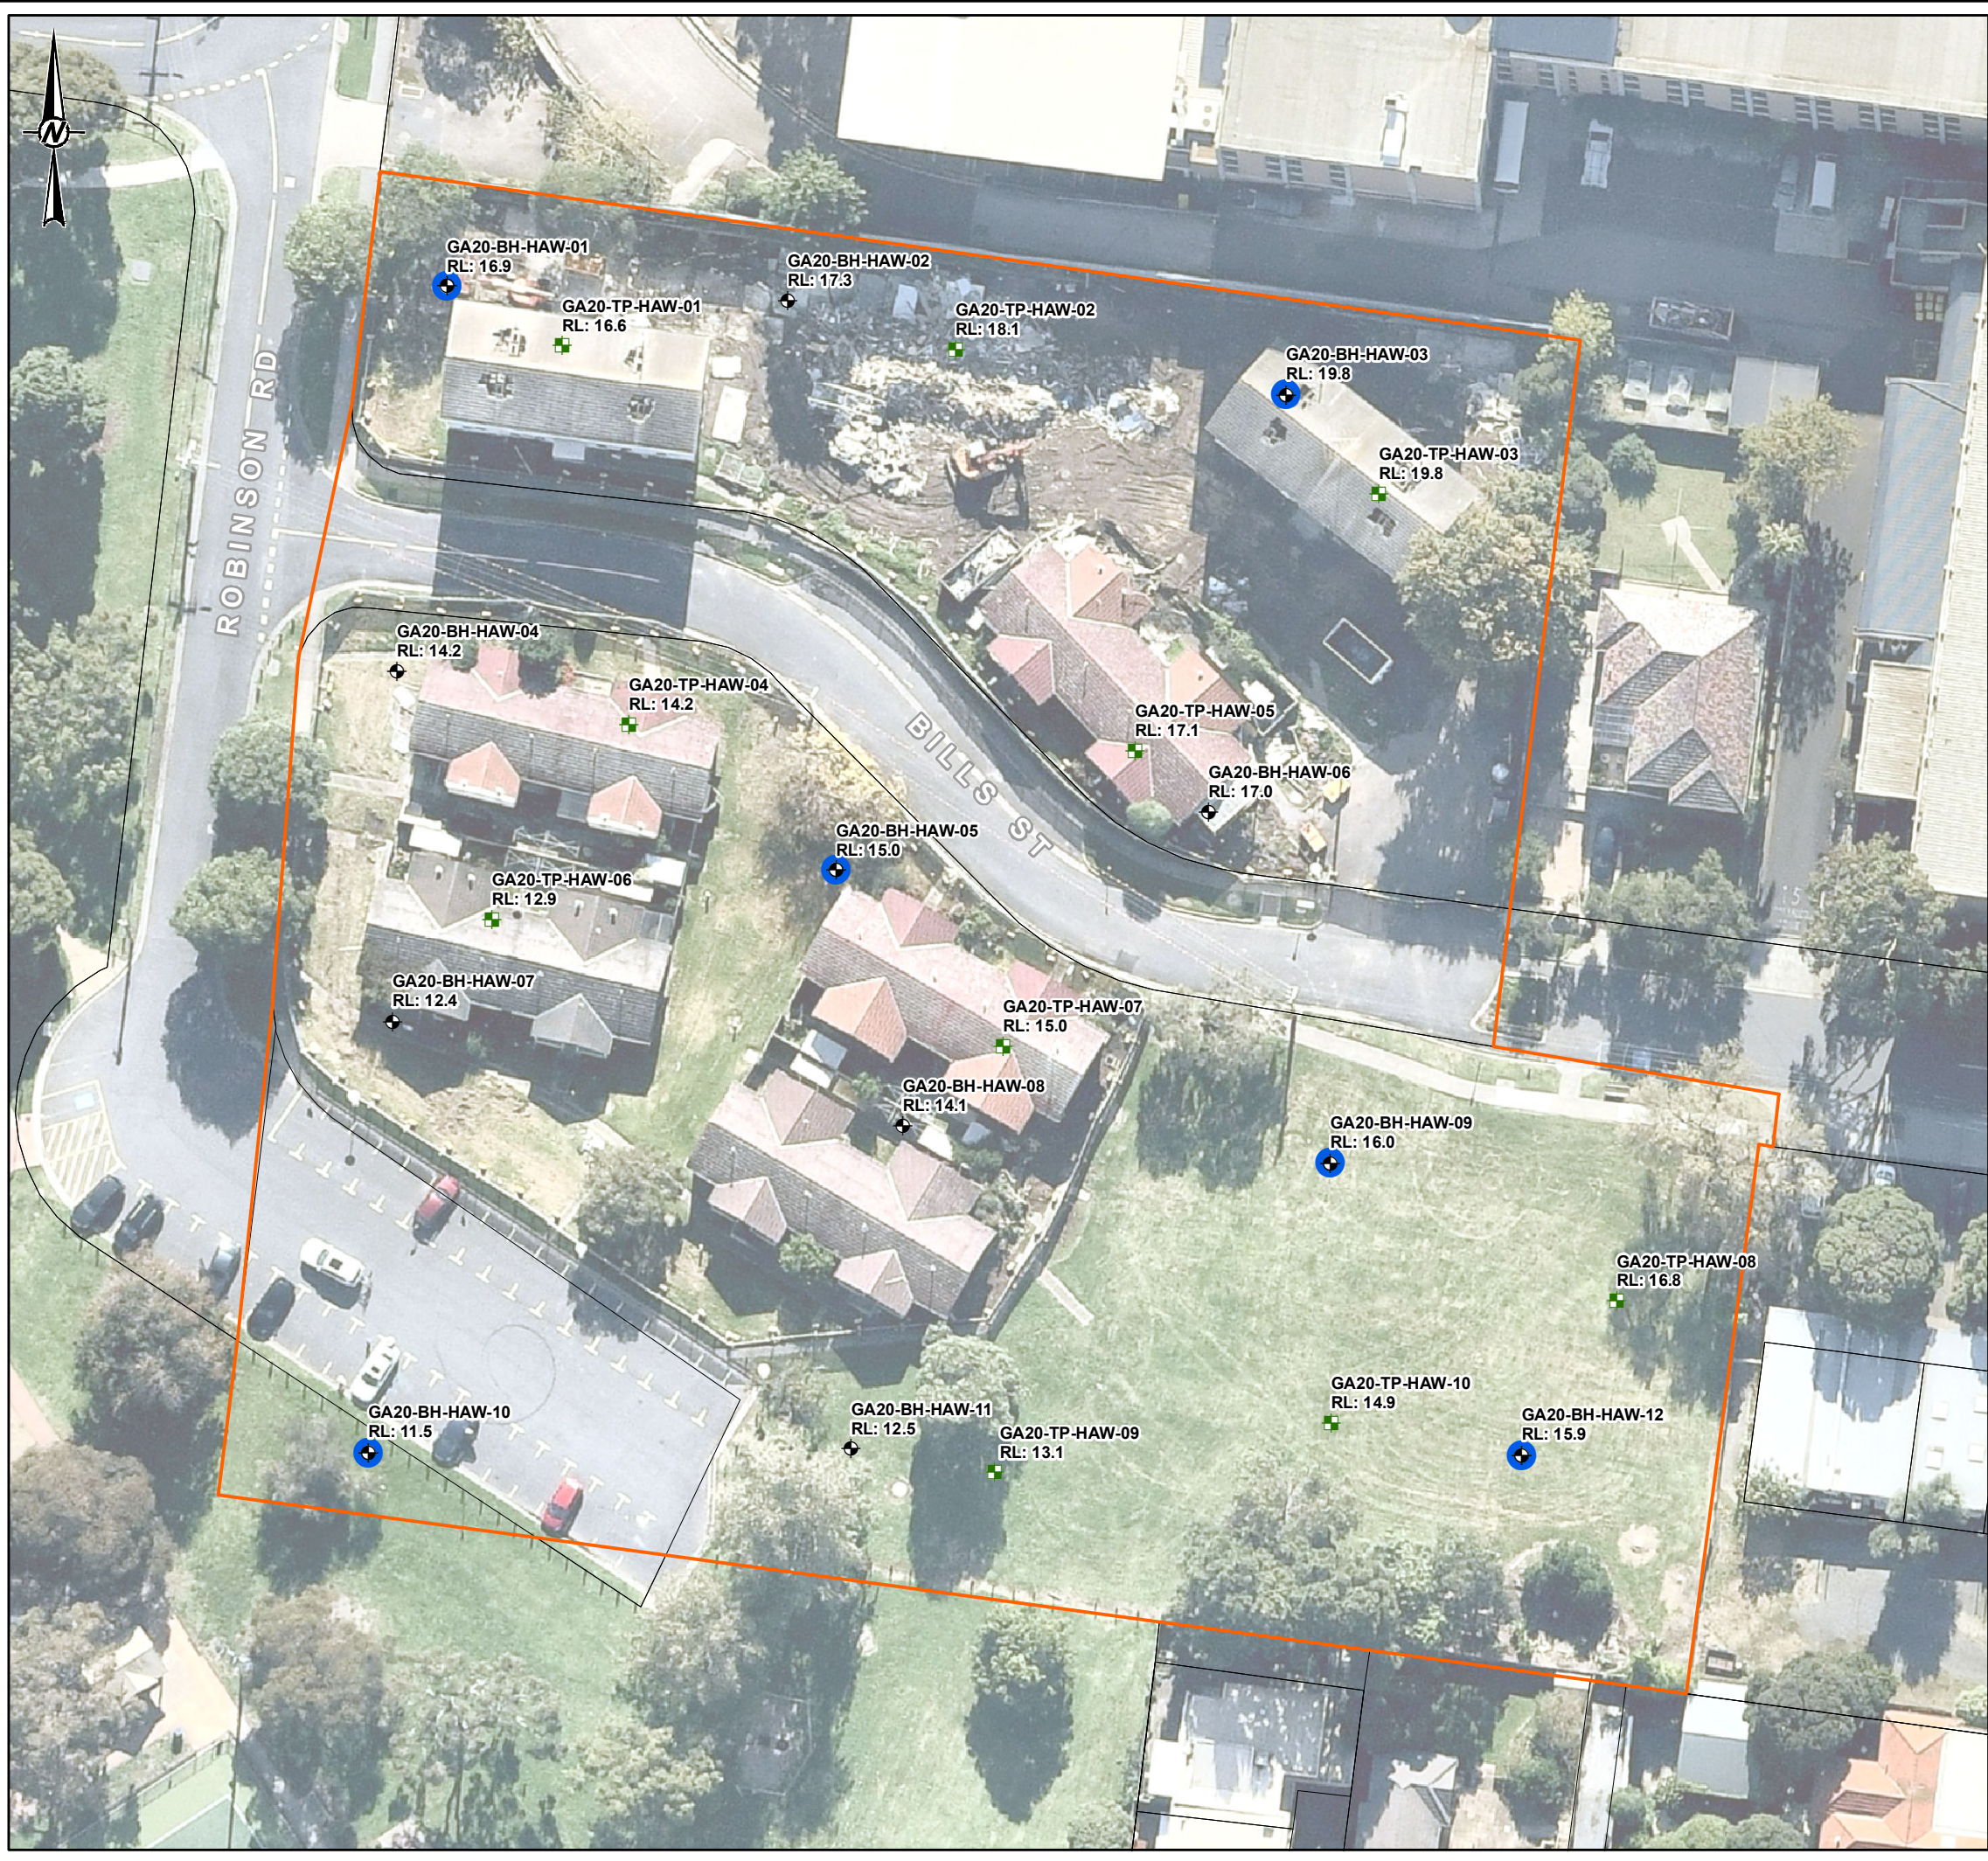
PROJECT NO. 20145767 CONTROL 022-R REV. 0 FIGURE 1

- LEGEND
- Geotechnical Borehole Location
 - Testpit Location
 - Borehole with Groundwater Monitoring Well
 - Site Extent

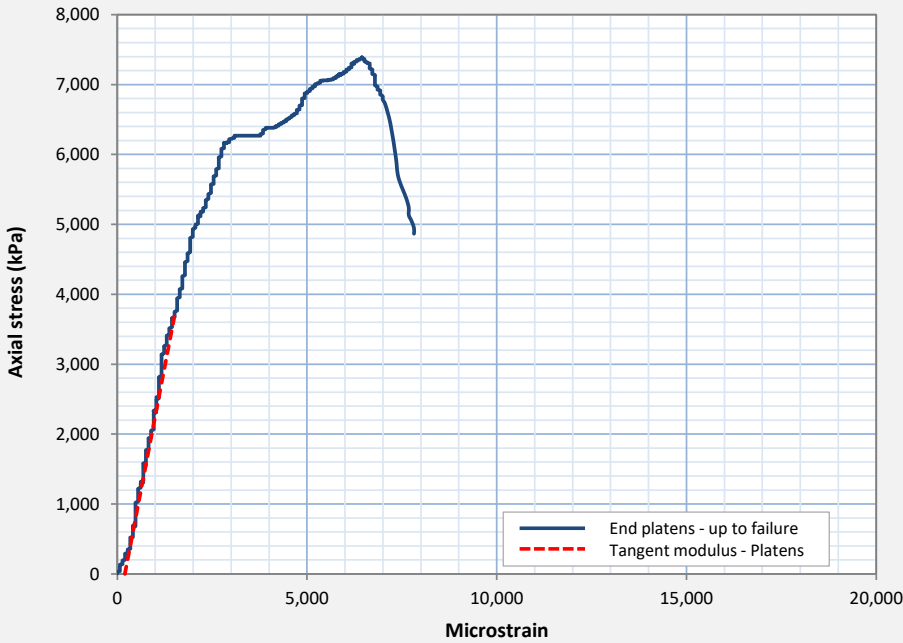
Tangent platen modulus*: 2.8 GPa Uniaxial Compressive Strength: 7.4 MPa			
		<i>*Inferred at 50% of peak axial stress (using end platen strain)</i>			
		Mode of failure: Failure by vertical shear with splitting

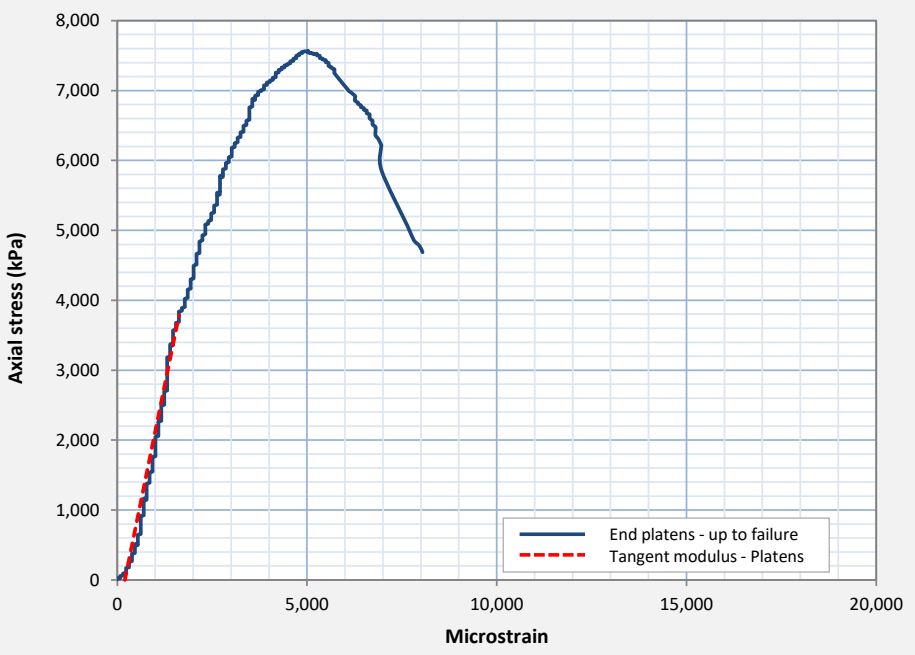
Tangent platen modulus*: 2.7 GPa		Uniaxial Compressive Strength: 7.6 MPa	
		*Inferred at 50% of peak axial stress (using end platen strain)			
Mode of failure:		Failure by diagonal shear approximately 80 degrees to horizontal with splitting

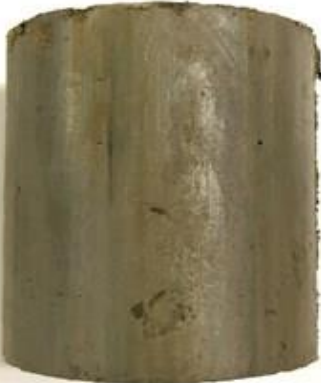
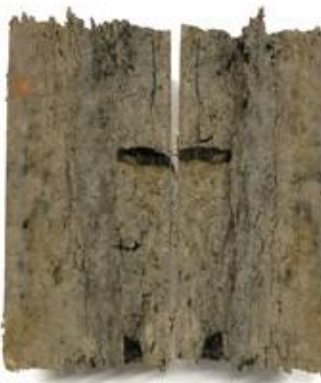
Pre-test photo	Post-test photo	Permeability test details

Permeant used:	Distilled water
		Method of saturation:	Back pressure saturation
		Estimate of initial saturation:	97.7%
		Saturation B value:	98%
		Confining Pressure (kPa):	1550
		Inlet Pressure (kPa):	1510
		Outlet Pressure (kPa):	1490
		Mean effective stress (kPa):	50
		Hydraulic Head (kPa):	20
		Moisture content after test:	13.8%
Permeability: (m/s)		2E-09
