# **SURVEY AND ASSESSMENT OF LANDSCAPES**

## **6.0 SURVEY AND ASSESSMENT OF LANDSCAPES**

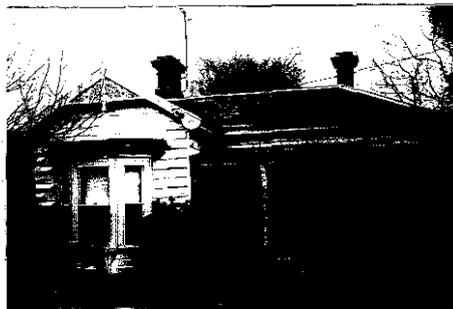
VICTORIAN WEATHERBOARD HOUSE  
WITH RUSTICATED FRONT

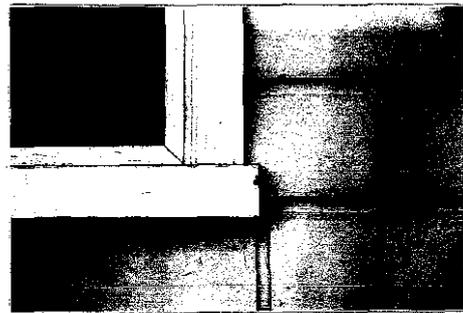
DETAIL - RUSTICATED WEATHERBOARDS

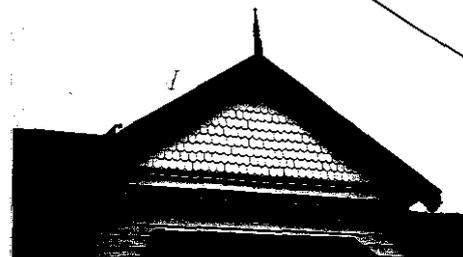
IMITATION SHINGLES TO GABLE

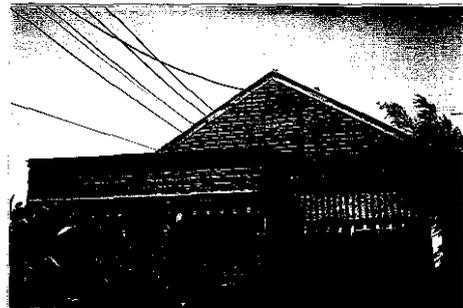
IMITATION BRICK CLADDING AND UNSYMPATHETIC ADDITION

In recent years a great many external wall lining materials have been placed on the market to be fixed over timber weatherboards or in place of them. These materials are generally promoted as providing maintenance free finishes, and they range from aluminium and fibre cement imitation weatherboards, to imitation brick and stone. While some of these materials do reduce maintenance painting many do not, and they in turn produce their own maintenance problems. These can result from inadequate protection to the building due to poor installation, or from the poor quality of the product itself. By retaining moisture behind them they can promote rotting in the original cladding or in the wall structure itself.

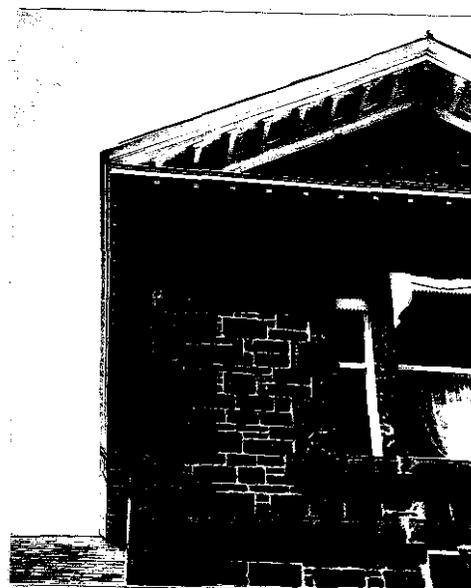
HEAVY QUOINING TO AN EARLY BLUESTONE FACADE

It was common for masonry buildings to be embellished with decorative dressings around their corners, openings and parapets. Corners, and door and window openings were sometimes provided with quoins which consisted of raised sections of brickwork projecting out from the facade. A similar effect was achieved by using different coloured bricks set flush with the facade. The tops of openings were supported with curved iron bars, called arch bars, or by flat gauged brick arches which were sometimes formed from specially shaped bricks. Near the top of the facade a projecting string course was often included to break the line of upper facade. This consisted of one or more projecting courses of masonry either left exposed or rendered.

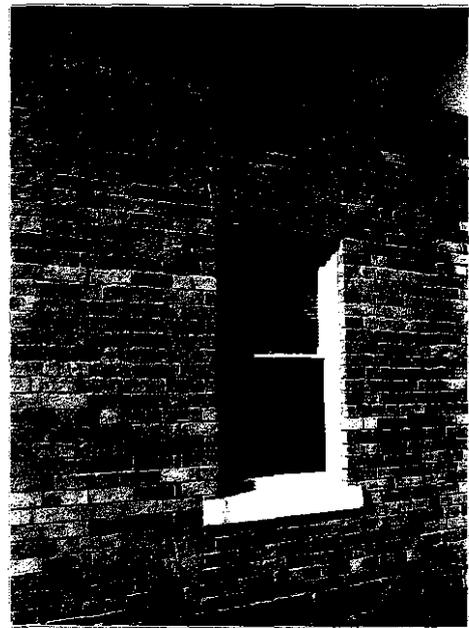
SEVERE EROSION CAUSED BY  
SANDBLASTING

Where polychromatic buildings have been painted this has often been done for reasons of fashion in the twentieth century. On occasions it was also done to waterproof the facade. This has been ill-advised, because the application of a paint membrane is often detrimental, having a suffocating effect on the brickwork, inhibiting its ability to breathe and causing dampness to rise higher up the wall or pass to its interior face to escape. It is also important to remember that another reason for previous owners to have overpainted a wall is where alterations have been made to the building, such as bricking-in a door or window, or adding a room in ill-matching brickwork. Careful observation of the brickwork should be made to determine whether subsequent patching of the brickwork has been undertaken on the building in question. If the brickwork does appear intact, the overpainting can in many cases be easily removed without damaging the brickwork or the mortar joints. The most effective method of paint removal is through the application of an appropriate solvent that is then removed by steam or hot water. The more effective solvents are usually methylene chloride based but at higher strengths than are generally available commercially. Other chemicals such as caustic soda or acids may dissolve the paint but they leave harmful salts in the brickwork and should not be used. Steam cleaning is a process performed by several contractors in Melbourne, and it is fast and very effective. It is important to note that sandblasting and other abrasive techniques of paint removal are very destructive to both the hard outer surface of bricks and the mortar joints and such techniques are in general **TOTALLY UNSUITABLE** for use on brick buildings.

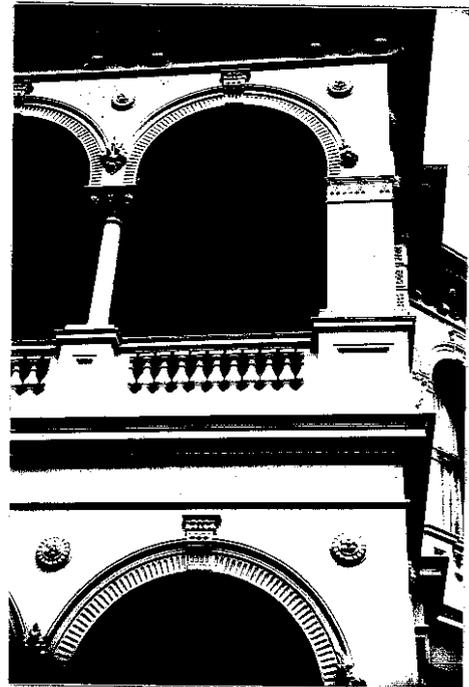
STUCCOED MASONRY WITH  
DECORATIVE MOULDINGS

The decorative mouldings that were applied were either run in situ, or precast and fixed to the building. Continuous mouldings such as cornices, hood mouldings over doors and windows, cappings and the like, were run with metal templates cut to the

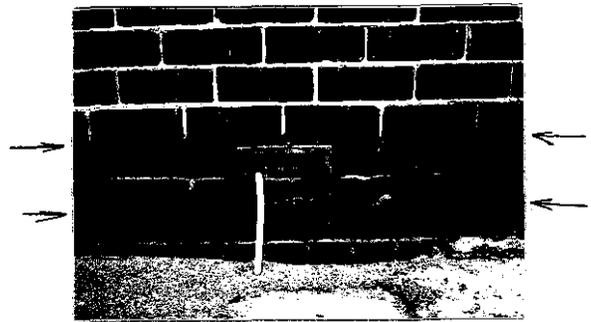
BITUMEN AND SAND DAMP PROOF COURSES VISIBLE ABOVE AND BELOW AN AIR VENT.

To prevent ground moisture rising up the structure, walls were provided with a damp proof course. This is a band of material that is impervious to water, set in one or more of the horizontal courses near to the ground. Its purpose is to stop the brickwork above absorbing ground water. The most common damp proof courses in nineteenth century buildings are

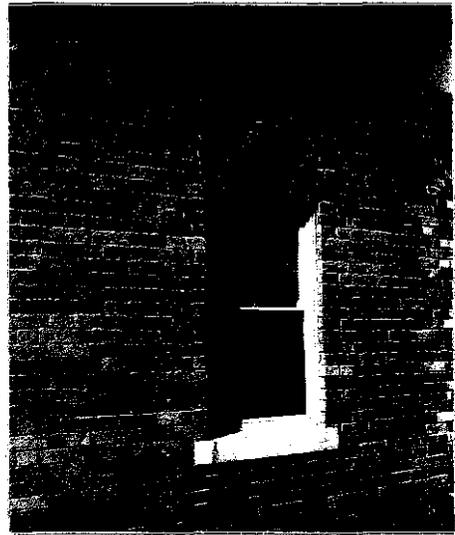
SEVERE EROSION CAUSED BY  
SANDBLASTING.

application of an appropriate solvent that is then removed by steam or hot water. The more effective solvents for oil and some acrylic paints are usually methylene chloride based but at higher strengths than are generally available commercially. Other chemicals such as caustic soda, or acids may dissolve the paint but they leave harmful salts in the masonry and should not be used. Steam cleaning is a process performed by several contractors in Melbourne, and it is fast and very effective. One of the problems with the process is that it will not remove putty and plaster fillers that are sometimes applied to brickwork before painting. Where this is the case it may be preferable to repaint rather than to clean off the paint. To determine the potential effectiveness of the approach always carry out a small trial area of cleaning before proceeding. It is important to note that sandblasting and other abrasive techniques of paint removal are very destructive to both the hard outer surface of bricks and the mortar joints and such techniques are **TOTALLY UNSUITABLE** for use on brick buildings.

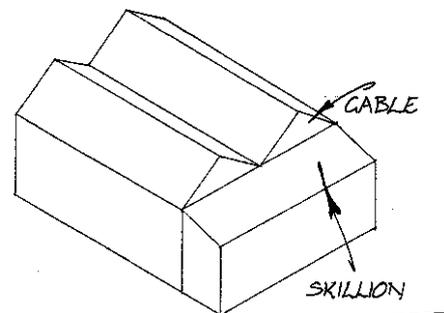
THE THREE BASIC ROOF FORMS.

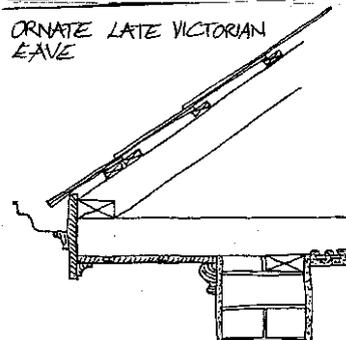
TYPICAL VICTORIAN SIDE EAVE DETAIL.

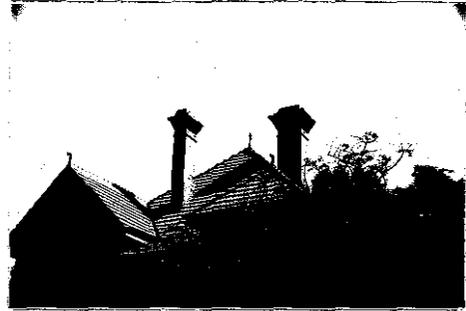
TALL BRICK CHIMNEYS WITH CORBELLED TOPS.

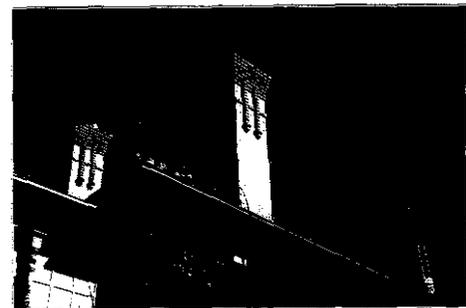
CHIMNEYS WITH CORBELLED BRICK TOPS AND STRAPWORK OVER ROUGHCAST RENDER SHAFTS.

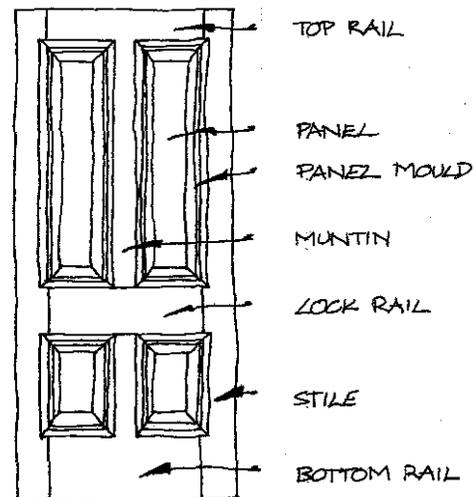
TYPICAL FOUR PANEL DOOR.

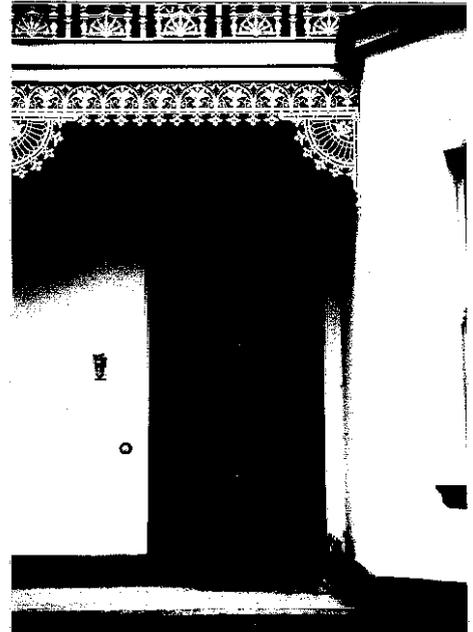
SIX PANEL DOOR WITH GLAZED FANLIGHT AND SIDELIGHTS.

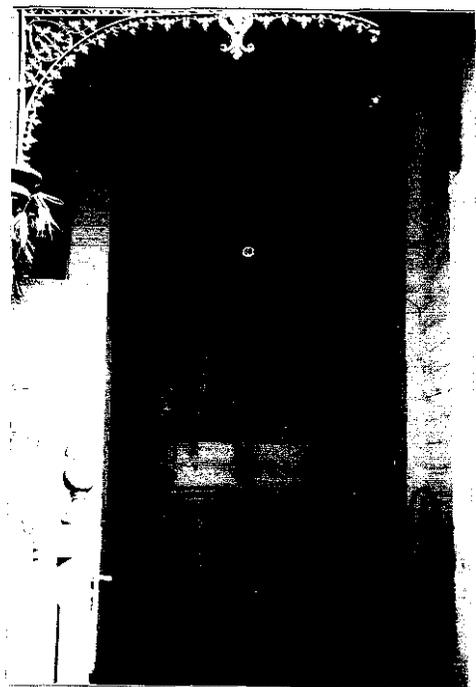
FOUR PANEL DOOR WITH GLAZED FANLIGHT AND SIDELIGHTS.

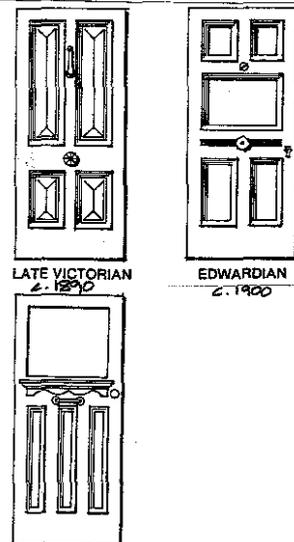
TYPICAL LATE VICTORIAN AND EDWARDIAN DOORS.

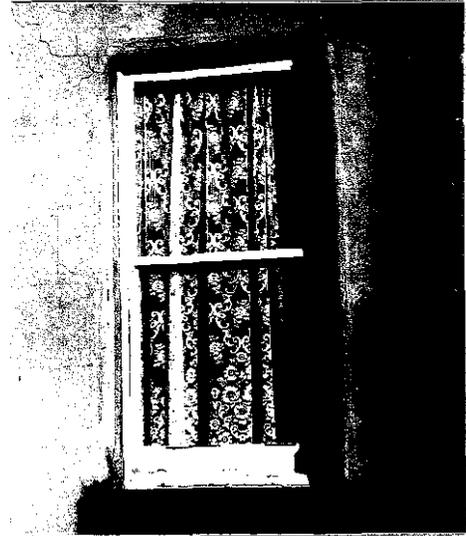
TYPICAL VICTORIAN DOUBLE HUNG  
SASH WINDOW

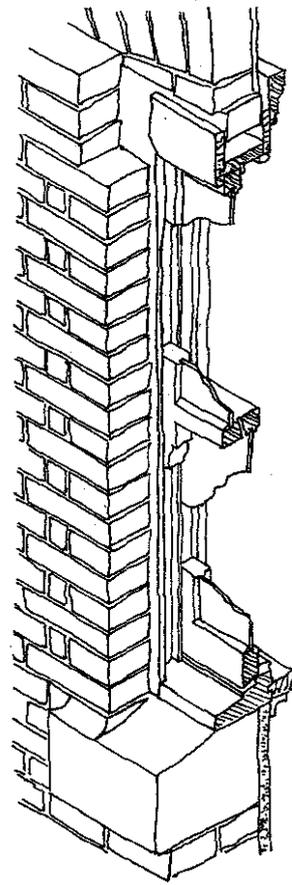
SECTION THROUGH A DOUBLE HUNG WINDOW.

The window furniture, that is the sash lifts and locks, was generally chosen from a relatively limited number of types and varied in quality with the scale of the building. The sash lifts were applied to the bottom rail of the lower sash, and were usually either brass rings or inverted hooks. The lock was applied to the meeting rail of the lower sash and the most common types used a lever action to slide in under the keeper

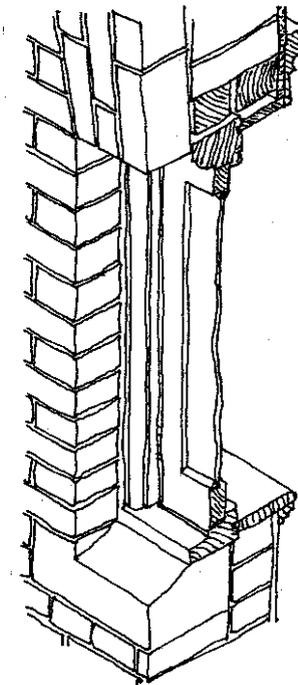
SECTION THROUGH A TYPICAL CASEMENT

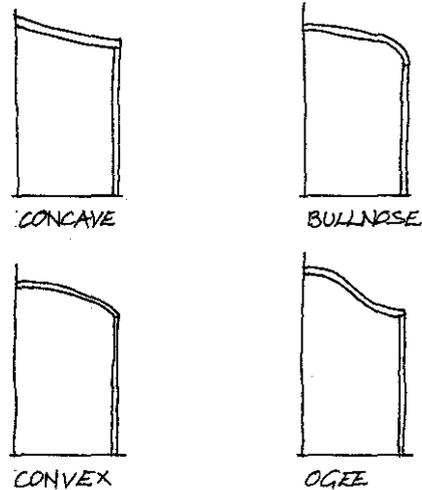
TYPICAL VERANDAH ROOF PROFILES.

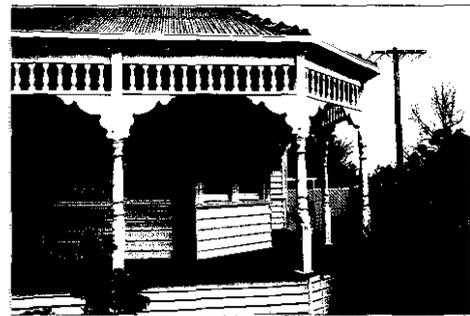
TYPICAL EDWARDIAN VERANDAH  
NB: VERANDAH ROOF IS A CONTINUATION OF THE MAIN ROOF BUT HAS A MORE GENTLE PITCH.

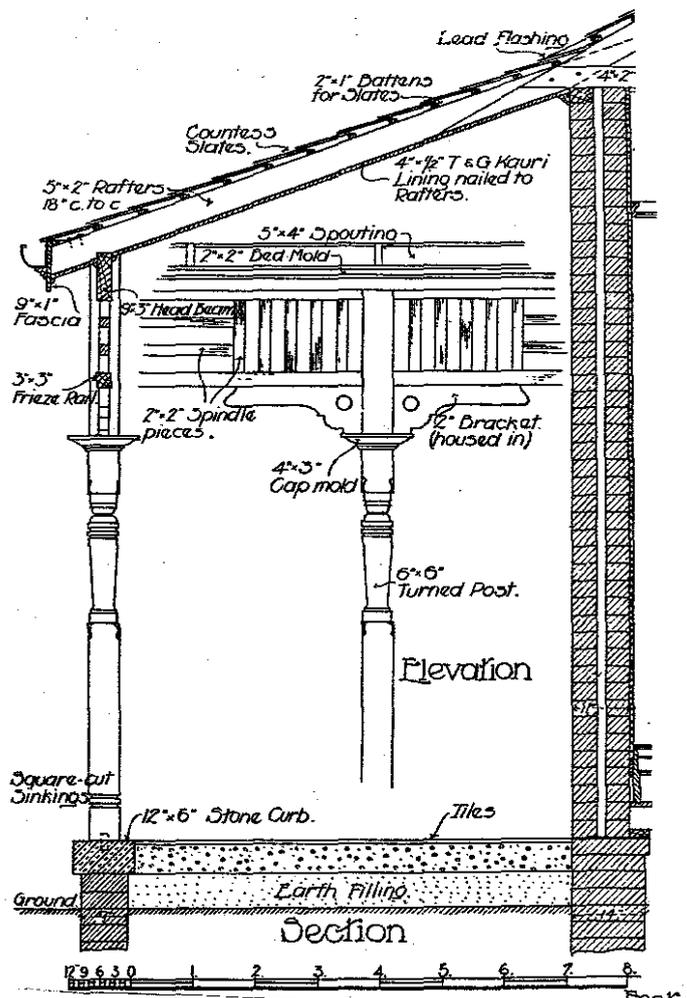
TYPICAL SECTION THROUGH VERANDAH  
(R. HADDON AUSTRALIAN ARCHITECTURE 1908)

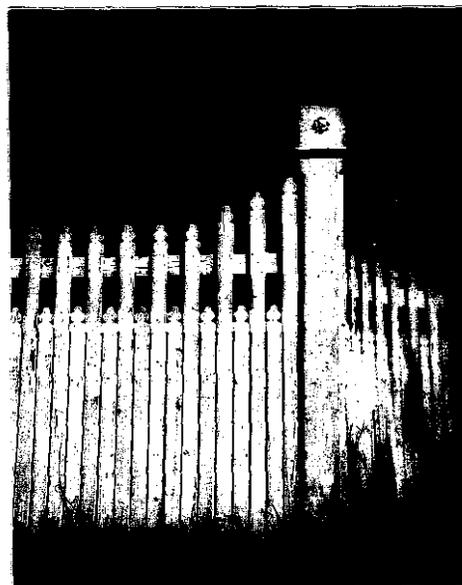
ORNATE VICTORIAN PICKET FENCE  
 NB: STOP CHAMFERED POST  
 CAST METAL ROSETTE AND  
 POST CAPPING.

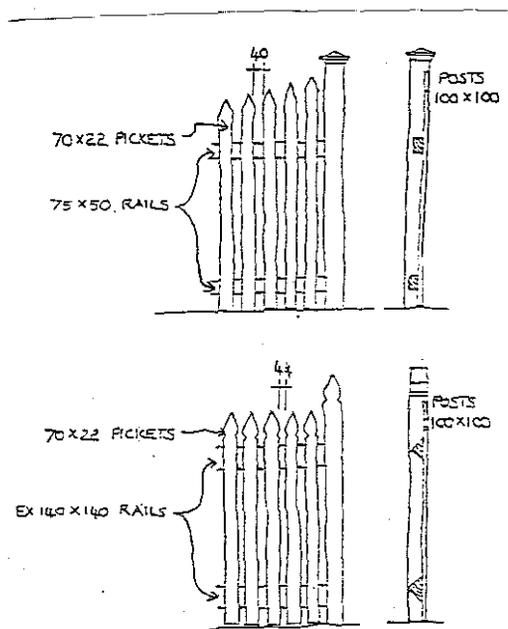
TYPICAL PICKET FENCE DETAILS.

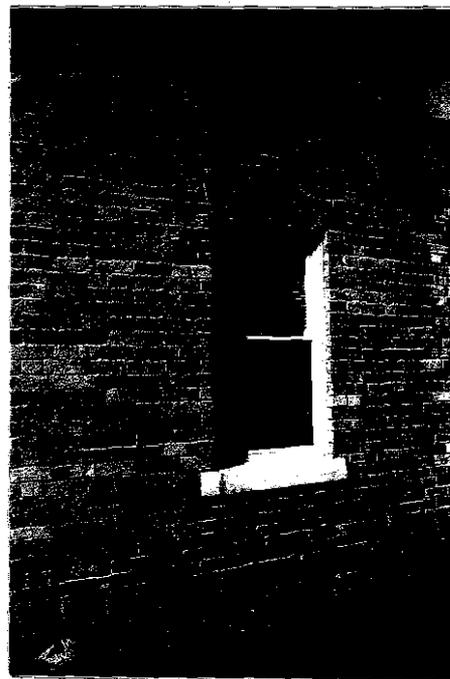
SEVERE EROSION CAUSED BY  
SANDBLASTING.

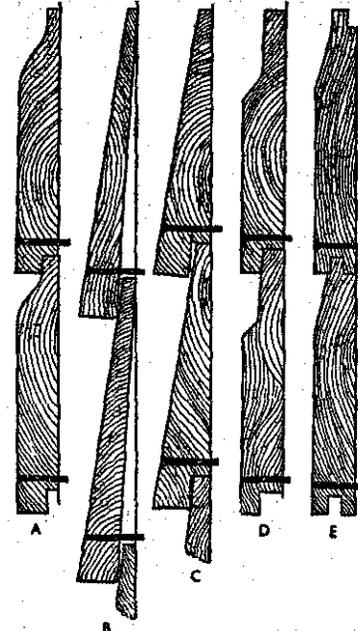
Fig. 1. Five types of weather boarding. B, the most commonly used and suitable for all general work, permits some adjustment of overlap. A, C and D, being rebated, and E, tongued and grooved, have a fixed overlap; but these possess a somewhat better appearance and superior weather-proof qualities.
