E. Arborist Report

Siena College Masterplan development Riversdale Road, Camberwell VIC Arboricultural Impact Assessment

Arboricultural Impact Assessment Report regarding ninety-six (96) trees located within the vicinity of the proposed Masterplan (Stages 1–4) at Siena College, 815 Riversdale Road, Camberwell

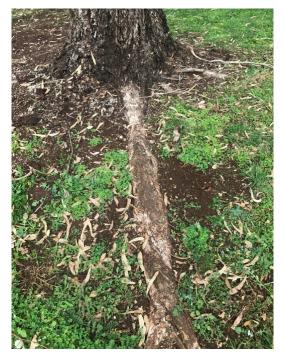
Damage to tree roots (Figure 35 and Figure 36) and the lower portion of a tree's trunk is a common and often unnecessary occurrence that can lead to the entry of decay fungi into a tree's structural framework. Once present, decay may develop in larger structural roots and/or the base of the trunk, which can result in a reduction in tree health and in severe cases even compromise stability.

Figure 35. An example of damage to tree roots caused via mowing. (Luke Dawson, June 2017).

Another advantage to mulching around the trunk and root crown is that it limits damage to both parts from mowing equipment. This in turn reduces mechanical damage and compaction.

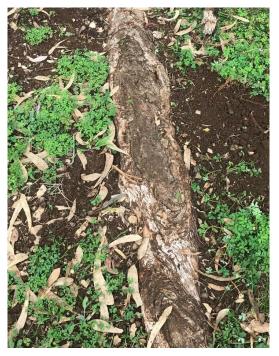
Figure 36. Image showing wound caused to upper portion of surface root by mower. (Luke Dawson, June 2017).

- Mulching around young and established trees negates the need for brush cutter and/or lawn mower use around the base of a tree. Mulching therefore not only creates a barrier between tree roots and trunk that are susceptible to damage, it improves soil condition, minimises soil compaction and decreases the total area required for mowing.

- Where mulching is not feasible, raising the cutting height of mowers and maintaining grass at a greater height can avoid unnecessary 'scalping' of roots and damage to mowers/blades.
