Structural Inspection Report

32 Corby Street, Balwyn North VIC 3104

Prepared for Sanjiv Vij

Project Ref No.	16949	Version	2	Date	27/04/2022
Version	Issue Description				Date
1	FINAL – Issued to Client				September 29, 2021
2	FINAL – Issued to Client				April 27, 2022
<i>This report has been prepared in accordance with the terms and conditions of appointment. YG Consulting Engineers cannot accept any responsibility for any use of or reliance on the contents of this report by any third party.</i>

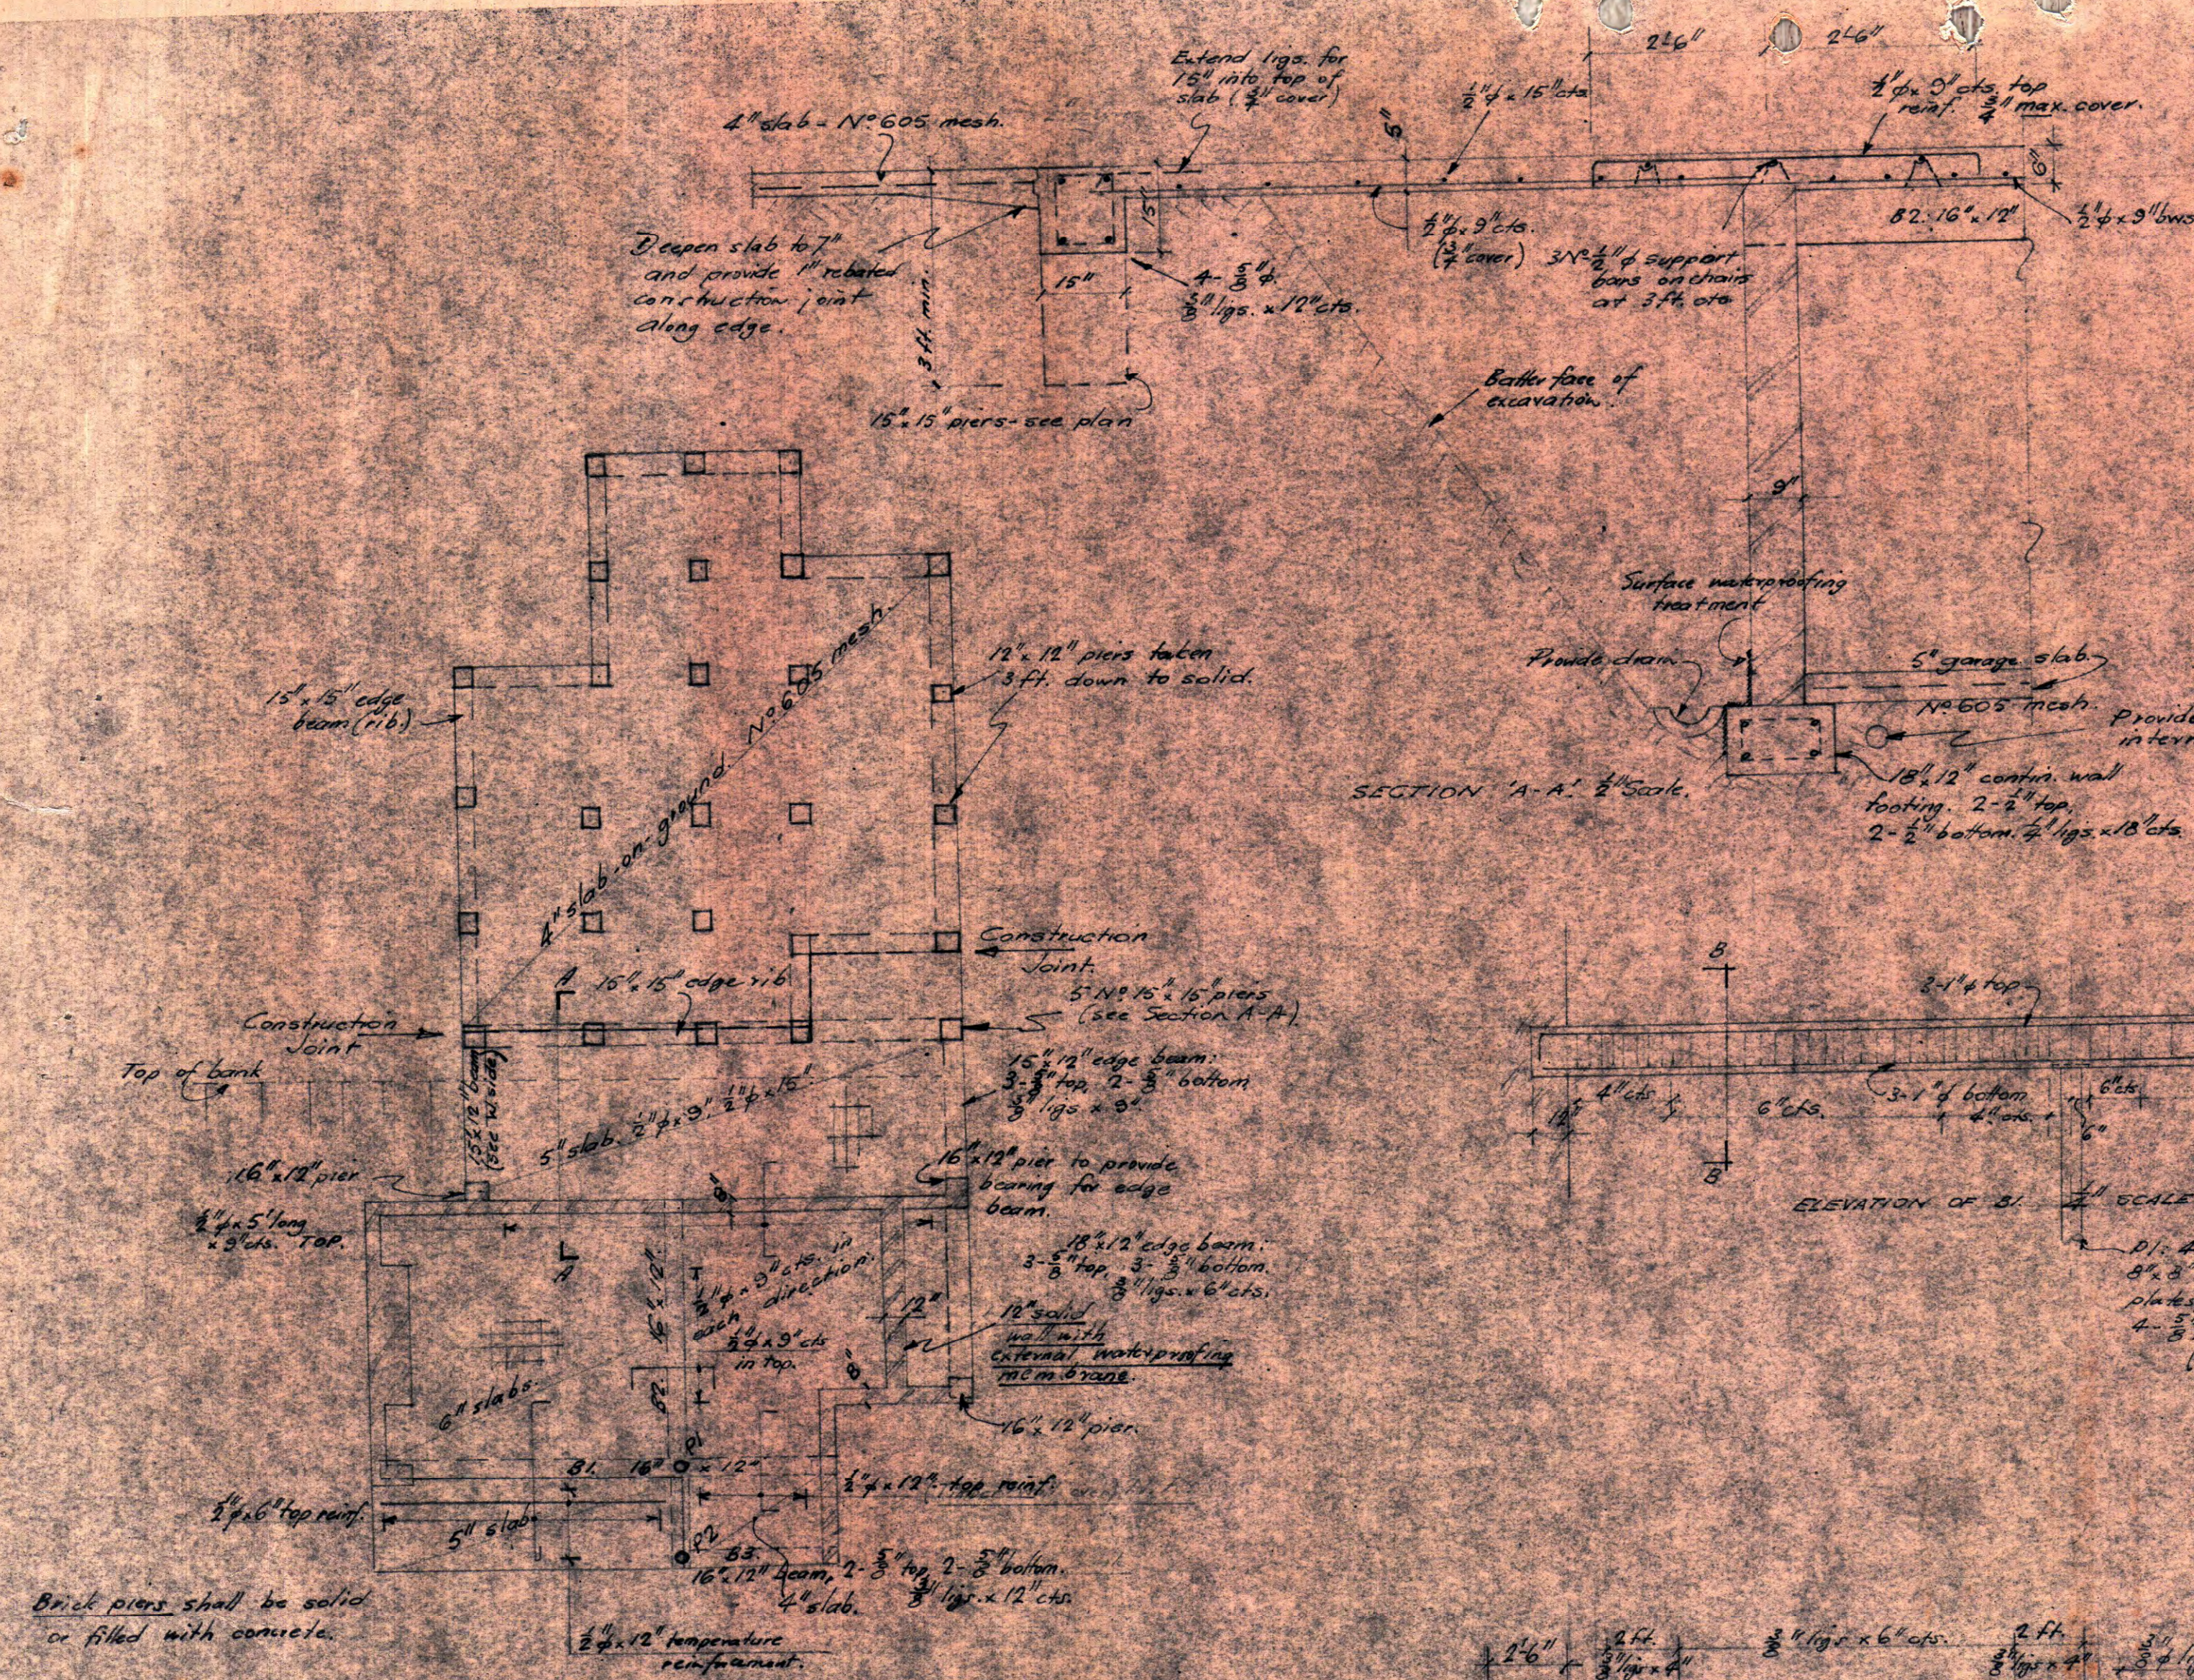
FLOOR CONSTRUCTION PLAN 3/8" Scale.
(Showing walls columns etc. under.)

In addition to the defects listed above, we have analysed existing construction drawings (see Appendix B) for the subject building. The construction drawings show the floor construction plan for the subject building, with a cross-section detail of the storeroom area marked as 'Section A-A'. We encountered a discrepancy in which the storeroom area is shown as a subfloor with soil batter. We believe that additional construction works were undertaken in the storeroom area after the subject building was built by underpinning the walls to create a new storage space. The Client shall investigate whether a building permit was lodged with the Council for these works. As the construction drawings show soil batter in the storeroom, the upper floor slab directly above this area may not have been designed to span the entire width of the storeroom. Our concern is that these additional works could have potentially affected the structural integrity of the subject building.
