Creswick Estate Precinct (HO646)

Grading Assessment Date: 17 August 2018

Address: 14 and 16 Calvin Street, Hawthorn

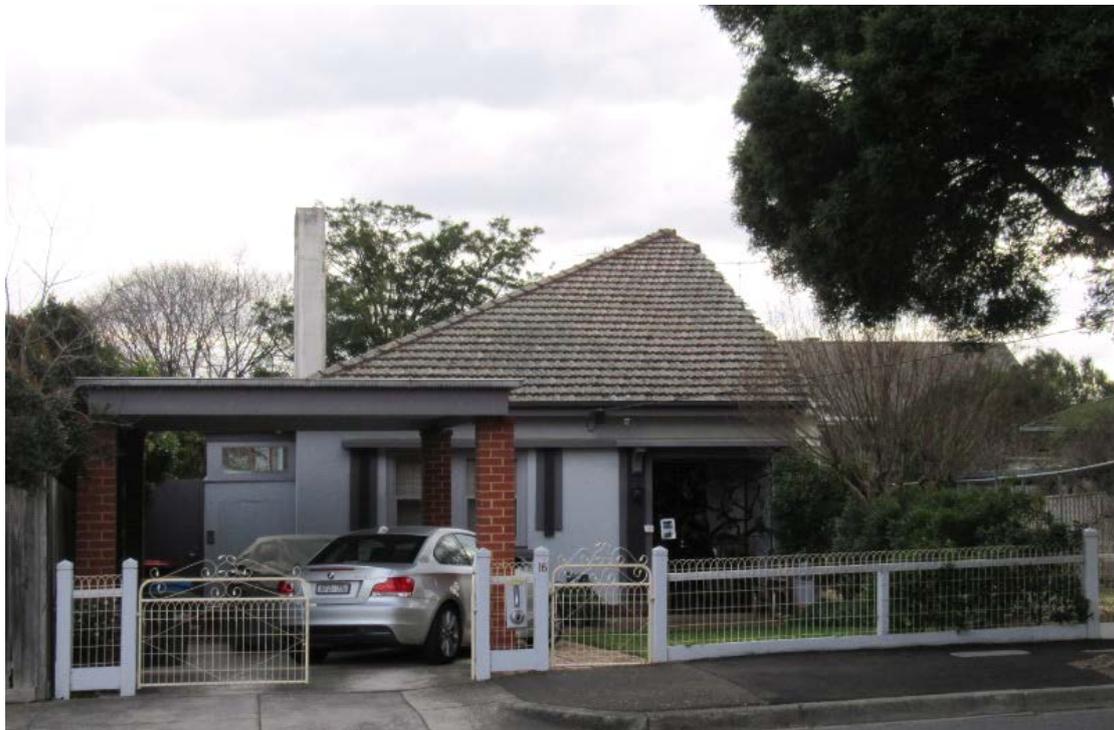
Figure 1. 16 Calvin Street (left) and the vacant lot (right) where the other half of the semi-detached pair was located. (City of Boroondara, August 2018)

However, 14 Calvin Street was demolished in January 2017 after the study was adopted by Council and submitted to the Minister for Planning for approval. This left half of the semi-detached pair at 16 Calvin Street (depicted on the previous page).

The remaining half of the semi-detached pair at 16 Calvin Street has not changed, in and of itself, since it was graded Contributory in 2014. However, the pair was originally massed to appear as a single dwelling, and the shared roof form was a very visually dominating high pyramidal hip. In its current state, 16 Calvin Street is clearly an entirely incomplete composition, as the two dwellings were designed to be read as a single whole. Unlike Victorian and some Edwardian semi-detached houses that have a repetitive composition divided by party walls, 14 & 16 Calvin Street are more accurately compared to a double-fronted house that has lost half of its front façade and roof. Much like a double-fronted house that had been half-demolished, the remaining half at 16 Calvin Street no longer has the intactness to be Contributory in the precinct.

For this reason, it too should be downgraded to Non-contributory.

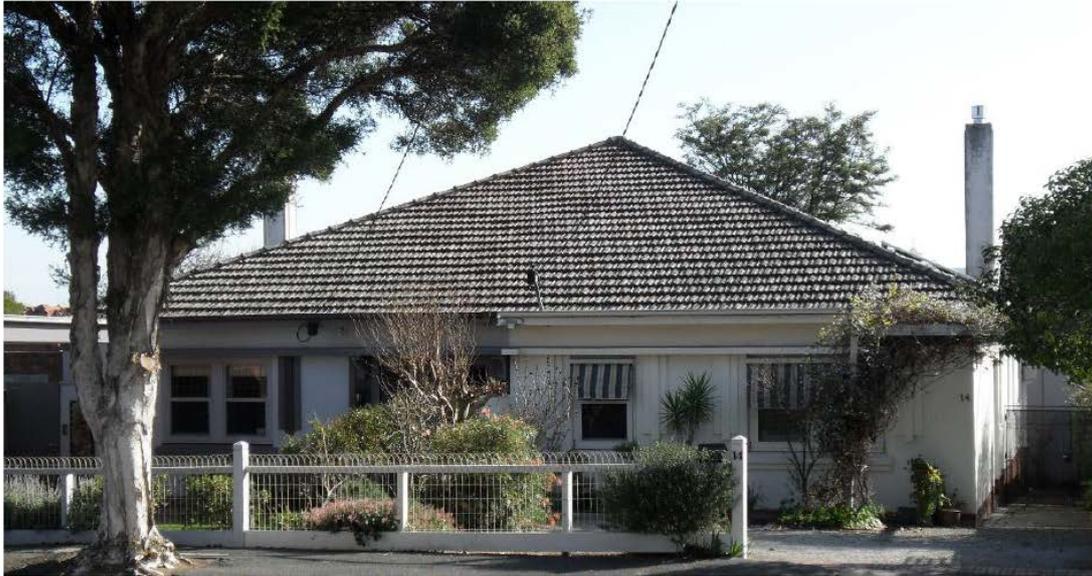
In the precinct citation, they were described as follows: *An example of the Moderne style is the duplex at 14-16 Calvin Street, with a high pyramidal roof and raised vertical strips around the windows.*

Figure 8. Moderne duplex at 14-16 Calvin Street, c1935-37. (Contributory)

Due to its high intactness, at that time, and because the precinct is significant for its interwar-era development including late-interwar duplexes, the pair was graded Contributory.
